ARBORIST REPORT & TREE PROTECTION PLAN

720 GRANITE COURT
PICKERING, ONTARIO

Date of Inspection: November 30, 2021

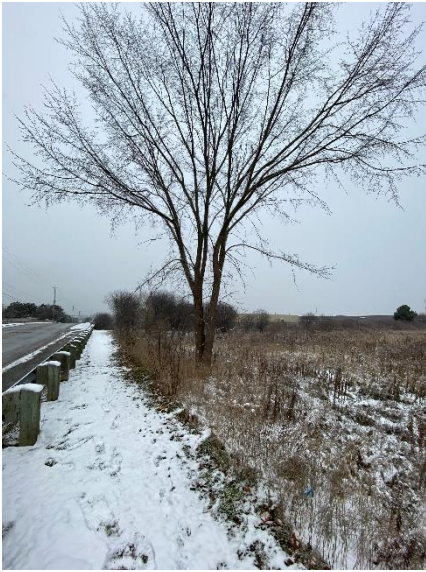
Figure 1: Tree 1

Tree #1 – White Elm (36.8, 38.5cm DBH)

Tree #1 36.8/38.8cm DBH White Elm (*Ulmus americana*) is a privately-owned deciduous tree growing adjacent to Granite Road to the west of the property. The tree has co-dominant stems and is botanically and structurally in good condition. This tree is in good overall condition. This tree conflicts with the proposed manhole location, removal with replacement planting is recommended.

| TREE INVENTORY & ASSESSMENT – 720 Granite Crt., Pickering | | | | | | | | | | | |
|---|---|---|---|---|---|---|---|---|---|---|---|
| 1 | American Elm | <i>Ulmus americana</i> | 36.8, 38.5 | Good | Good | Good | Good | Private | Dripline (5m) | The tree has good health, structure | Remove (P) |

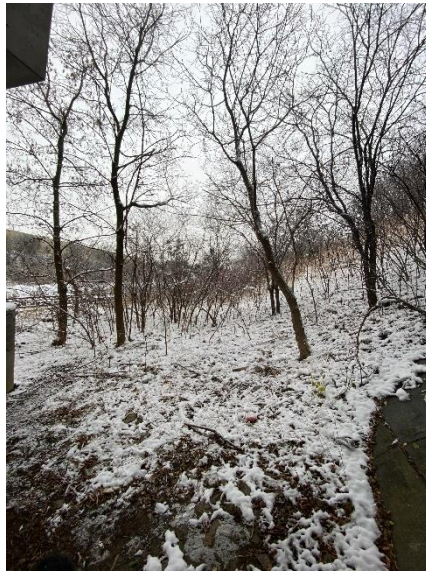
Figure 2: Tree 2-4

Tree #2 – Manitoba Maple (15cm DBH)

Tree #2, a 15cm DBH Manitoba Maple (*Acer negundo*) is a privately-owned deciduous tree growing on a slope. The tree has a bent trunk, and 20% dead branches. The tree is in fair overall condition. This tree conflicts with the proposed development, removal and replacement planting with a more desirable species is recommended.

Tree #3 – Manitoba Maple (17cm DBH)

Tree #3, a 17 cm DBH Manitoba Maple (*Acer negundo*) is a privately-owned deciduous tree growing on a slope close to a bridge. The tree has a bent trunk, 5% dead branches. The tree is in good overall condition. This tree conflicts with the proposed development, removal and replacement planting with a more desirable species is recommended.

Tree #4 – Manitoba Maple (18cm DBH)

Tree #4, an 18cm DBH Manitoba Maple (*Acer negundo*) is a privately-owned deciduous tree growing on a slope close to a bridge. The tree has a bent trunk, <5% dead branches, and is in fair health and structural condition, but in poor form due to the bent top. The tree has one dead overhanging branch. The tree is in fair overall condition. This tree conflicts with the proposed development, removal and replacement planting with a more desirable species is recommended.

| TREE INVENTORY & ASSESSMENT – 720 Granite Crt., Pickering | | | | | | | | | | | |
|---|---|---|---|---|---|---|---|---|---|---|---|
| 2 | Manitoba Maple | <i>Acer negundo</i> | 14.5 | Fair | Fair | Fair | Fair | Private | Dripline (3m) | Bent trunk, 20% dead branches, growing on the slope | Remove (P) |
| 3 | Manitoba Maple | <i>Acer negundo</i> | 17 | Good | Good | Good | Good | Private | Dripline (3m) | ~5% dead and dying branches, healthy tree | Remove (P) |
| 4 | Manitoba Maple | <i>Acer negundo</i> | 18 | Fair | Fair | Fair | Fair | Private | Dripline (2.5) | Bent top, one hanging dead branch | Remove (P) |

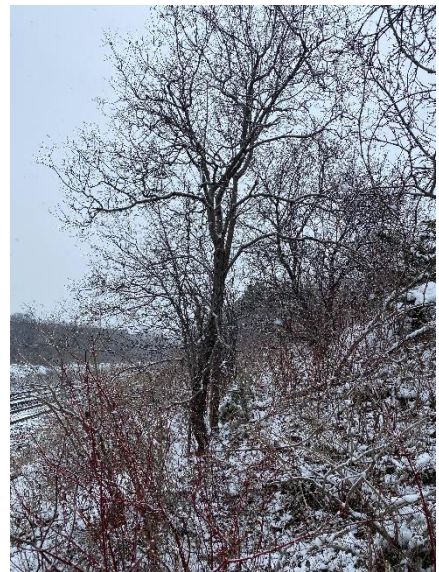
Figure 3: Tree 5

Tree #5 – Pin Cherry (20cm DBH)

Tree #5 is a 20 cm DBH Cherry tree (*Prunus species*) is a privately-owned deciduous tree growing at the mid-slope of the subject property. This tree has fair form, declining health, and fair structural condition. The tree has ~10% dead branches. The tree is in fair overall condition. This tree conflicts with the proposed development, removal and replacement planting is recommended.

| TREE INVENTORY & ASSESSMENT – 720 Granite Crt., Pickering | | | | | | | | | | | |
|---|---|---|---|---|---|---|---|---|---|---|---|
| 5 | Pin Cherry | <i>Prunus species</i> | 20 | Fair | Poor | Fair | Fair | Private | Dripline (2.5) | Growing on a slope, multiple dead branches, poor form | Remove (P) |

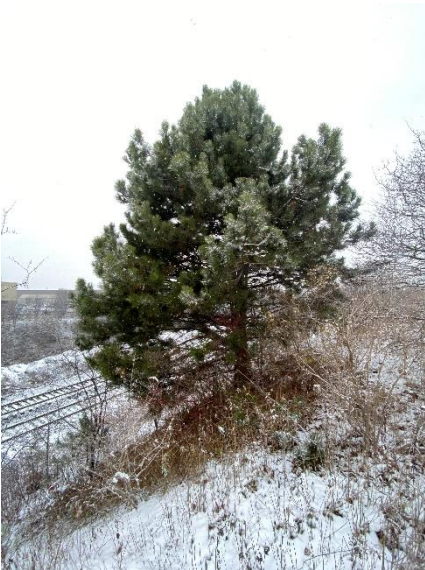
Figure 4: Tree 6

Tree #6 – Austrian Pine (40cm DBH)

Tree #6 is a 40cm DBH Austrian Pine (*Pinus nigra*) is a privately-owned evergreen tree growing at the top of the slope. This tree has fair form, good health, and structural condition. The tree is in good overall condition. This tree conflicts with the proposed development, removal and replacement planting is recommended.

| TREE INVENTORY & ASSESSMENT – 720 Granite Crt., Pickering | | | | | | | | | | | |
|---|---|---|---|---|---|---|---|---|---|---|---|
| 6 | Austrian Pine | <i>Pinus nigra</i> | 40 | Good | Good | Good | Good | Private | Dripline (5m) | Botanically and structurally tree is in good condition | Remove (P) |

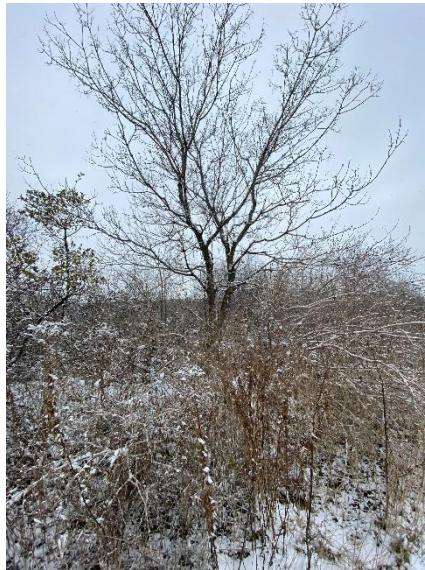
Figure 5: Tree 7

Tree #7 – Manitoba Maple (15cm DBH)

Tree #7, a 15 cm DBH Manitoba Maple (*Acer negundo*) is a privately owned deciduous tree growing on level ground. This tree has less than 10% dead small dead branches, fair form and structure, with good health. The tree is in fair overall condition. This tree conflicts with the proposed development, removal and replacement planting with a more desirable species is recommended.

| TREE INVENTORY & ASSESSMENT – 720 Granite Crt., Pickering | | | | | | | | | | | |
|---|---|---|---|---|---|---|---|---|---|---|---|
| 7 | Manitoba Maple | <i>Acer negundo</i> | 13, 15 | Fair | Fair | Fair | Fair | Private | Dripline (3m) | Codominant stem , few dead branches, fair health, included bark | Remove (P) |

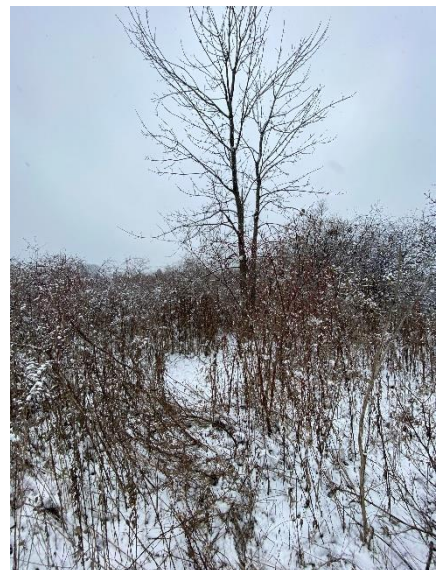
Figure 6: Tree 8

Tree #8 – Ash Tree (15cm DBH)

Tree #8, a 15cm DBH dead Ash tree (*Fraxinus species*) is a privately-owned deciduous tree growing on the subject property at level ground. The tree is 100% dead. The tree is recommended for removal.

| TREE INVENTORY & ASSESSMENT – 720 Granite Crt., Pickering | | | | | | | | | | | |
|---|---|---|---|---|---|---|---|---|---|---|---|
| 8 | Ash Tree | <i>Fraxinus species</i> | 15 | Poor | Poor | Poor | Dead | Private | Dripline | The tree is 100% dead | Remove (E) |

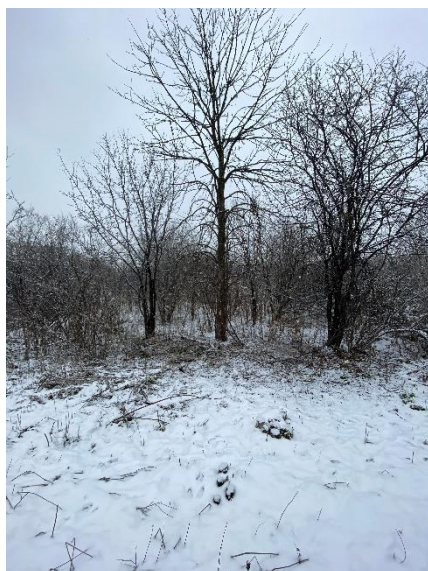
Figure 7: Tree 9

Tree #9 – Ash Tree (18cm DBH)

Tree #9, an 18cm DBH dead Ash tree (*Fraxinus species*) is a privately-owned deciduous tree growing on the subject property on the southern side, at the middle of the slope. The tree is in good structural condition. Some internal smaller branches are dead. This tree is in good overall condition. This tree conflicts with the proposed development, removal and replacement planting with a more desirable species is recommended.

| TREE INVENTORY & ASSESSMENT – 720 Granite Crt., Pickering | | | | | | | | | | | |
|---|---|---|---|---|---|---|---|---|---|---|---|
| 9 | Ash Tree | <i>Fraxinus species</i> | 18 | Poor | Poor | Poor | Dead | Private | Dripline | The tree is 100% dead | Remove (E) |

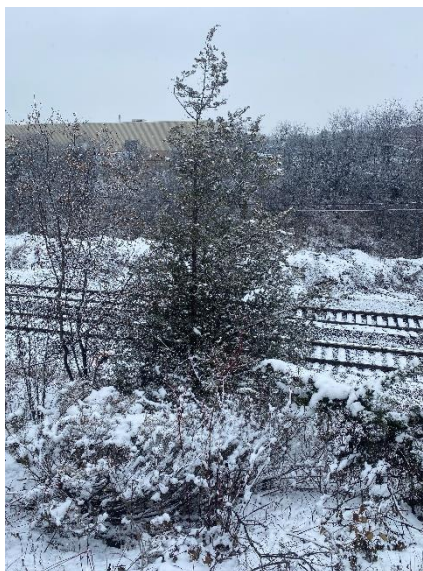
Figure 8: Tree 10

Tree #10– Eastern White Cedar (15cm DBH)

Tree #10, a 15cm DBH Eastern White Cedar (*Thuja occidentalis*) is a privately-owned evergreen tree growing on the subject property at level ground. The tree is 100% dead. The tree is recommended for removal.

| TREE INVENTORY & ASSESSMENT – 720 Granite Crt., Pickering | | | | | | | | | | | |
|---|---|---|---|---|---|---|---|---|---|---|---|
| 10 | E. White Cedar | <i>Thuja occidentalis</i> | 15 | Good | Good | Good | Good | Private | Dripline (2.5) | A healthy tree with good structure | Remove (P) |

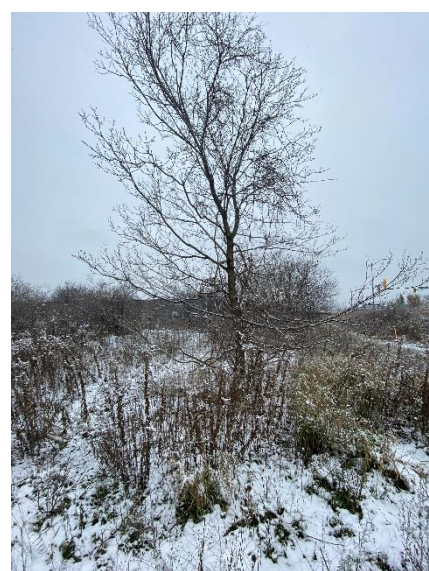
Figure 9: Tree 11

Tree #11 – Manitoba Maple (16cm DBH)

Tree #11, a 16 cm DBH Manitoba Maple (*Acer negundo*) is a privately owned deciduous tree growing on level ground. This tree has less than 10% dead small dead branches, fair form, and fair structure with good health. The tree is in fair overall condition. This tree is recommended for removal, as it conflicts with proposed development. Replacement planting is recommended.

| TREE INVENTORY & ASSESSMENT – 720 Granite Crt., Pickering | | | | | | | | | | | |
|---|---|---|---|---|---|---|---|---|---|---|---|
| 11 | Manitoba Maple | <i>Acer negundo</i> | 16 | Poor | Fair | Poor | Poor | Private | Dripline (2m) | Broken branch, wound, missing bark | Remove (P) |
