# ARBORIST REPORT

**PROJECT NAME:** 1163 Kingston Road  
**PROJECT NUMBER:** TRC148  
**DATE OF INSPECTIONS:** August 9, 2023  
October 23, 2023  
**PERSONS PRESENT:** Mike Hukezalie, ISA Certified Arborist

**LOCATION:** 1101A, 1105, 1163 Kingston Rd  
Pickering, Ontario.  
**DESCRIPTION:** Arborist report

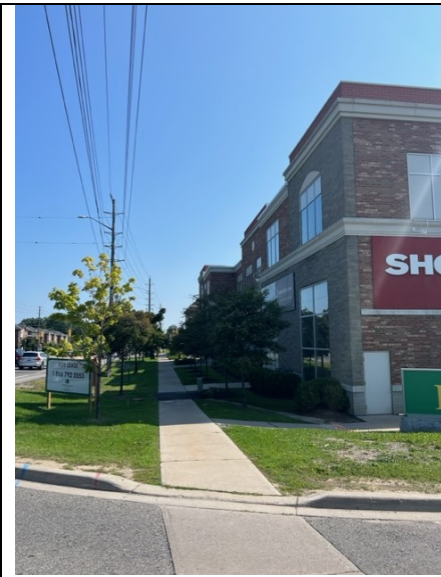
Image #1: View looking east along Kingston Road towards tree #501

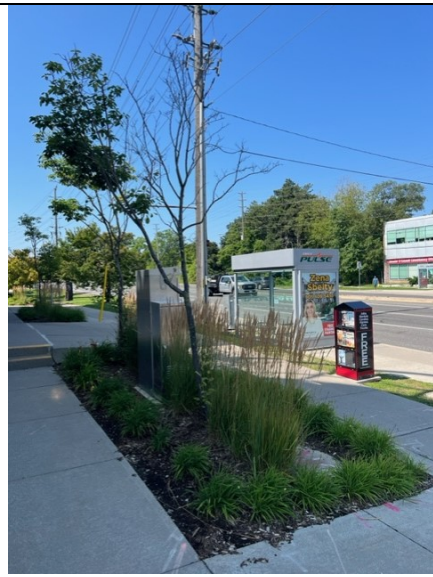
Image #2: View looking west along Kingston Road towards tree #521

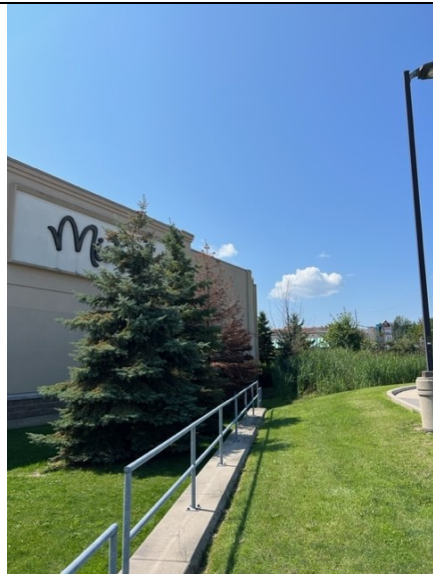
Image #7: View looking west towards group of conifer trees (#553 in foreground)

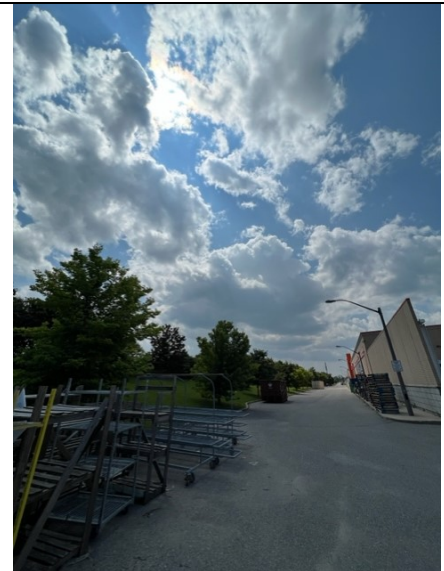
Image #12: View looking west along laneway running behind Home Depot (tree #593 in foreground)
