Project Name:
Liverpool House
 1294 Kingston Road
 City of Pickering

Sheet Title:
Tree Protection Plan

Designed: GM	Drawn: EA	Scale: 1:250	Drawing No.: TP-1
Date of Drawing: January 2019	Job No.: ADG001

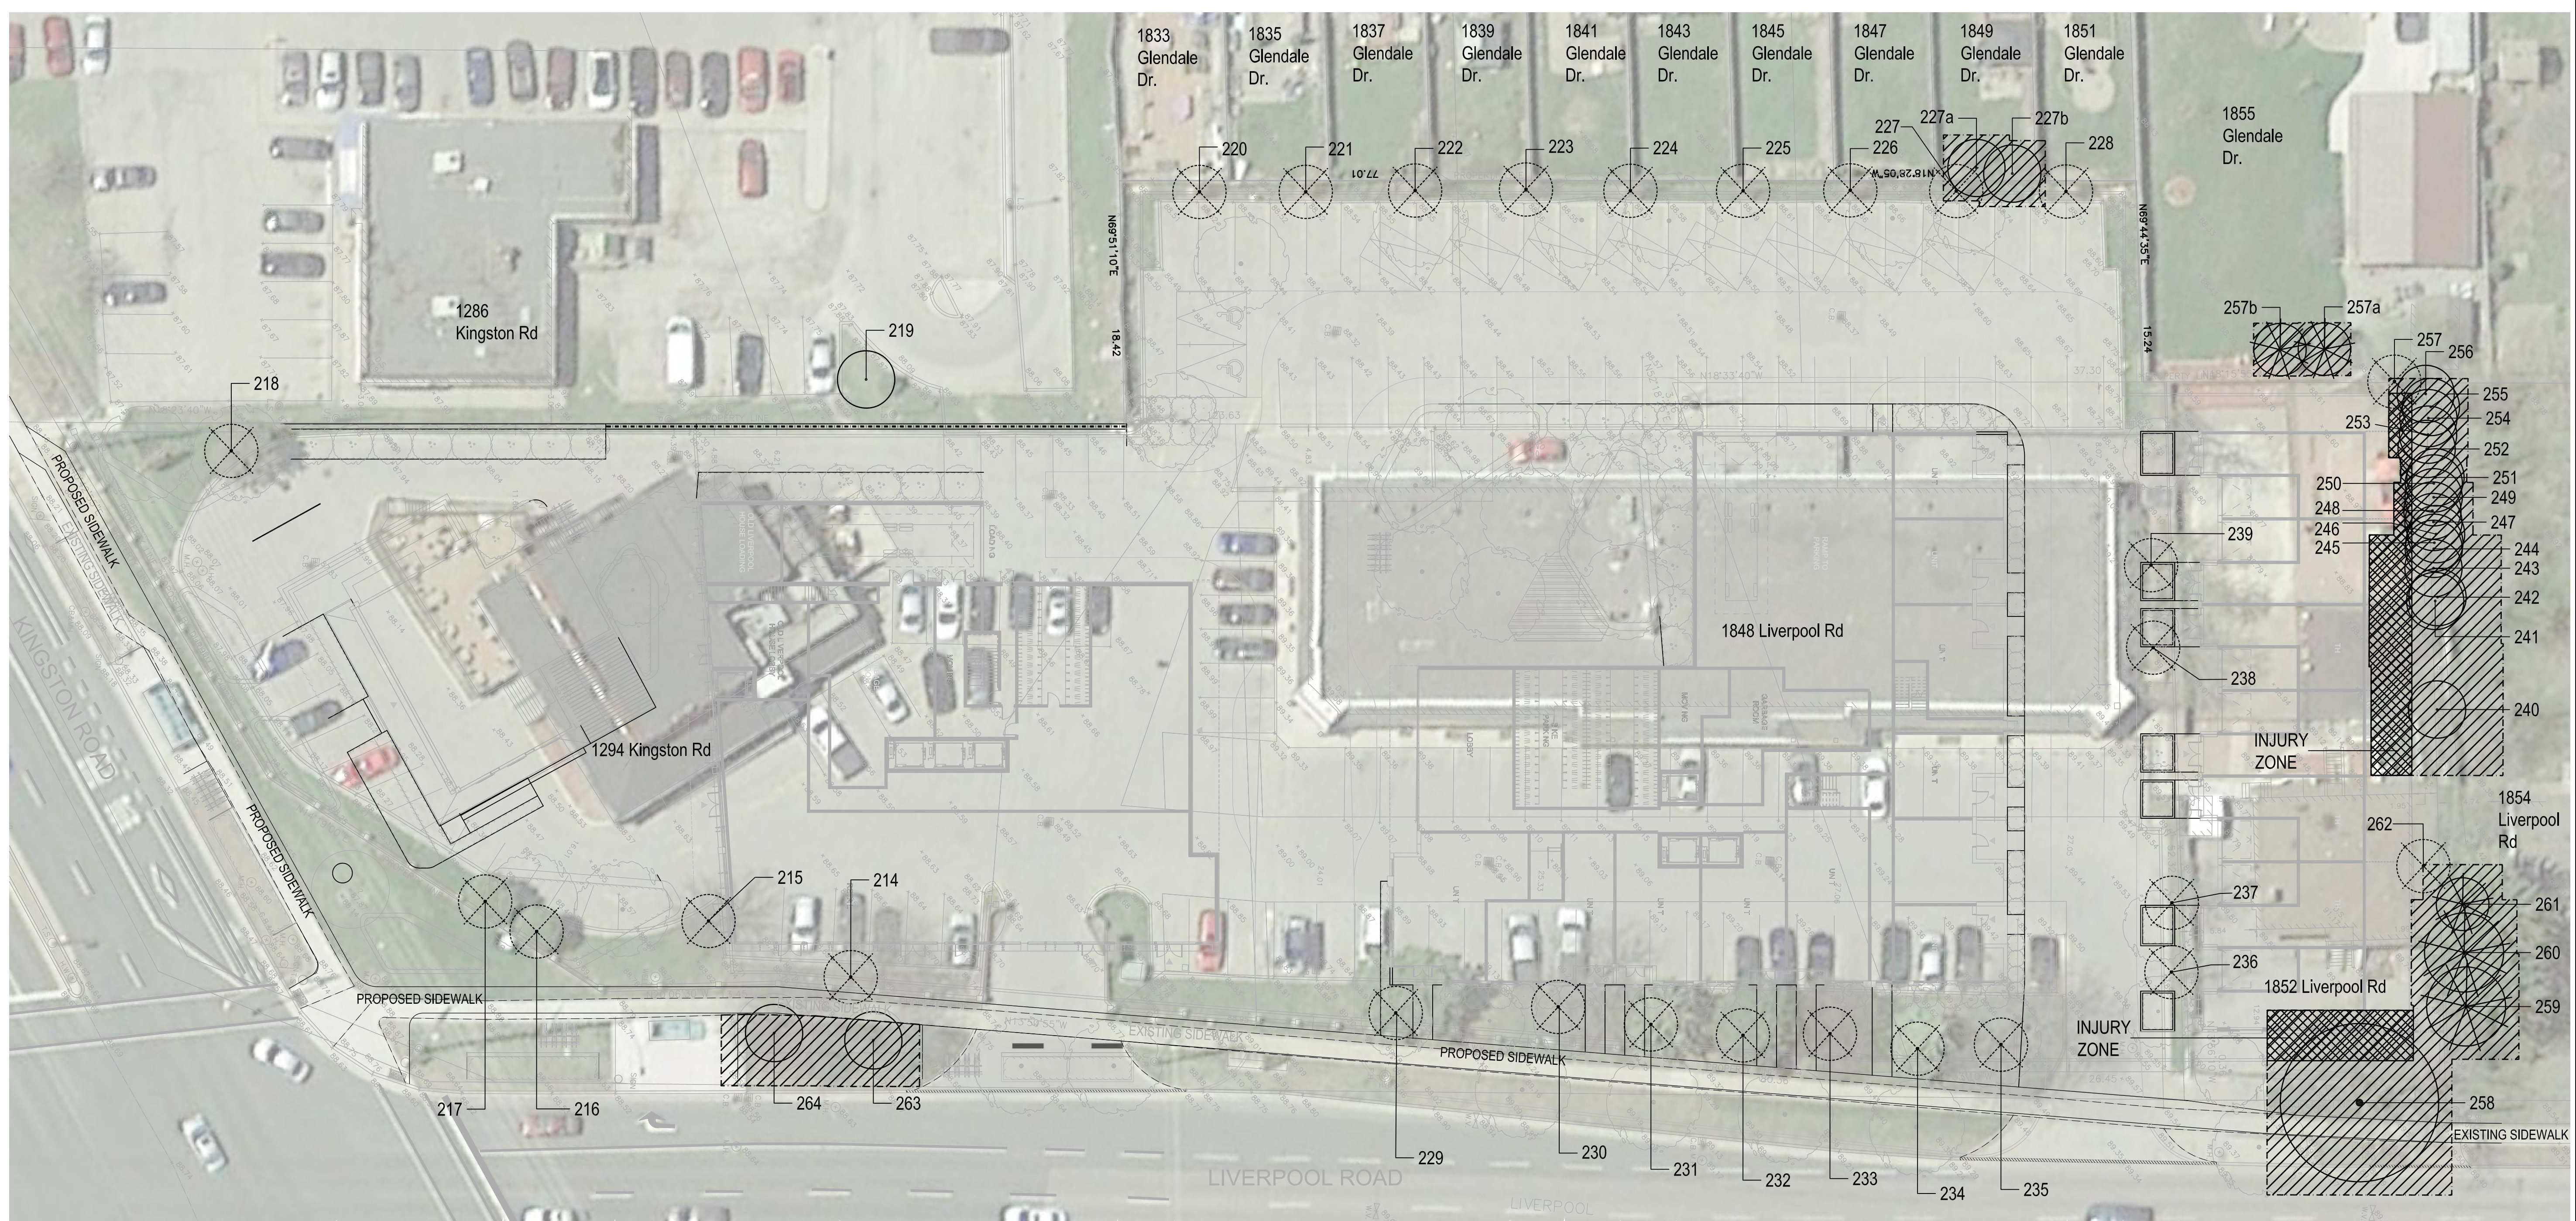
1 Tree Protection Plan Scale: 1:250

Tag#	Species	Common Name	DBH (cm)	Canopy Spread	Condition	Remarks	Tree Location	Tree Status	TPZ distance from trunk (m)	Replacement QTY
214	<i>Gleditsia triacanthos</i>	Honeylocust	38	8	Good		Private	Remove	5	2
215	<i>Tilia cordata</i>	Little Leaf Linden	28	6	Fair	Frost crack on west side of trunk, minor branch tip dieback	Private	Remove	4	1
216	<i>Thuja occidentalis</i>	White Cedar	26, 22	2	Good	Two trunk clump	Private	Remove	2	1
217	<i>Thuja occidentalis</i>	White Cedar	19, 18, 18	2	Good	Three trunk clump	Private	Remove	2	1
218	<i>Pinus nigra</i>	Austrian Pine	33	4	Poor	Canopy damage due to diplodia tip blight, trunk leaning east.	Private	Remove	3	2
219	<i>Picea pungens</i>	Colorado Spruce	11	1	Good	New tree planting on adjacent site	Private	Preserve	1.5	0
220	<i>Quercus robur</i>	Pyramidal English Oak	6	1	Good	New tree planting, tree stakes and ties wrapped around trunk.	Private	Remove	1.5	0
221	<i>Quercus robur</i>	Pyramidal English Oak	6	1	Good	New tree planting, tree stakes and ties wrapped around trunk.	Private	Remove	1.5	0

222	<i>Quercus robur</i>	Pyramidal English Oak	11	1	Good	New tree planting, tree stakes and ties wrapped around trunk.	Private	Remove	1.5	0
223	<i>Quercus robur</i>	Pyramidal English Oak	6	1	Good	New tree planting, tree stakes and ties wrapped around trunk.	Private	Remove	1.5	0
224	<i>Quercus robur</i>	Pyramidal English Oak	7	1	Good	New tree planting, tree stakes and ties wrapped around trunk.	Private	Remove	1.5	0
225	<i>Quercus robur</i>	Pyramidal English Oak	6	1	Dead	Tree is dead	Private	Remove	1.5	0
226	<i>Quercus robur</i>	Pyramidal English Oak	6	1	Good	New tree planting, tree stakes and ties wrapped around trunk.	Private	Remove	1.5	0
227	<i>Quercus robur</i>	Pyramidal English Oak	4	1	Good	New tree planting, tree stakes and ties wrapped around trunk.	Private	Remove	1.5	0
227a	<i>Prunus avium</i>	Domestic Cherry	10	3	Poor	Tree in adjacent property, trunk and limbs infected with canker decay	Private	Preserve	2.5	0

227b	<i>Prunus avium</i>	Domestic Cherry	10	3	Poor	Tree in adjacent property, part of canopy is dead due to fungal decay	Private	Preserve	2.5	0
228	<i>Quercus robur</i>	Pyramidal English Oak	7	1	Good	New tree planting, tree stakes and ties wrapped around trunk.	Private	Remove	1.5	0

229	<i>Pinus nigra</i>	Austrian Pine	40	8	Good		Private	Remove	5	2
230	<i>Gleditsia triacanthos</i>	Honeylocust	36	8	Good		Private	Remove	5	2
231	<i>Picea pungens</i>	Colorado Spruce	34	4	Good		Private	Remove	3	2
232	<i>Pinus nigra</i>	Austrian Pine	35	5	Fair	Trunk leaning south, included bark between 2 co-dominant leaders 2m from grade.	Private	Remove	3.5	2
233	<i>Tilia cordata</i>	Little Leaf Linden	39	6	Good		Private	Remove	4	2
234	<i>Picea pungens</i>	Colorado Spruce	32	4	Poor	Canopy sparse due to needle cast disease, bleeding cankers observed on trunk.	Private	Remove	3	2
235	<i>Gleditsia triacanthos</i>	Honeylocust	42	8	Good		Private	Remove	5	2
236	<i>Acer platanoides</i>	Norway Maple	25	4	Poor	Frost crack on west side of trunk, minor branch tip dieback	Private	Remove	3	1
237	<i>Acer platanoides</i>	Norway Maple	30	4	Poor	Frost crack on west side of trunk, severe branch tip dieback	Private	Remove	3	2

238	<i>Acer platanoides</i>	Norway Maple	32	6	Good		Private	Remove	4	1
239	<i>Acer platanoides</i>	Norway Maple	36	6	Poor	Tree in decline, 1/2 of canopy dead and removed by others	Private	Remove	4	1
240	<i>Ulmus pumila</i>	Siberian Elm	31, 22, 19, 19	8	Good	4 trunk clump	Private	Preserve	5	0
241	<i>Ulmus pumila</i>	Siberian Elm	39, 39	8	Good	2 trunk clump	Private	Preserve	5	0
242	<i>Acer negundo</i>	Manitoba Maple	25, 14	6	Poor	2 trunk clump, base of tree growing from the root flare of tree 241	Private	Preserve	4	0
243	<i>Ulmus pumila</i>	Siberian Elm	17	2	Poor	Part of hedge, branch fall observed in canopy	Private	Preserve	2	0
244	<i>Ulmus pumila</i>	Siberian Elm	27	2	Poor	Tree in decline, branch fall observed in canopy	Private	Preserve	2	0
245	<i>Ulmus pumila</i>	Siberian Elm	17	3	Poor	Tree canopy leaning north	Private	Preserve	2.5	0
246	<i>Ulmus pumila</i>	Siberian Elm	18	2	Poor	Part of hedge, branch fall observed in canopy	Private	Preserve	2	0

247	<i>Ulmus pumila</i>	Siberian Elm	26	4	Poor	Trunk fused to tree 248.	Private	Preserve	3	0

248	<i>Ulmus pumila</i>	Siberian Elm	14	2	Hazard	Tree trunk hollow, severe canopy dieback	Private	Preserve	2	0
249	<i>Ulmus pumila</i>	Siberian Elm	18	3	Poor	North trunk severely pruned in the past	Private	Preserve	2.5	0
250	<i>Ulmus pumila</i>	Siberian Elm	25	3	Good	Minor branch fall in canopy	Private	Preserve	2.5	0
251	<i>Ulmus pumila</i>	Siberian Elm	17	2	Poor	Severe branch fall in canopy	Private	Preserve	2	0
252	<i>Ulmus pumila</i>	Siberian Elm	21	2	Poor	Top of tree collapsed	Private	Preserve	2	0
253	<i>Ulmus pumila</i>	Siberian Elm	19, 15	2	Poor	Two trunk clump, canopy dieback	Private	Preserve	2	0
254	<i>Ulmus pumila</i>	Siberian Elm	23	4	Fair	Canopy lopsided favoring west side of trunk.	Private	Preserve	3	0
255	<i>Ulmus pumila</i>	Siberian Elm	19	2	Poor	Minor branch fall in canopy, canopy leaning west	Private	Preserve	2	0
256	<i>Thuja occidentalis</i>	White Cedar	19	2	Fair	2 leaders originating from trunk at 1m from grade, included bark between leaders.	Private	Preserve	2	0

257	<i>Acer negundo</i>	Manitoba Maple	31	6	Hazard	Tree trunk severely girdled by adjacent wood fence, fall hazard.	Private	Remove	4	2
257a	<i>Picea pungens</i>	Colorado Spruce	10	2	Good	Tree on adjacent property	Private	Preserve	2	0
257b	<i>Picea pungens</i>	Colorado Spruce	10	2	Good	Tree on adjacent property	Private	Preserve	2	0
258	<i>Acer saccharinum</i>	Silver Maple	86	12	Good	5 leader at 1.5m from grade, good canopy vigor	City	Preserve	7	0
259	<i>Picea glauca</i>	White Spruce	50	6	Good	Tree located in adjacent property	Private	Preserve	4	0
260	<i>Picea glauca</i>	White Spruce	48	6	Good	Tree located in adjacent property	Private	Preserve	4	0
261	<i>Picea glauca</i>	White Spruce	29	4	Good	Tree located in adjacent property	Private	Preserve	3	0
262	<i>Acer negundo</i>	Manitoba Maple	21, 20, 19, 14	4	Poor	Tree growing adjacent to building foundation, canopy leaning northwest	Private	Remove	3	1
263	<i>Prunus avium</i>	Bird Cherry	45	5	Poor	Cavity decay observed in junction between main lateral limbs in canopy, 2 main lateral limbs occur at 1m from grade.	City	Preserve	3.5	0

264	<i>Prunus avium</i>	Bird Cherry	65, 45	6	Poor	Frost crack on south trunk, cavity decay observed on north leaning trunk	City	Preserve	4	0
									Total Replacement Qty =	29
