City of Pickering

Schedule B Municipal Class Environmental Assessment – Project File Pine Creek Erosion Assessment

Aquafor Beech Ltd.

Published: May 10th, 2024

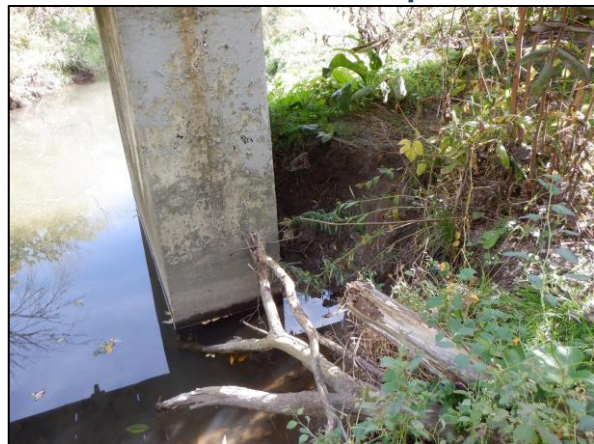
Figure 2-5: Erosion Site #4 – Scouring & Erosion around Bridge Footings

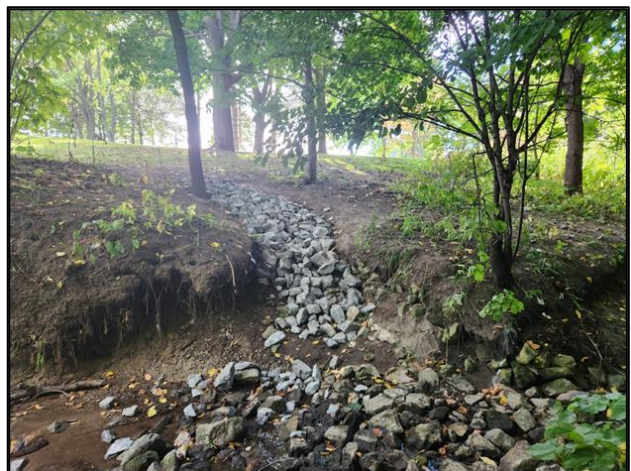
Figure 2-10: Failure of Rip-Rap Bank Treatment Intended to Prevent a Loss of Parkland due to Active Erosion Processes.

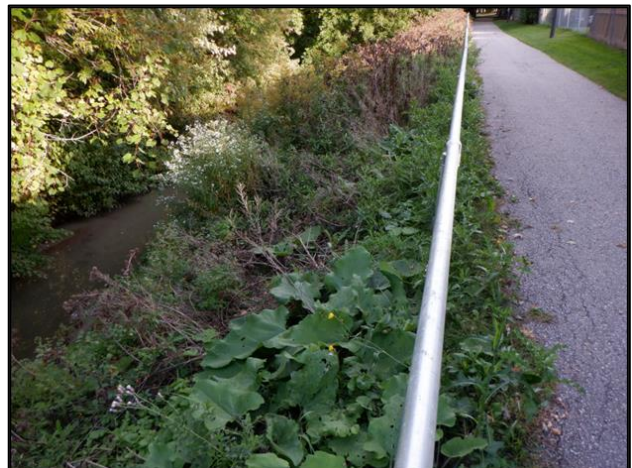
Figure 2-15: Erosion Site #10 – Bank Erosion Actively Encroaching Towards the Existing Multi-Use Trail

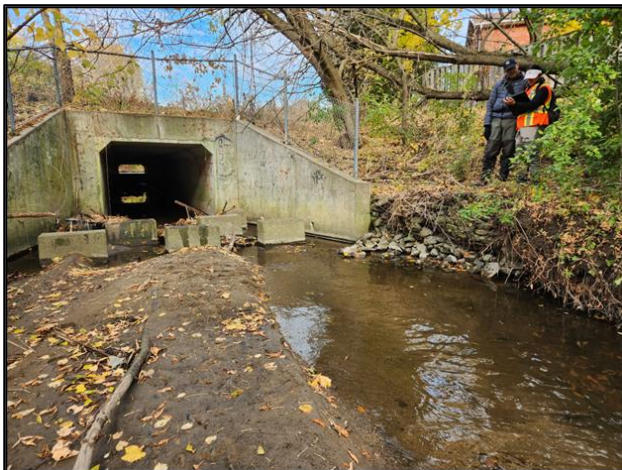
The contraction and expansion of flows through the Dixie Road Culvert Crossing creates a risk of downstream scour and erosion. This penchant for erosion has been historically mitigated through the application of energy dissipation blocks downstream of the culvert, coupled with gabion basket retaining walls along the downstream channel banks. However, overtime age and exposure to hydrodynamic forces have led to the failure of the aforementioned gabion baskets (Erosion Site #11 – **Figure 2-17** & **Figure 2-18**).

Figure 2-17: Erosion Site #11 – Gabion Baskets Downstream of Dixie Road

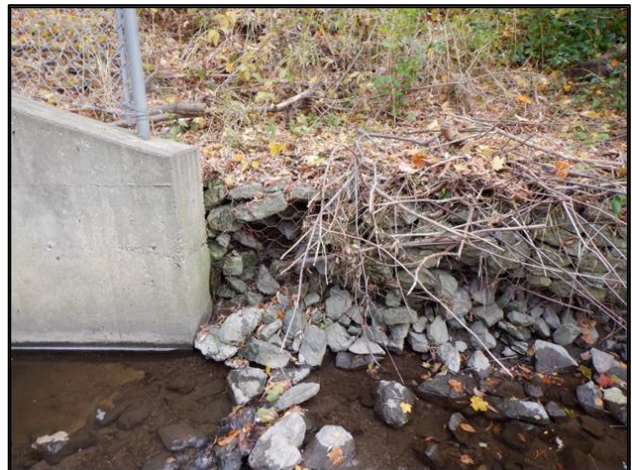
Figure 2-18: Erosion Site #11 – Observed Gabion Basket Failure

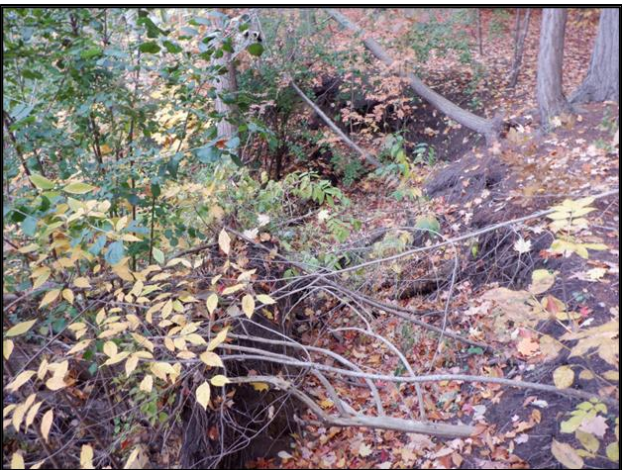
Figure 2-19: Erosion Site #12 – Mass Debris Jams Forcing Channel to Erode Eastward

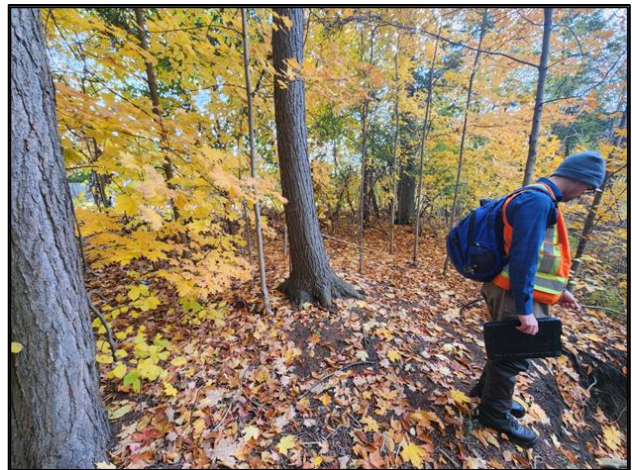
Figure 2-20: Erosion Site #12 – Minimal Offset (<10 m) between Dixie Road Sidewalk and Top of Erosion Scar.

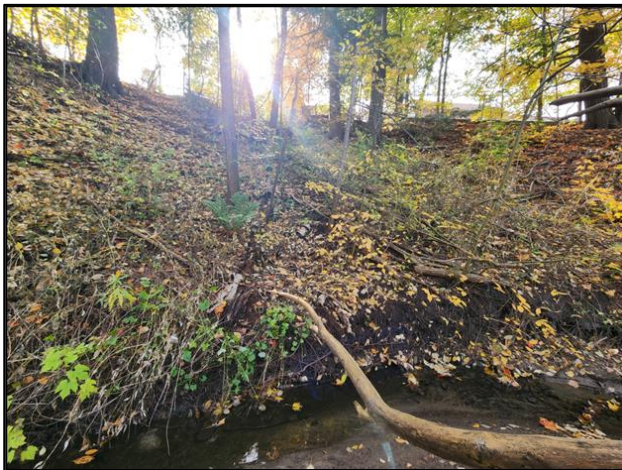
Figure 2-22: Erosion Site #13 – Toe Erosion Creating Risk to Private Property.

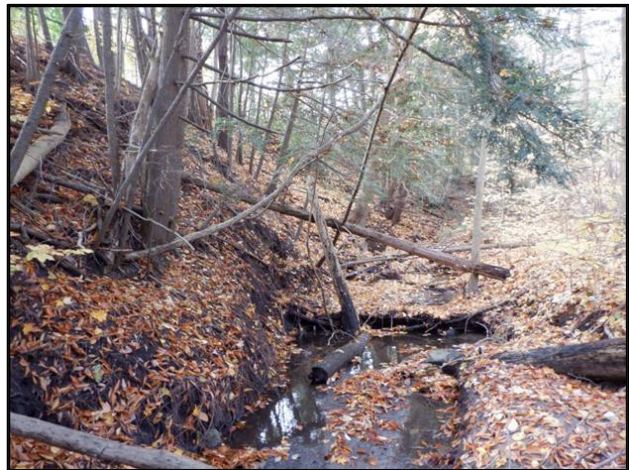
Figure 2-23: Erosion Site #14 – Observed Debris Jams and Bank Erosion.

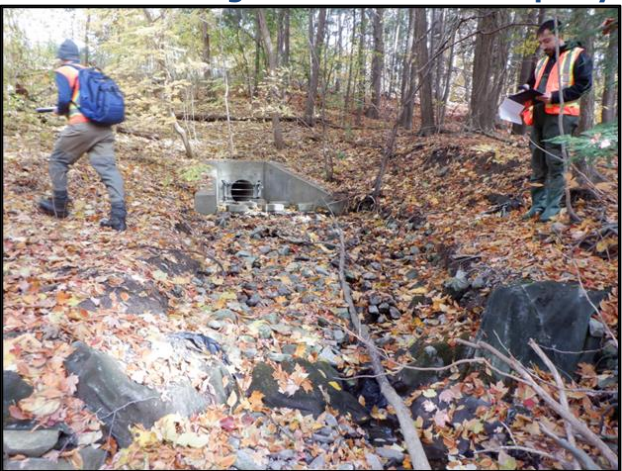
Figure 2-24: Erosion Site #15 – Eroding Outfall Channel

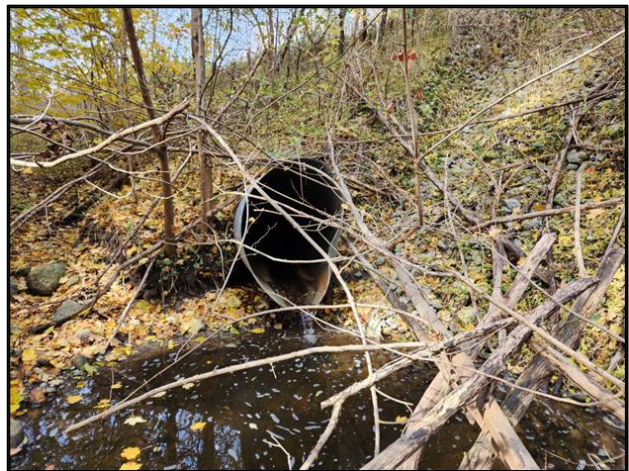
Figure 2-25: Erosion Site #16 – Undercutting of Deformed CSP Culvert

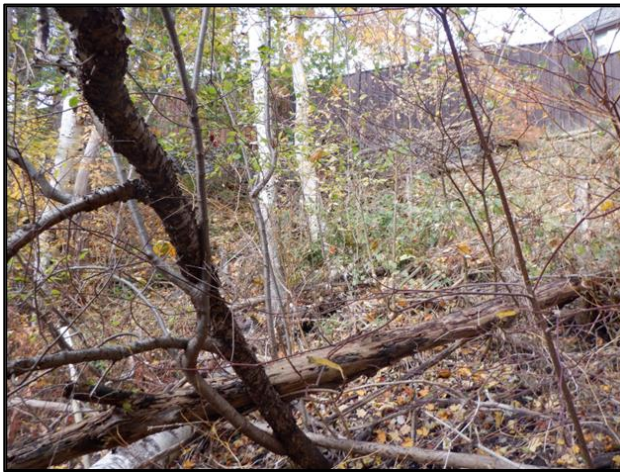
Figure 2-27: Erosion Site #17 – Toe Erosion Creating Risk to Private Property on Grafton Court.

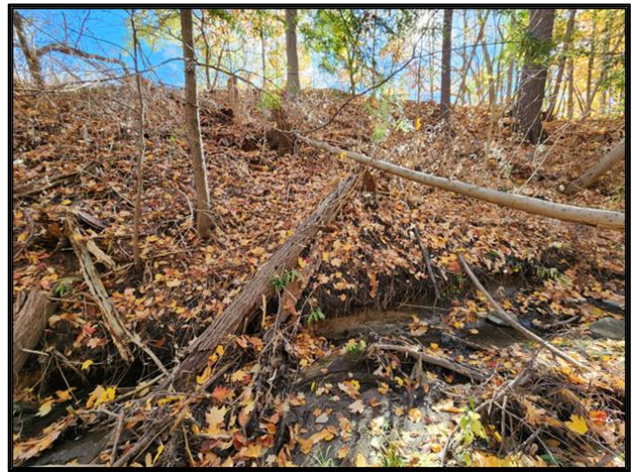
Figure 2-28: Erosion Site #18 – Observed Debris Accumulation and Bank Erosion Adjacent to Finch Avenue.

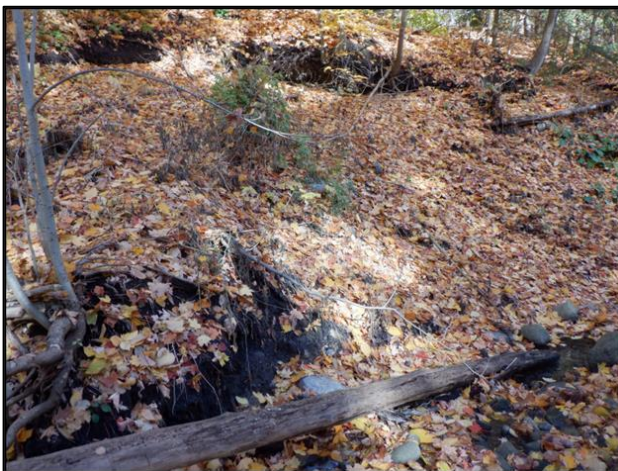
Figure 2-29: Erosion Site #20 – Toe Erosion Creating Risk to Private Property on Duncannon Drive.

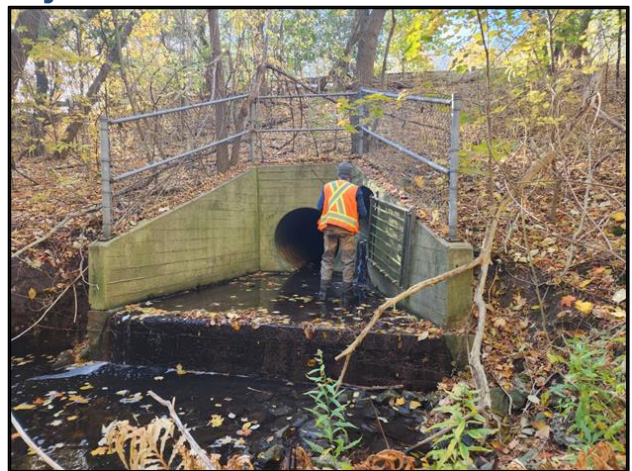
Figure 2-30: Erosion Site #21 – Significant Scouring Observed Downstream of Fairport Road Outfall.

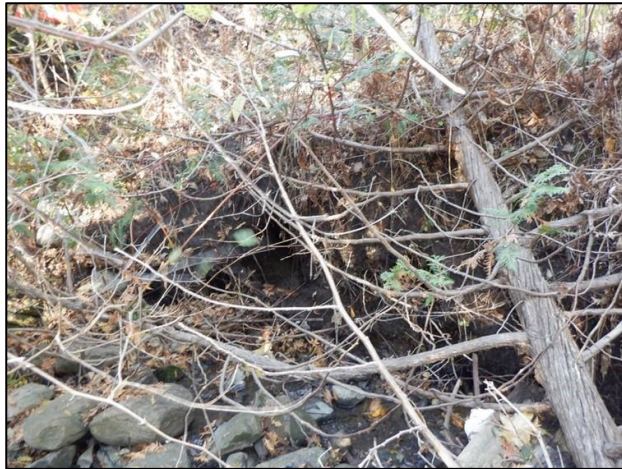
Figure 2-32: Erosion Site #22 – Debris Jam Downstream of the Lynn Heights Drive Culvert.

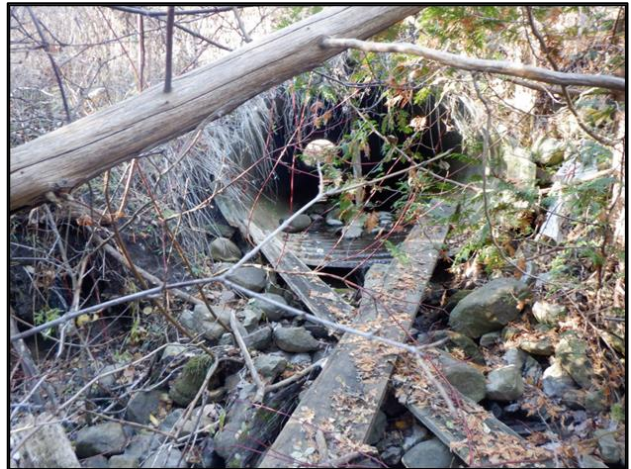
Figure 2-33: Erosion Site #22 – Observed Scouring Downstream of the Lynn Heights Drive Culvert.

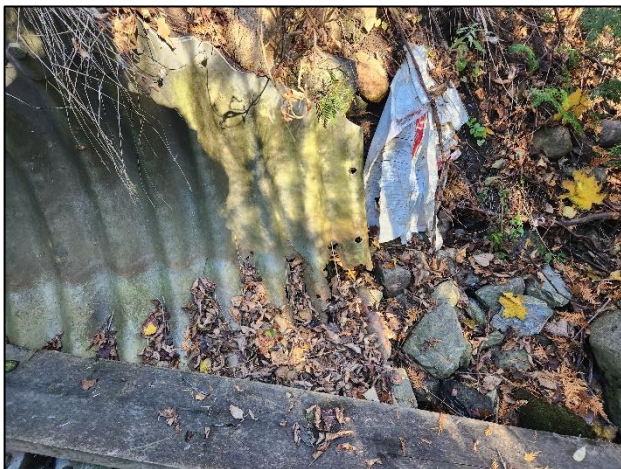
Figure 2-34: Erosion Site #22 – Observed Structural Degradation at the Culvert Outlet.

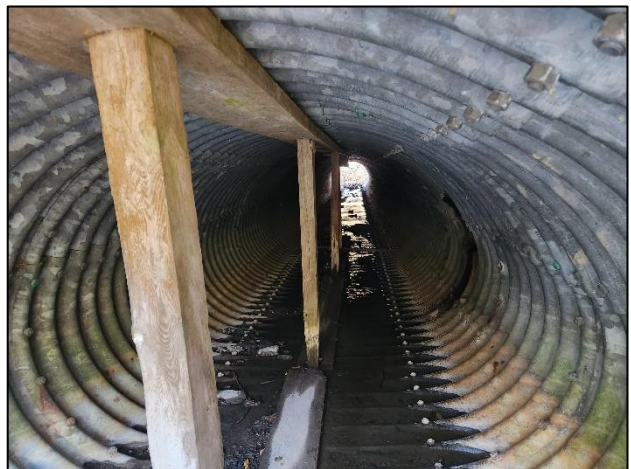
Figure 2-35: Erosion Site #22 – Wooden Support Posts Observed within the Lynn Heights Drive Culvert.

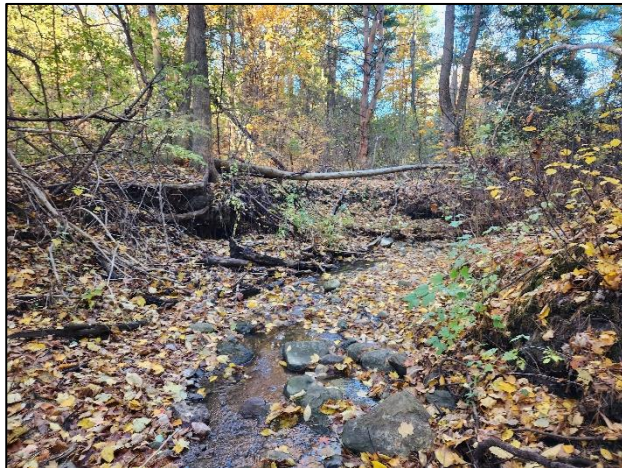
Figure 2-37: Observed Channel Widening and Bank Erosion within Lynn Heights Park.

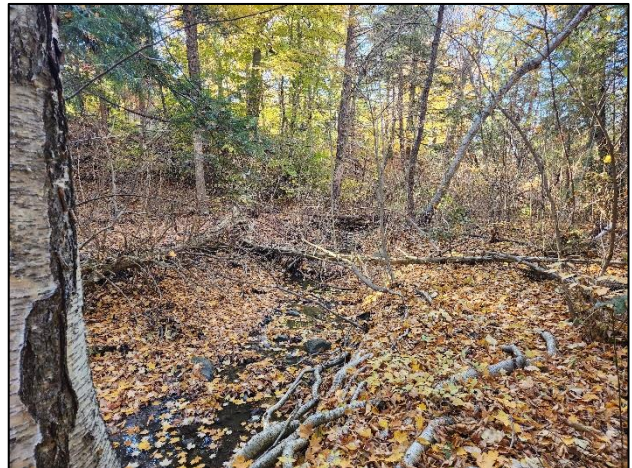
Figure 2-38: Observed Uprooted Fallen Trees Creating a Debris Jam in Lynn Heights Park.

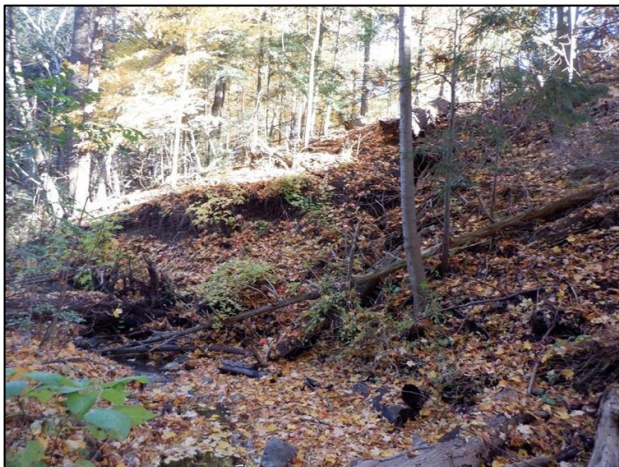
Figure 2-39: Erosion Site #23 – Observed Toe Erosion Creating Risk to Private Property on Duncannon Drive

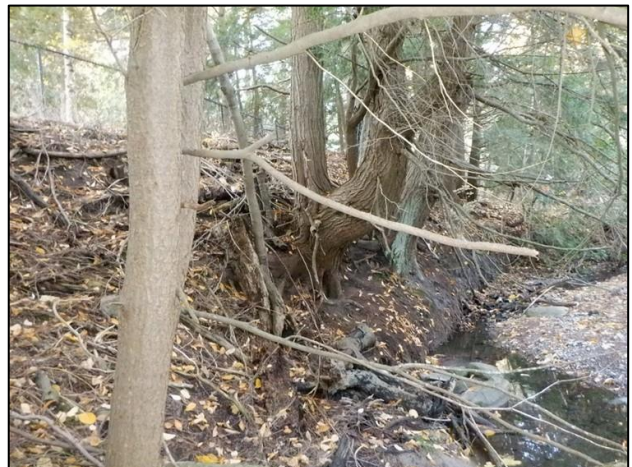
Figure 2-40: Erosion Site #24 – Actively Eroding Bank behind Duncannon Drive Properties.

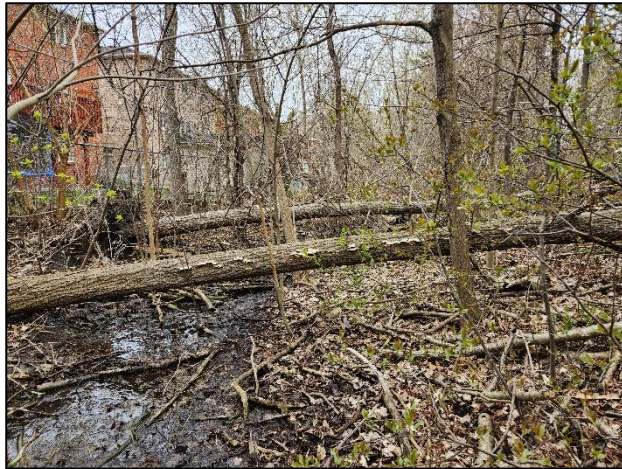
Figure 2-42: Erosion Site #25 – Observed Bank Erosion and Undercutting of Trees in the Kitley Ravine Corridor.

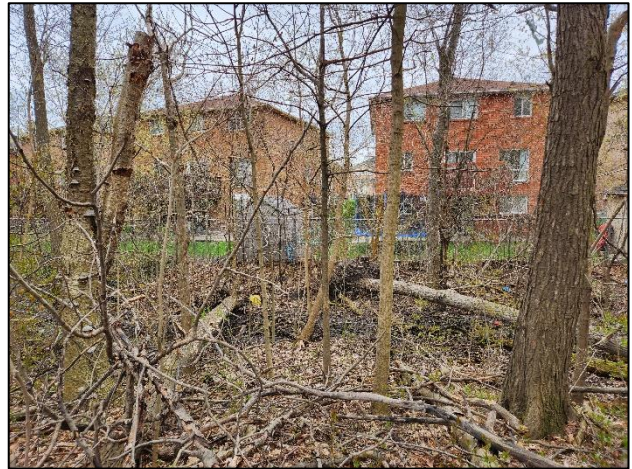
Figure 2-43: Erosion Site #25 – Observed Debris Jams within the Kitley Ravine Corridor.

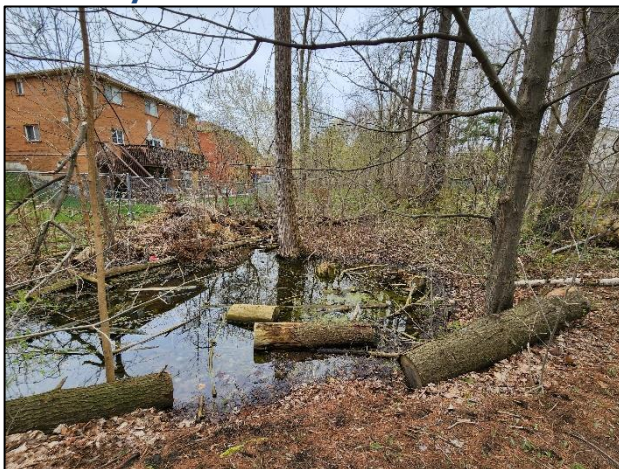
Figure 2-44: Erosion Site #25 – Ponding within the Kitley Ravine Corridor

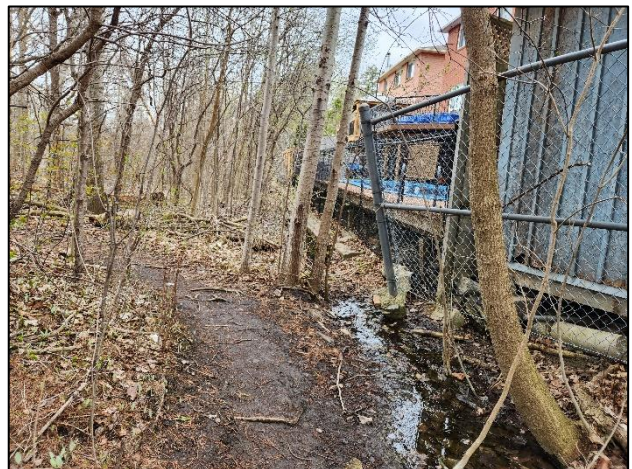
Figure 2-45: Erosion Site #25 – Encroachment of the Kitley Ravine Drainage Ditch towards Private Property.

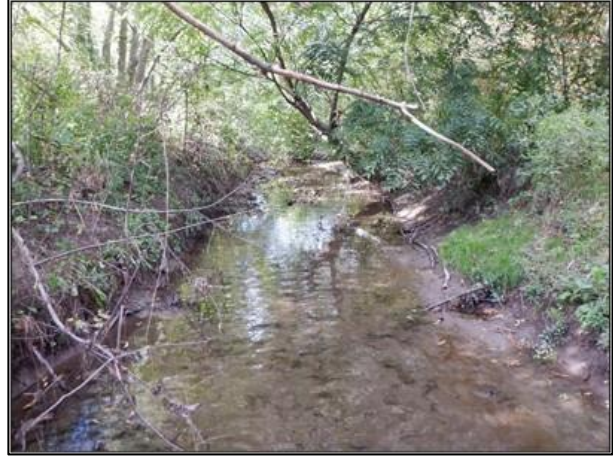
Figure 3-11: Looking Upstream at the Densely Vegetated Banks Where Erosion at the Toe of Bank can be Observed on the Left Bank

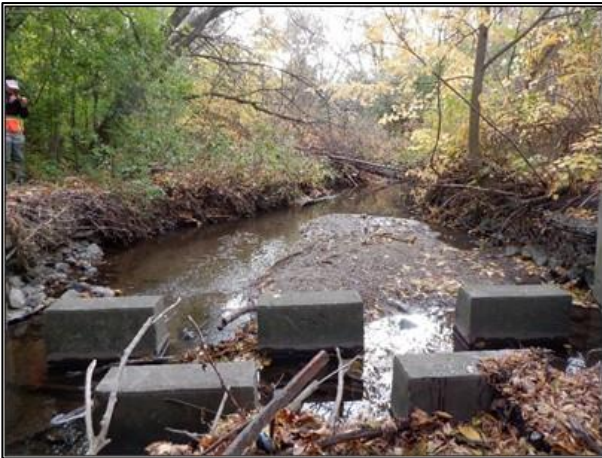
Figure 3-12: Sediment Accumulation Occurring Downstream of Energy Dissipation Blocks at the Dixie Road Culvert Causing Aggradation of the Bed and Active Channel Widening.
