L1V1B5 Preliminary Hydrogeological Investigation

Type of Document: Final Report

Project Name: 1101A, 1105 and 1163 Kingston Road, Pickering, Ontario

GTR-22015419-B0

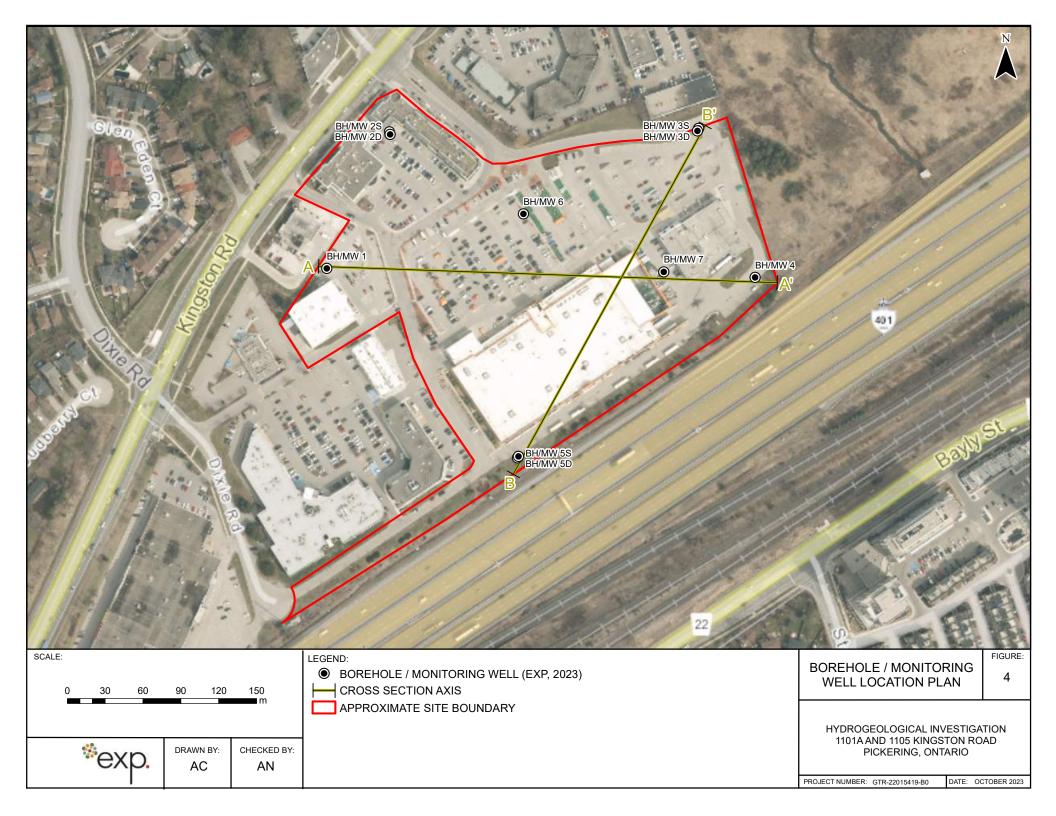
The borehole and monitoring well locations are shown on Figure 4. Geological cross-sections were generated based on the available borehole logs completed as part of the previous and current investigations and shown on Figure 5A (Cross section A-A') and on Figure 5B (Cross section B-B'). The cross section shows a simplified representation of soil conditions and soil deposits may be interconnected differently than represented. Borehole logs used to generate both cross-sections are provided in Appendix B.

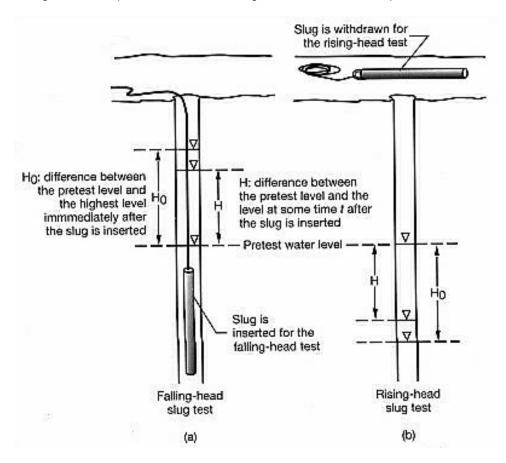
The figure below depicts a schematic of a slug and bail test and the respective water level changes.

A Single Well Response Test (SWRT), also known as a bail test or a slug test, is conducted in order to determine the saturated hydraulic conductivity (K) of an aquifer. The method of the SWRT is to characterize the change of groundwater level in a well or borehole over time.
