**PDF – A16 HYDROGEOLOGICAL STUDY,
PREPARED BY CAMBIUM INC.,
SEPTEMBER 7, 2019**

Hydrogeological Assessment - 5329 Old Brock Road, Pickering, Ontario

2019-09-17

Prepared for:
1972229 Ontario Ltd.

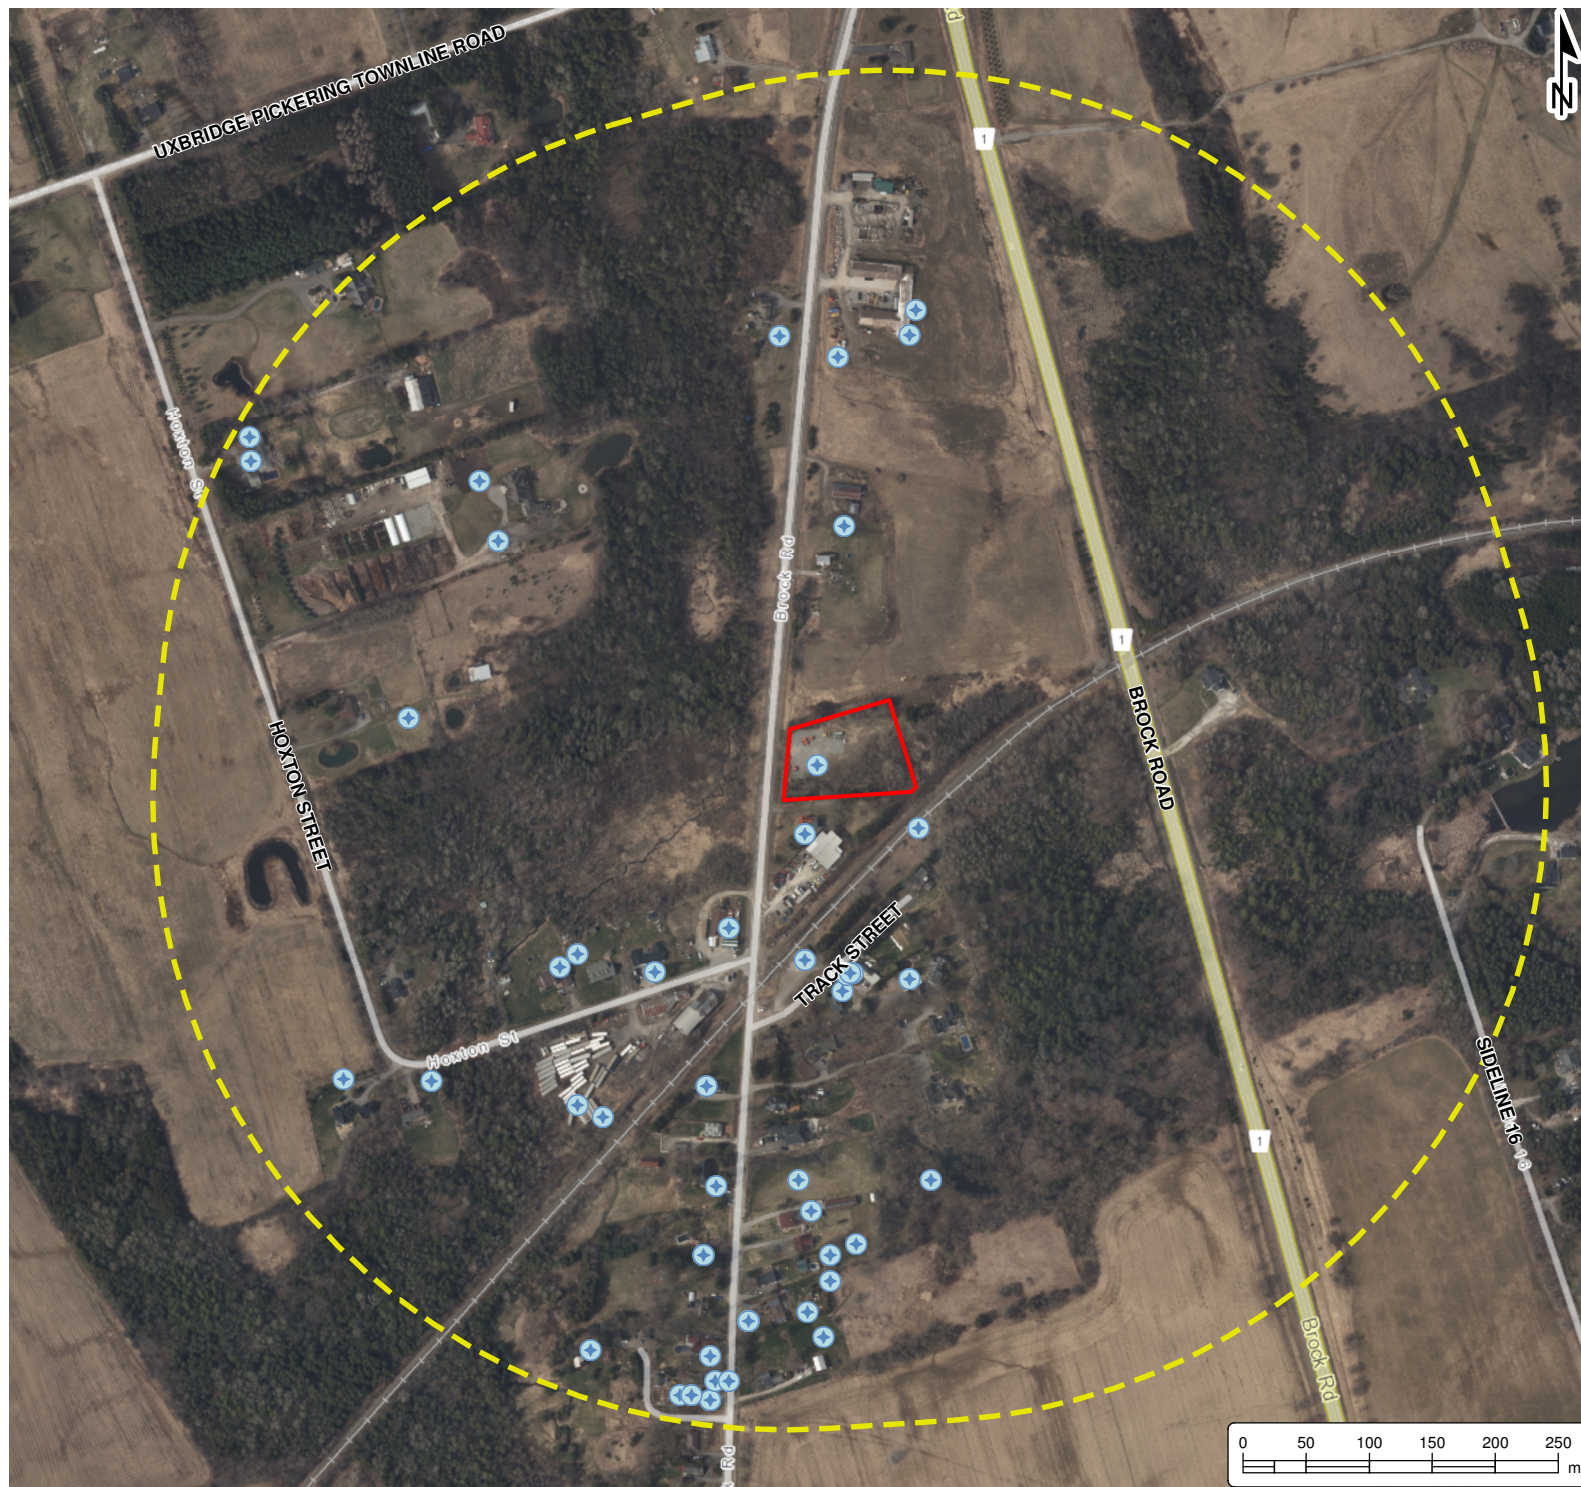
Project No.:	8964-001	Date:	September 2019
Scale:	1:6,000	Rev.:	
Created by:	MAT	Projection:	NAD 1983 UTM Zone 17N
Checked by:	KW	Figure:	2

**HYDROGEOLOGICAL
ASSESSMENT -
5329 OLD BROCK ROAD**
GRANT MORRIS ASSOCIATES LTD.
5329 Old Brock Road,
Pickering, Ontario

The depth of the drilled wells ranged from about 11 to 98 mbgs. Static water levels that ranged from 0.00 mbgs to 37.80 mbgs. The depth of dug wells ranged from about 7 to 11 mbgs. Static water levels ranging from 2.00 mbgs to 6.10 mbgs. The average recommended pumping rates for the drilled and dug wells were 64.1 L/min (16.9 GPM) and 16.8 L/min (4.4 GPM), respectively.

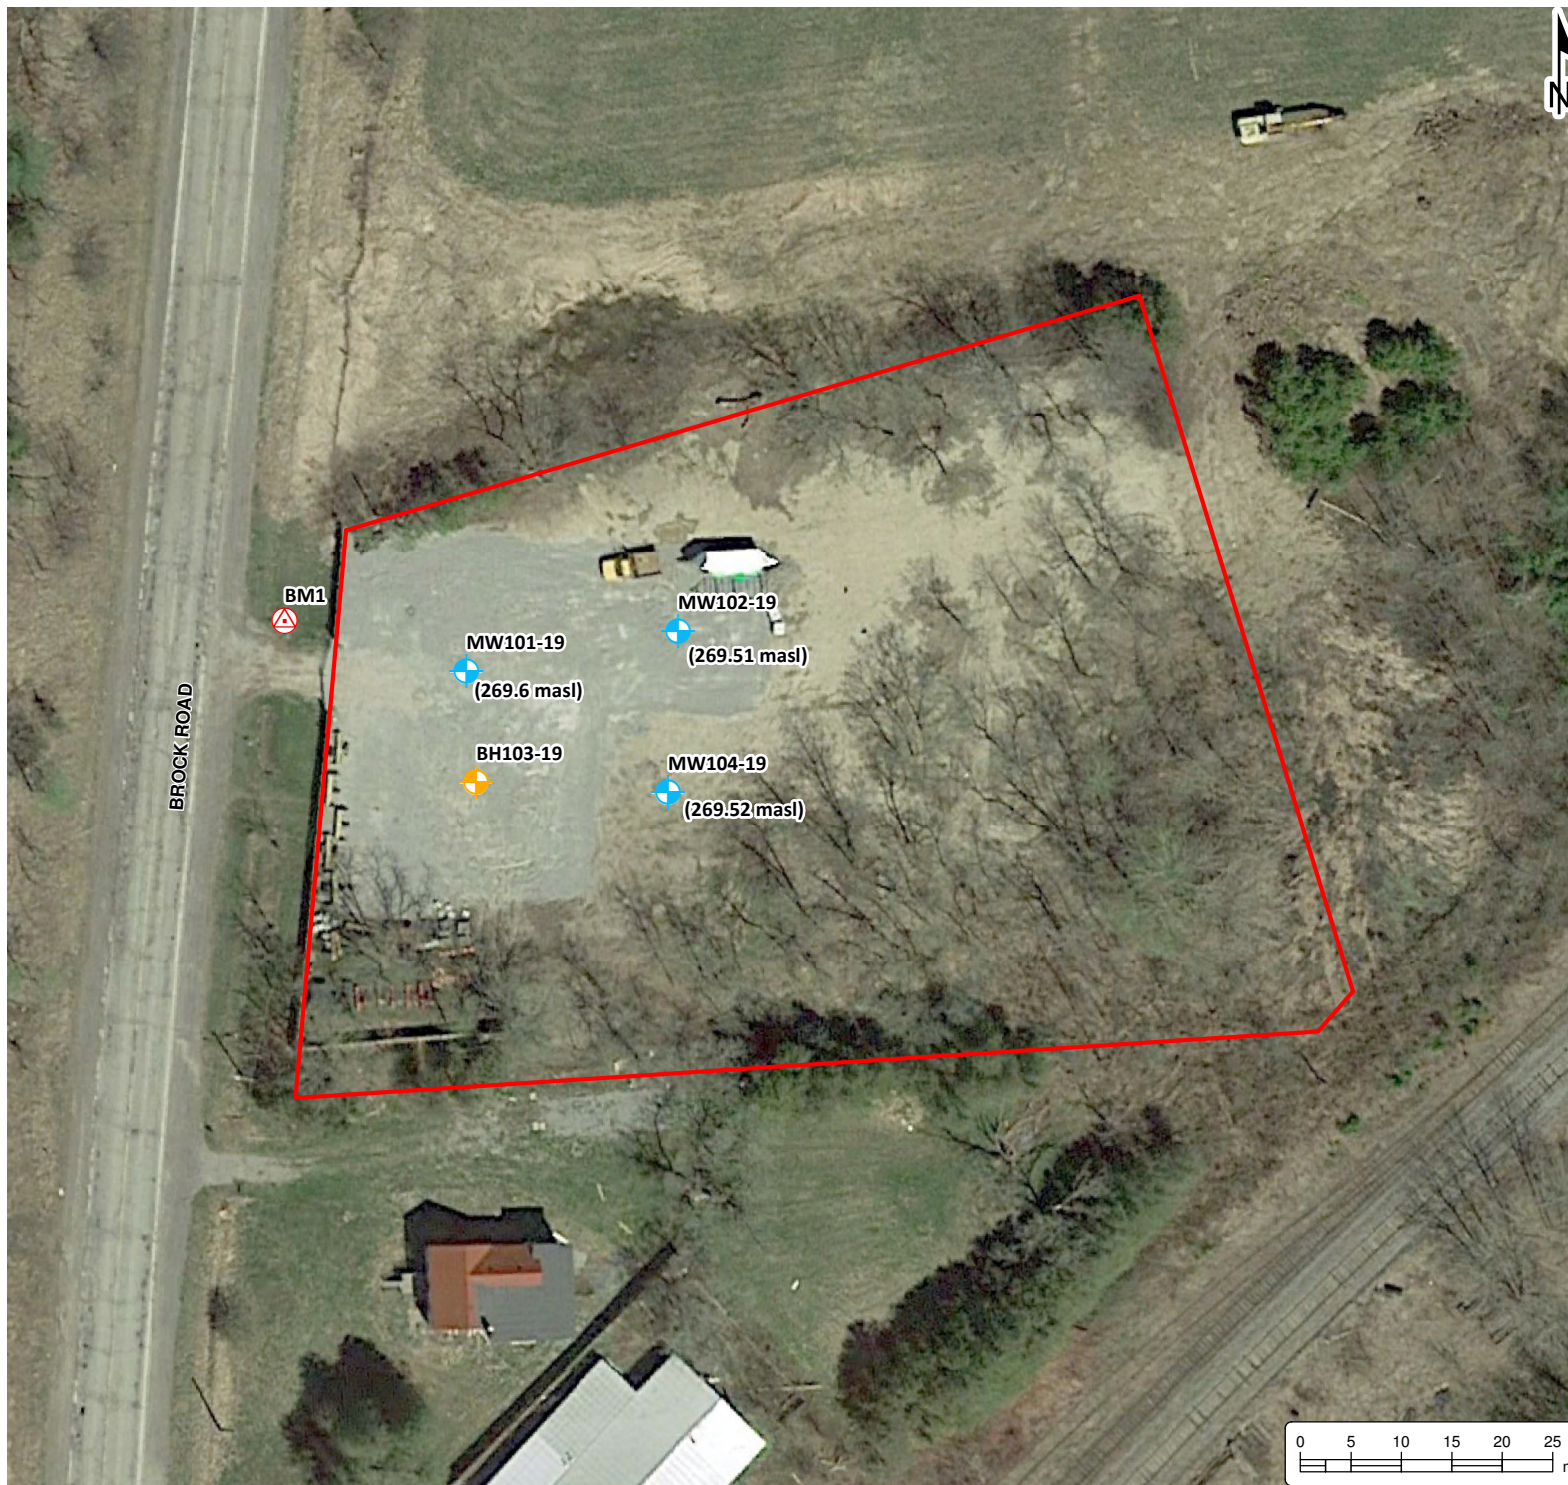
HYDROGEOLOGICAL ASSESSMENT -
5329 OLD BROCK ROAD
 GRANT MORRIS ASSOCIATES LTD.
 5329 Old Brock Road,
 Pickering, Ontario

The borehole locations were mapped using handheld GPS unit while elevations were surveyed relative to a benchmark (top culvert at the entrance to the Site). The geodetic elevation of the top of culvert at inlet side is 270.53 masl according to a survey plan provided by the Client. Borehole locations are shown on Figure 3. Borehole logs are included in Appendix B.
