Geomorphic Assessment

230 Finch Ave, City of Pickering

Petticoat Creek Watershed

April 2024 **220352**

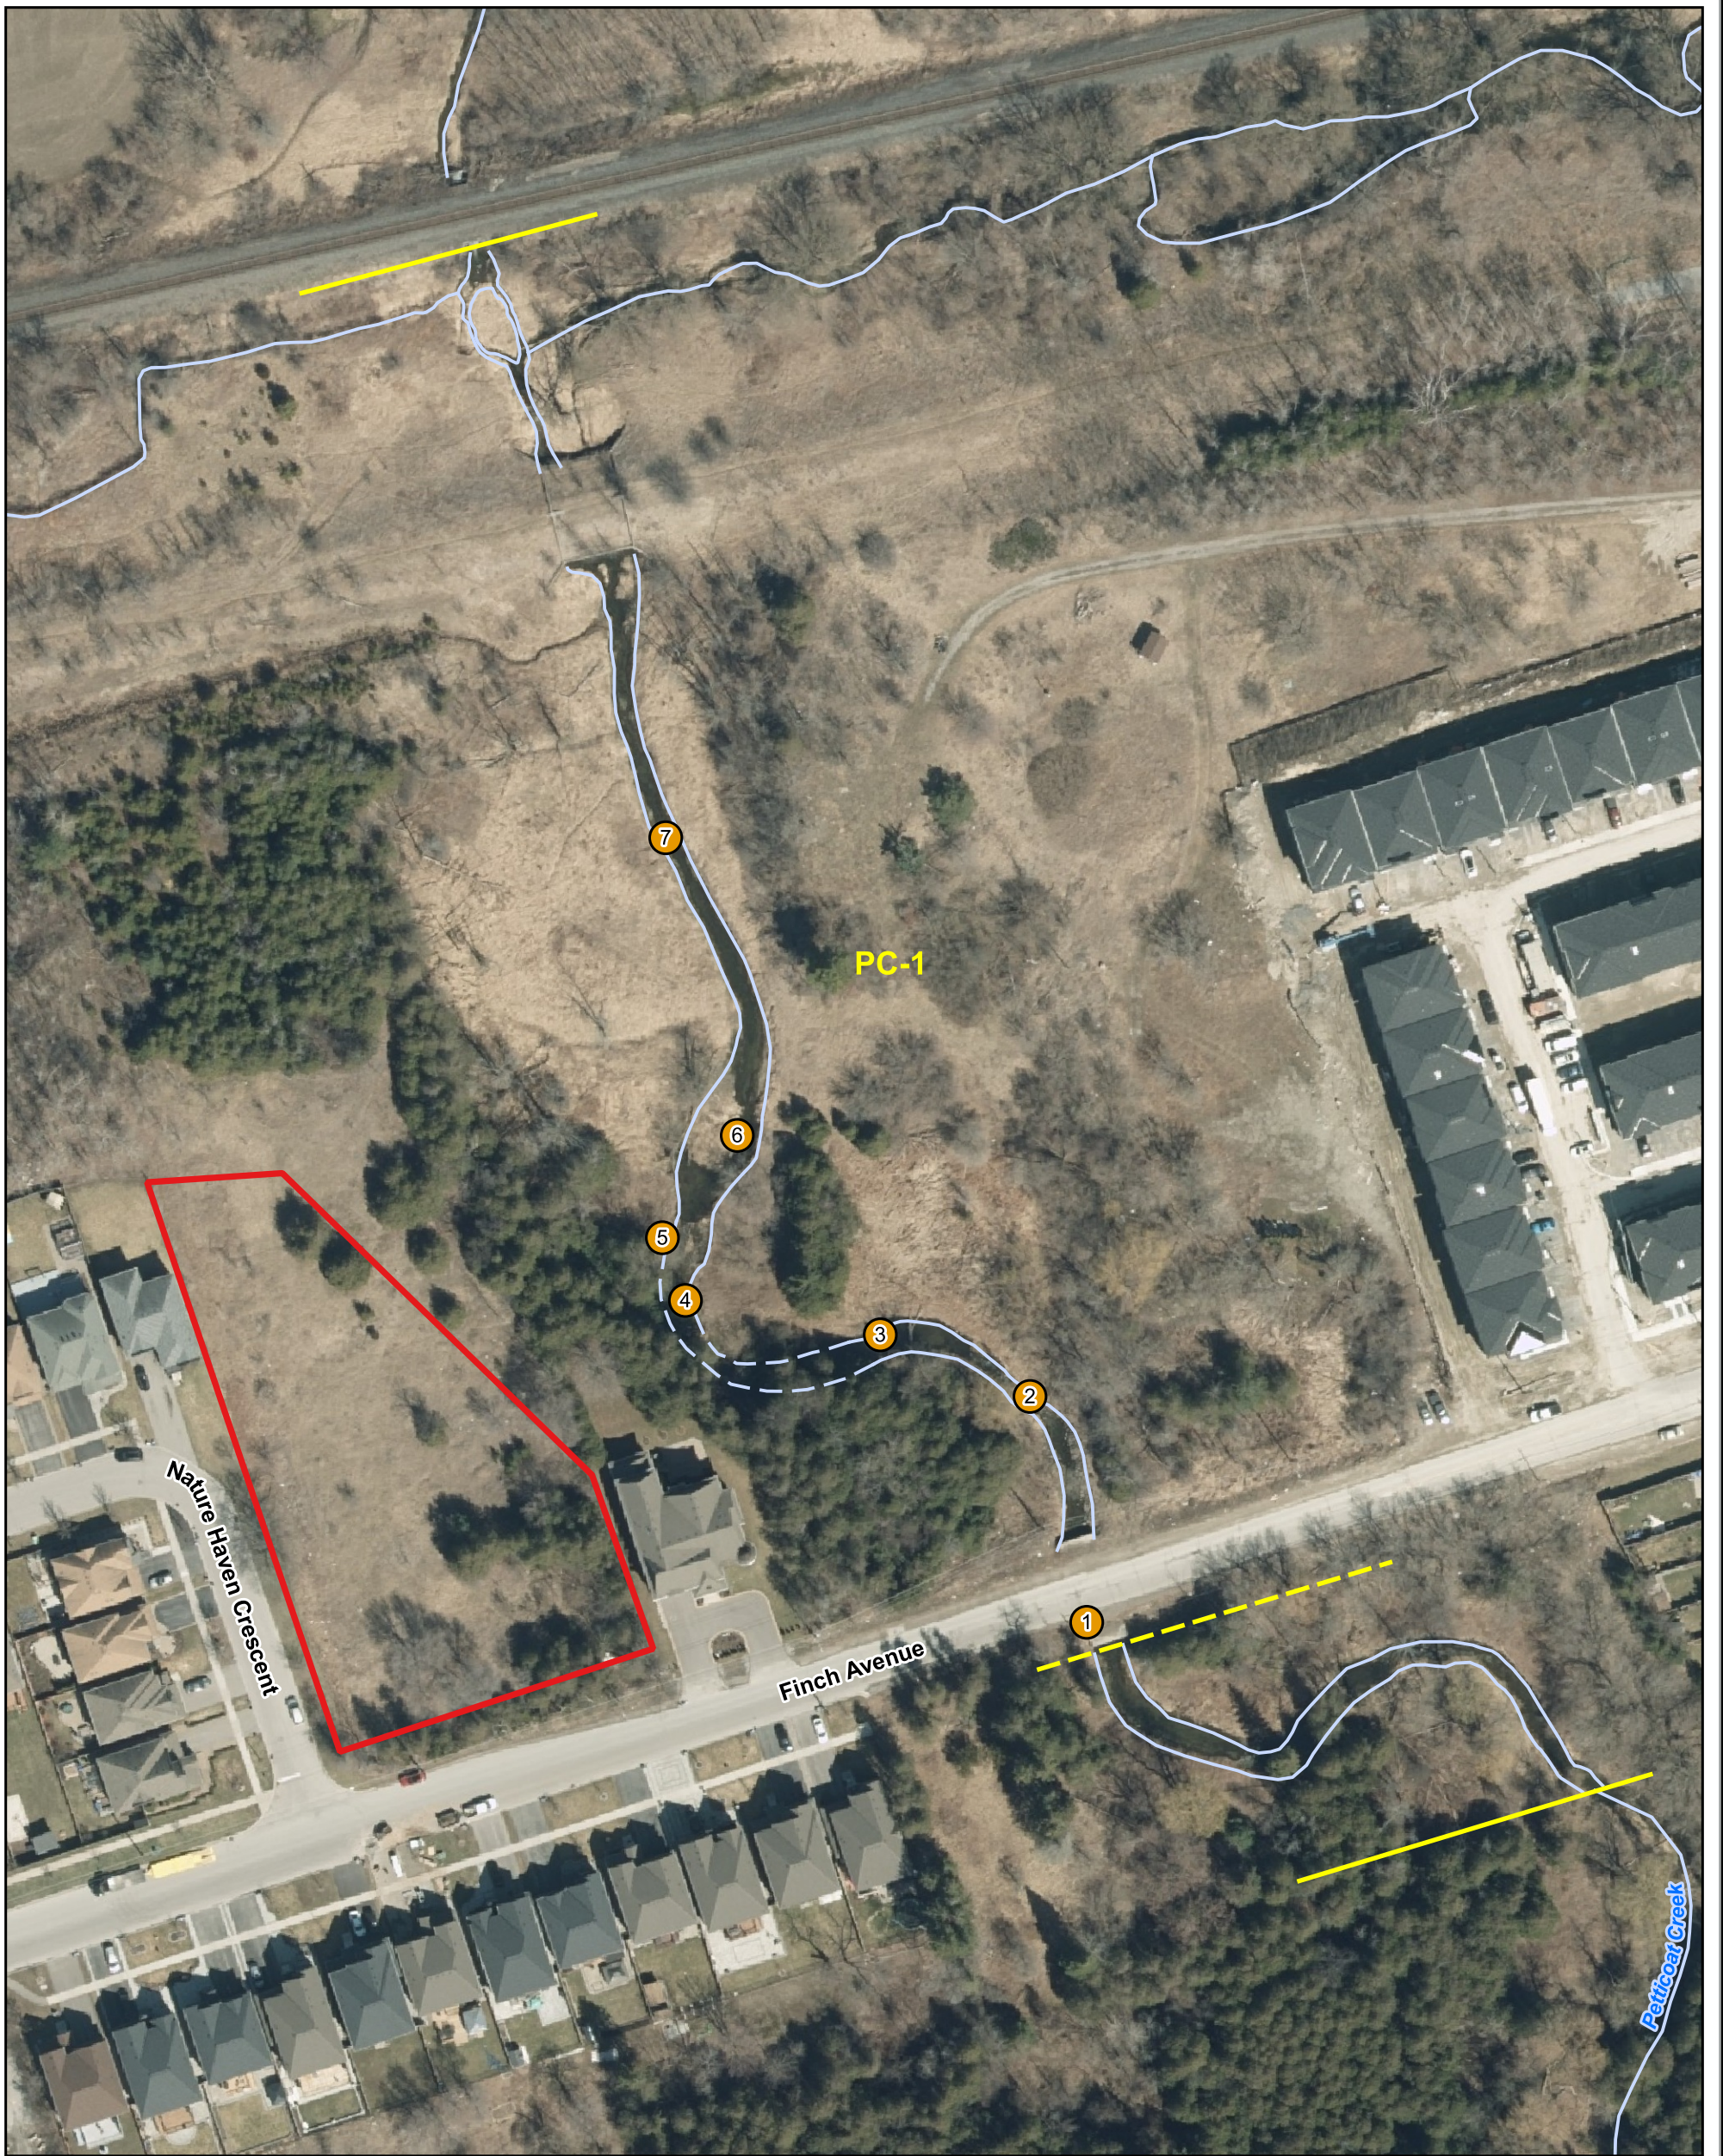
Reach and Photo Locations Figure 2

For the purposes of this study, the portion of Petticoat Creek extending from the rail line to downstream of Finch Avenue (approximately 50 m) was delineated as a single reach (Reach PC-1, see **Figure 2**). The determination of reach extents was based on a desktop assessment of transitions in riparian vegetation, degree of valley confinement and meander geometry (channel planform) and the limit of existing residential development west of the creek based on available aerial imagery and topographic mapping. Field verification of reach extents was limited by property access/ownership.

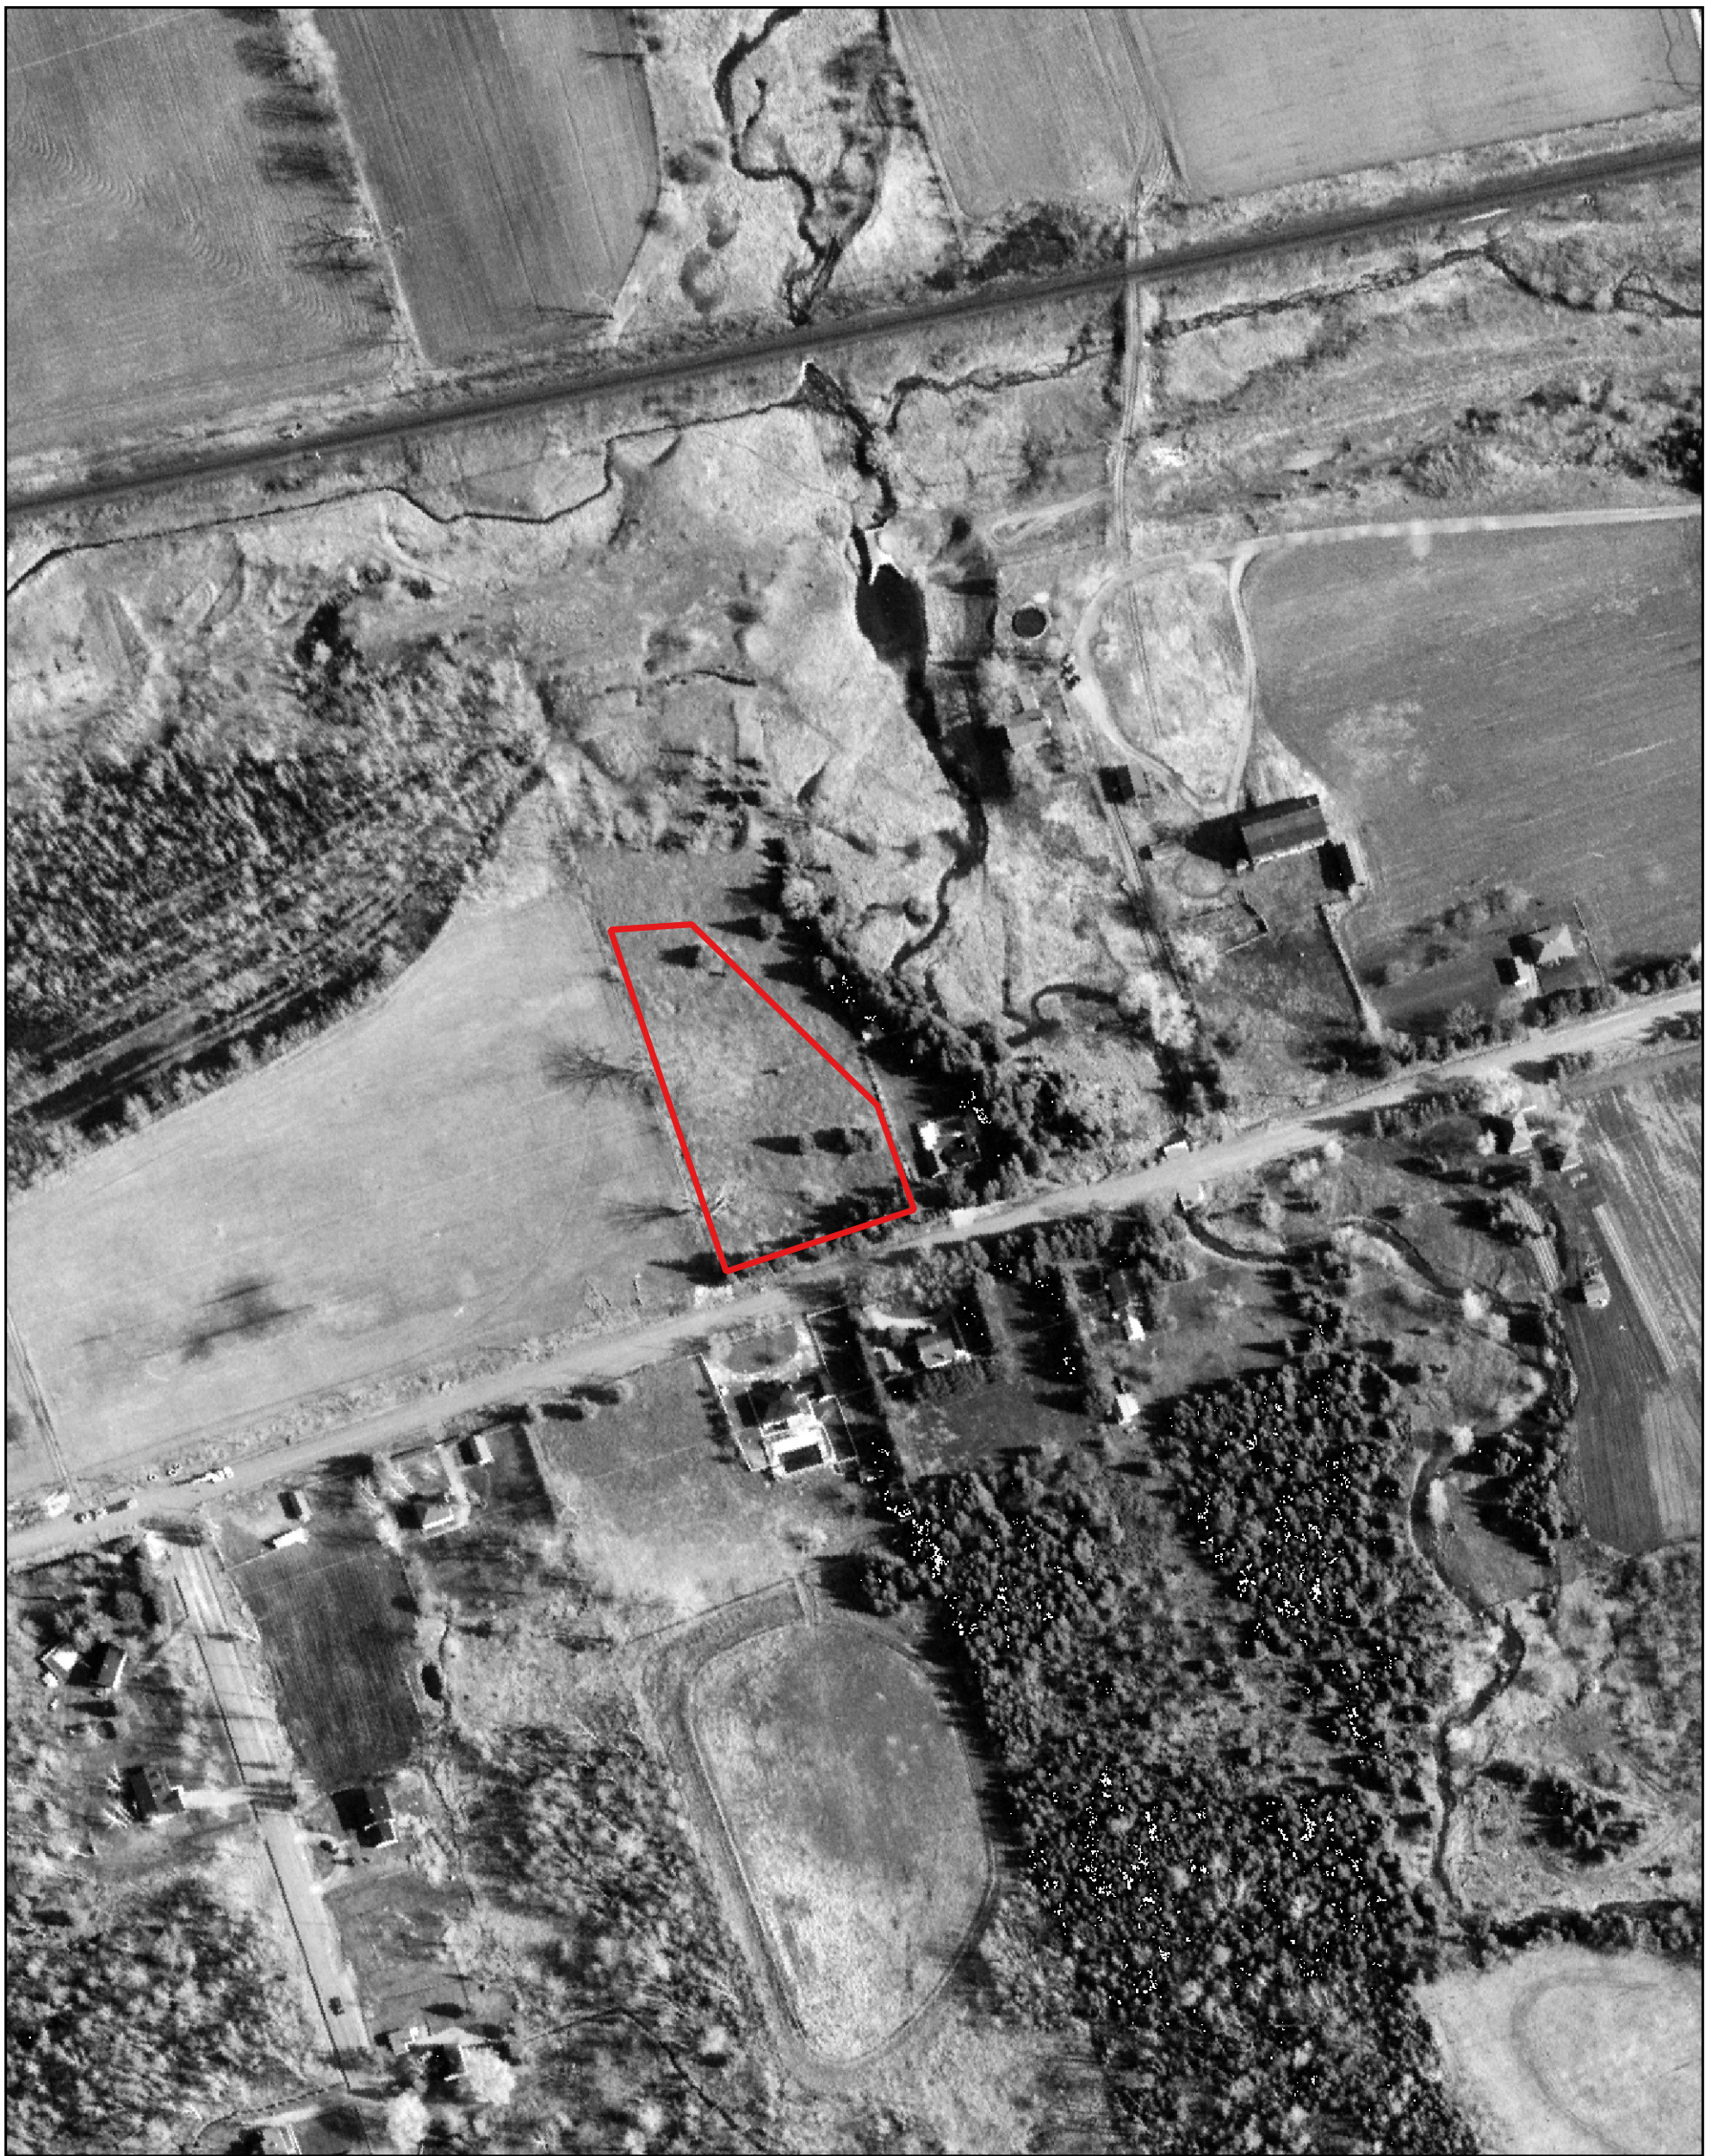
Year	Scale, Source	Observations
1972	1:12,000 Northway/Photomap/Remote Sensing Ltd.	Surrounding land use is predominantly agricultural, with low density residential development observed along Finch Avenue. Within the subject property, the parcel appears to be maintained, but buildings are not present. The existing residential home to the east can be observed. North of the subject property, the rail line has been constructed. Petticoat creek crosses under the rail line and flows east of the subject property to the Finch Avenue crossing, which appears to have been recently replaced.

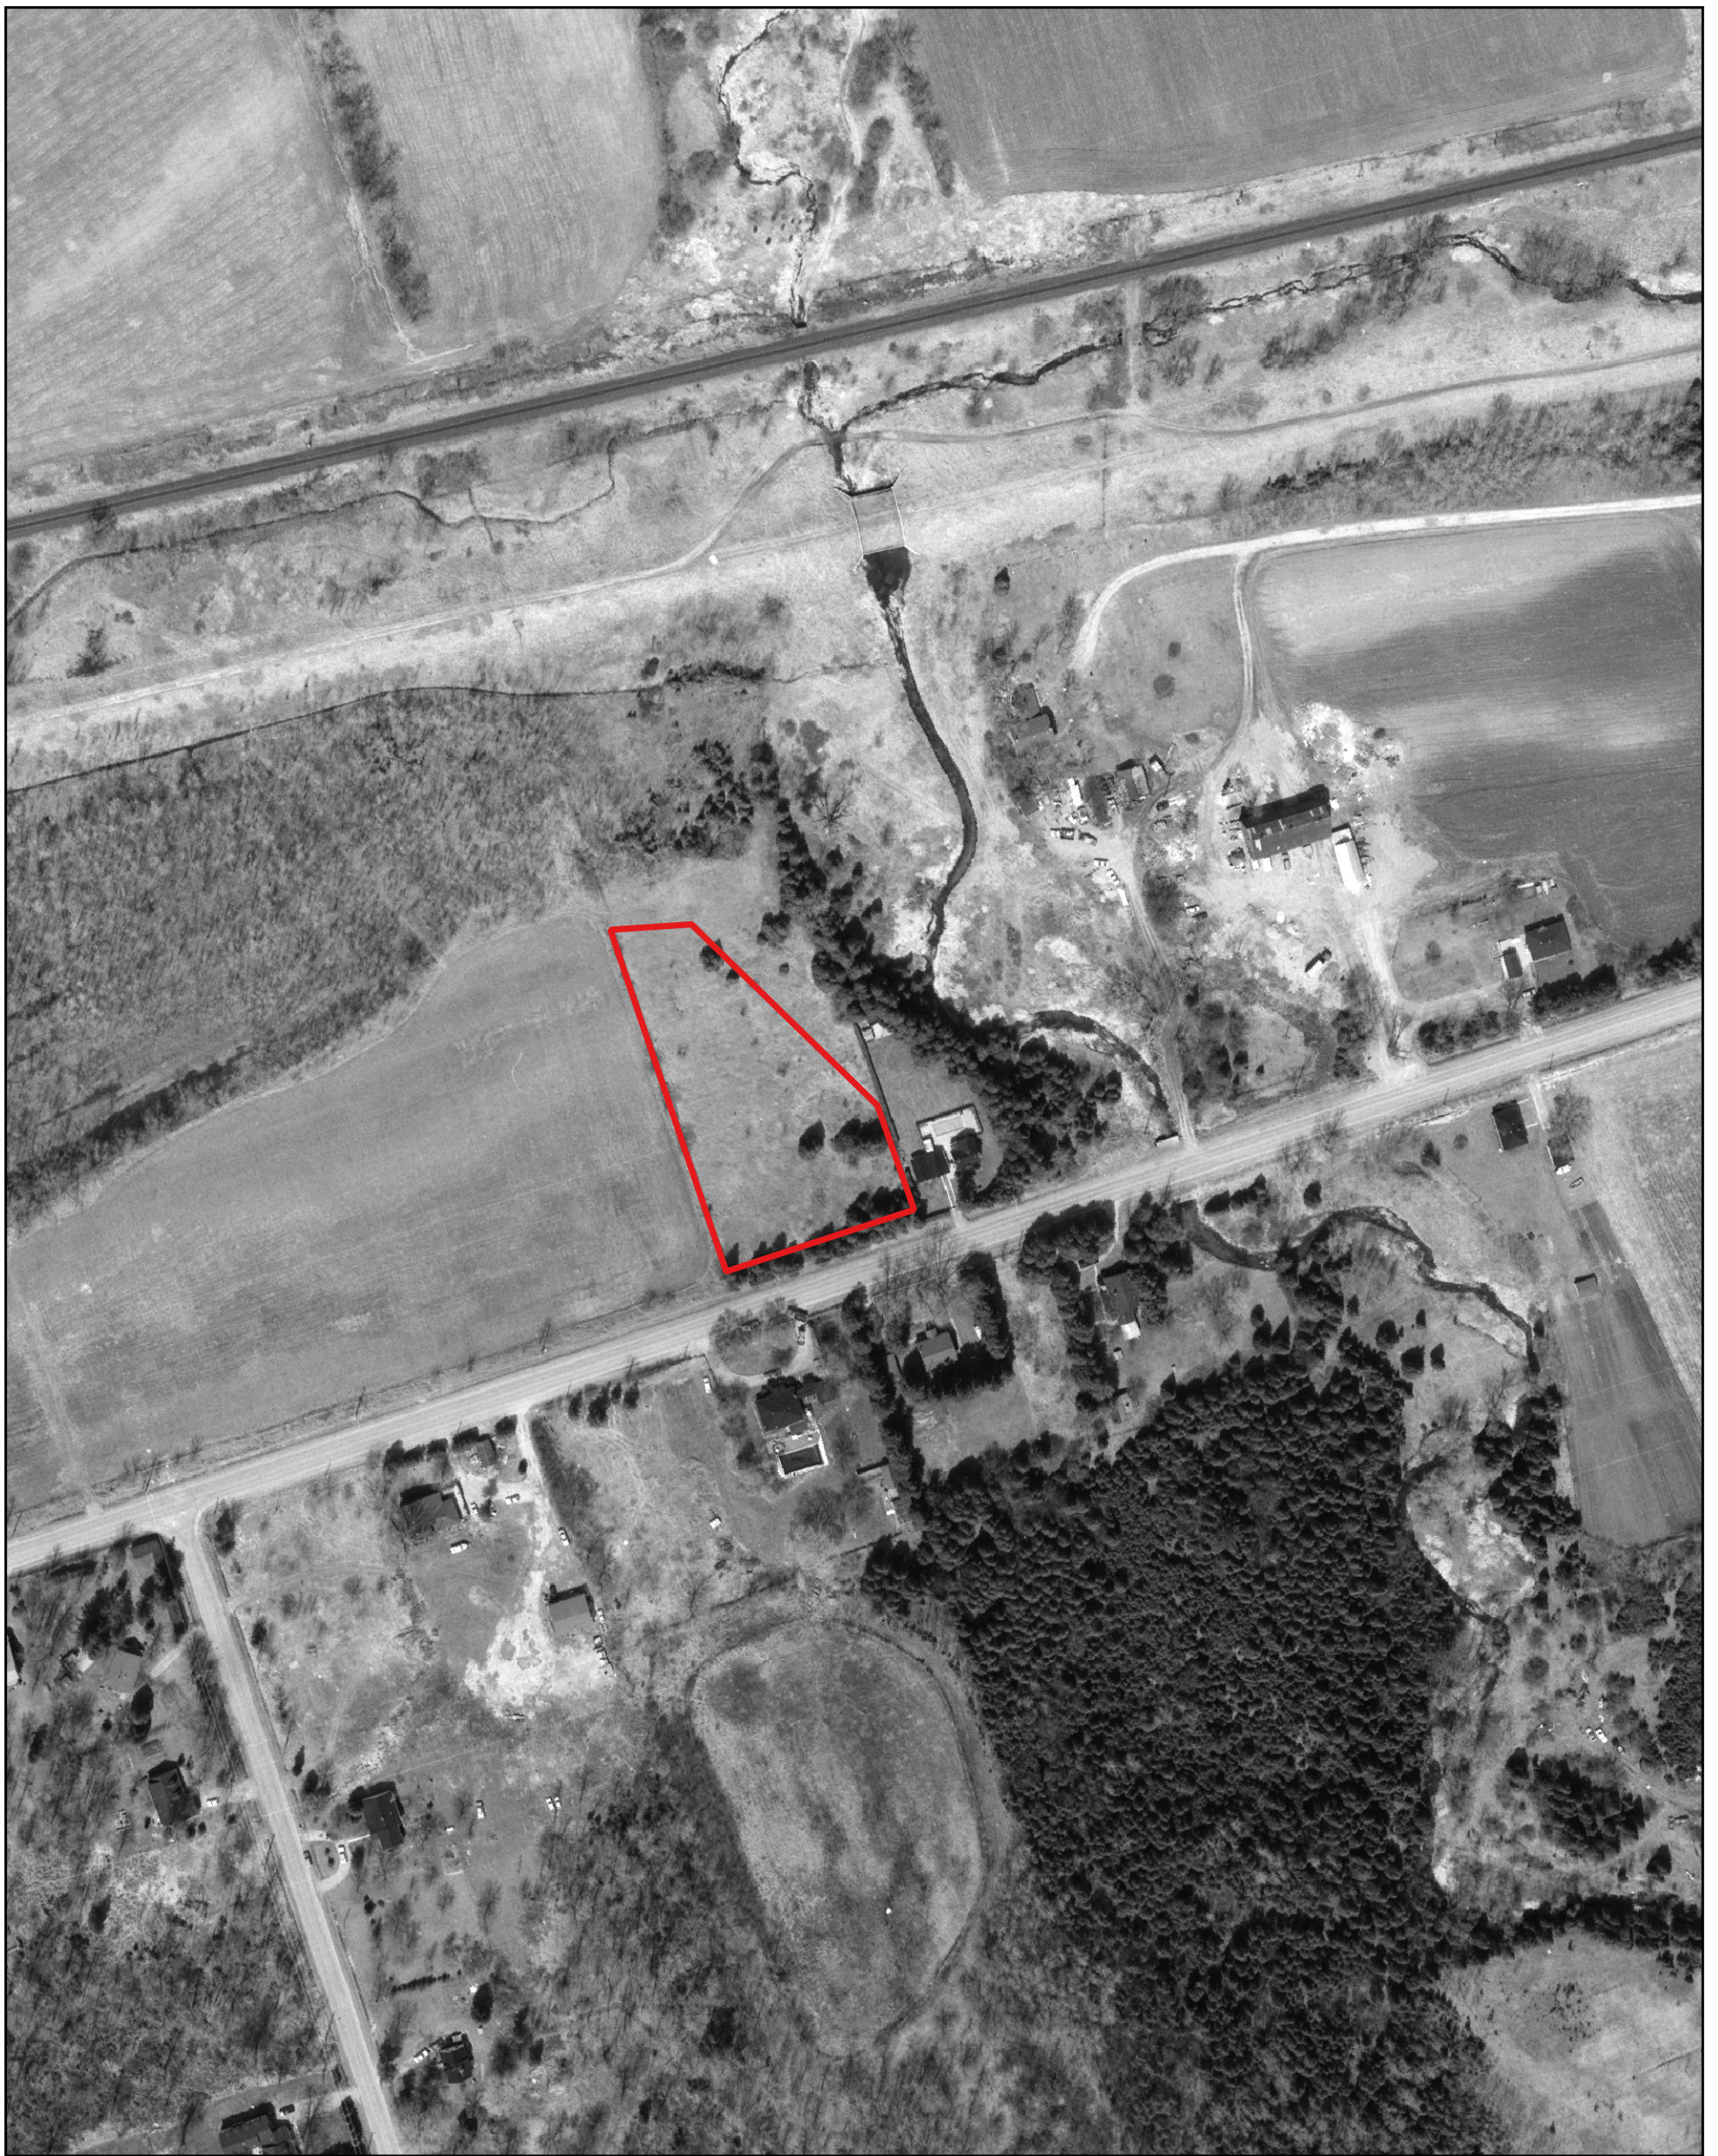
Year	Scale, Source	Observations
		South of the rail crossing, two small tributaries that run along the rail embankment confluence with Petticoat Creek. Downstream of this confluence, the main branch channel appears have outflanked a culvert crossing, downstream of which a scour pool can be observed. Evidence of saturation, and potential historic channel activity, can be observed in the floodplain downstream of the scour pool. Further downstream, the channel is observed to have a highly sinuous channel planform.
1988	1:8,000 Northway/Photomap/Remote Sensing Ltd.	Land use surrounding the subject property remained largely agricultural, with the exception of increased farm structures observed immediately east of the creek. Land use within the subject property remains unchanged. An increase in tree cover along the valley slopes can be observed. Finch Avenue has been widened. South of the rail line, the outflanked culvert has been replaced by a larger crossing structure. South of this structure, Petticoat Creek has been straightened. Evidence of planform adjustment can be observed in the form of bank erosion and slumping along meander bends upstream and downstream of Finch Avenue.

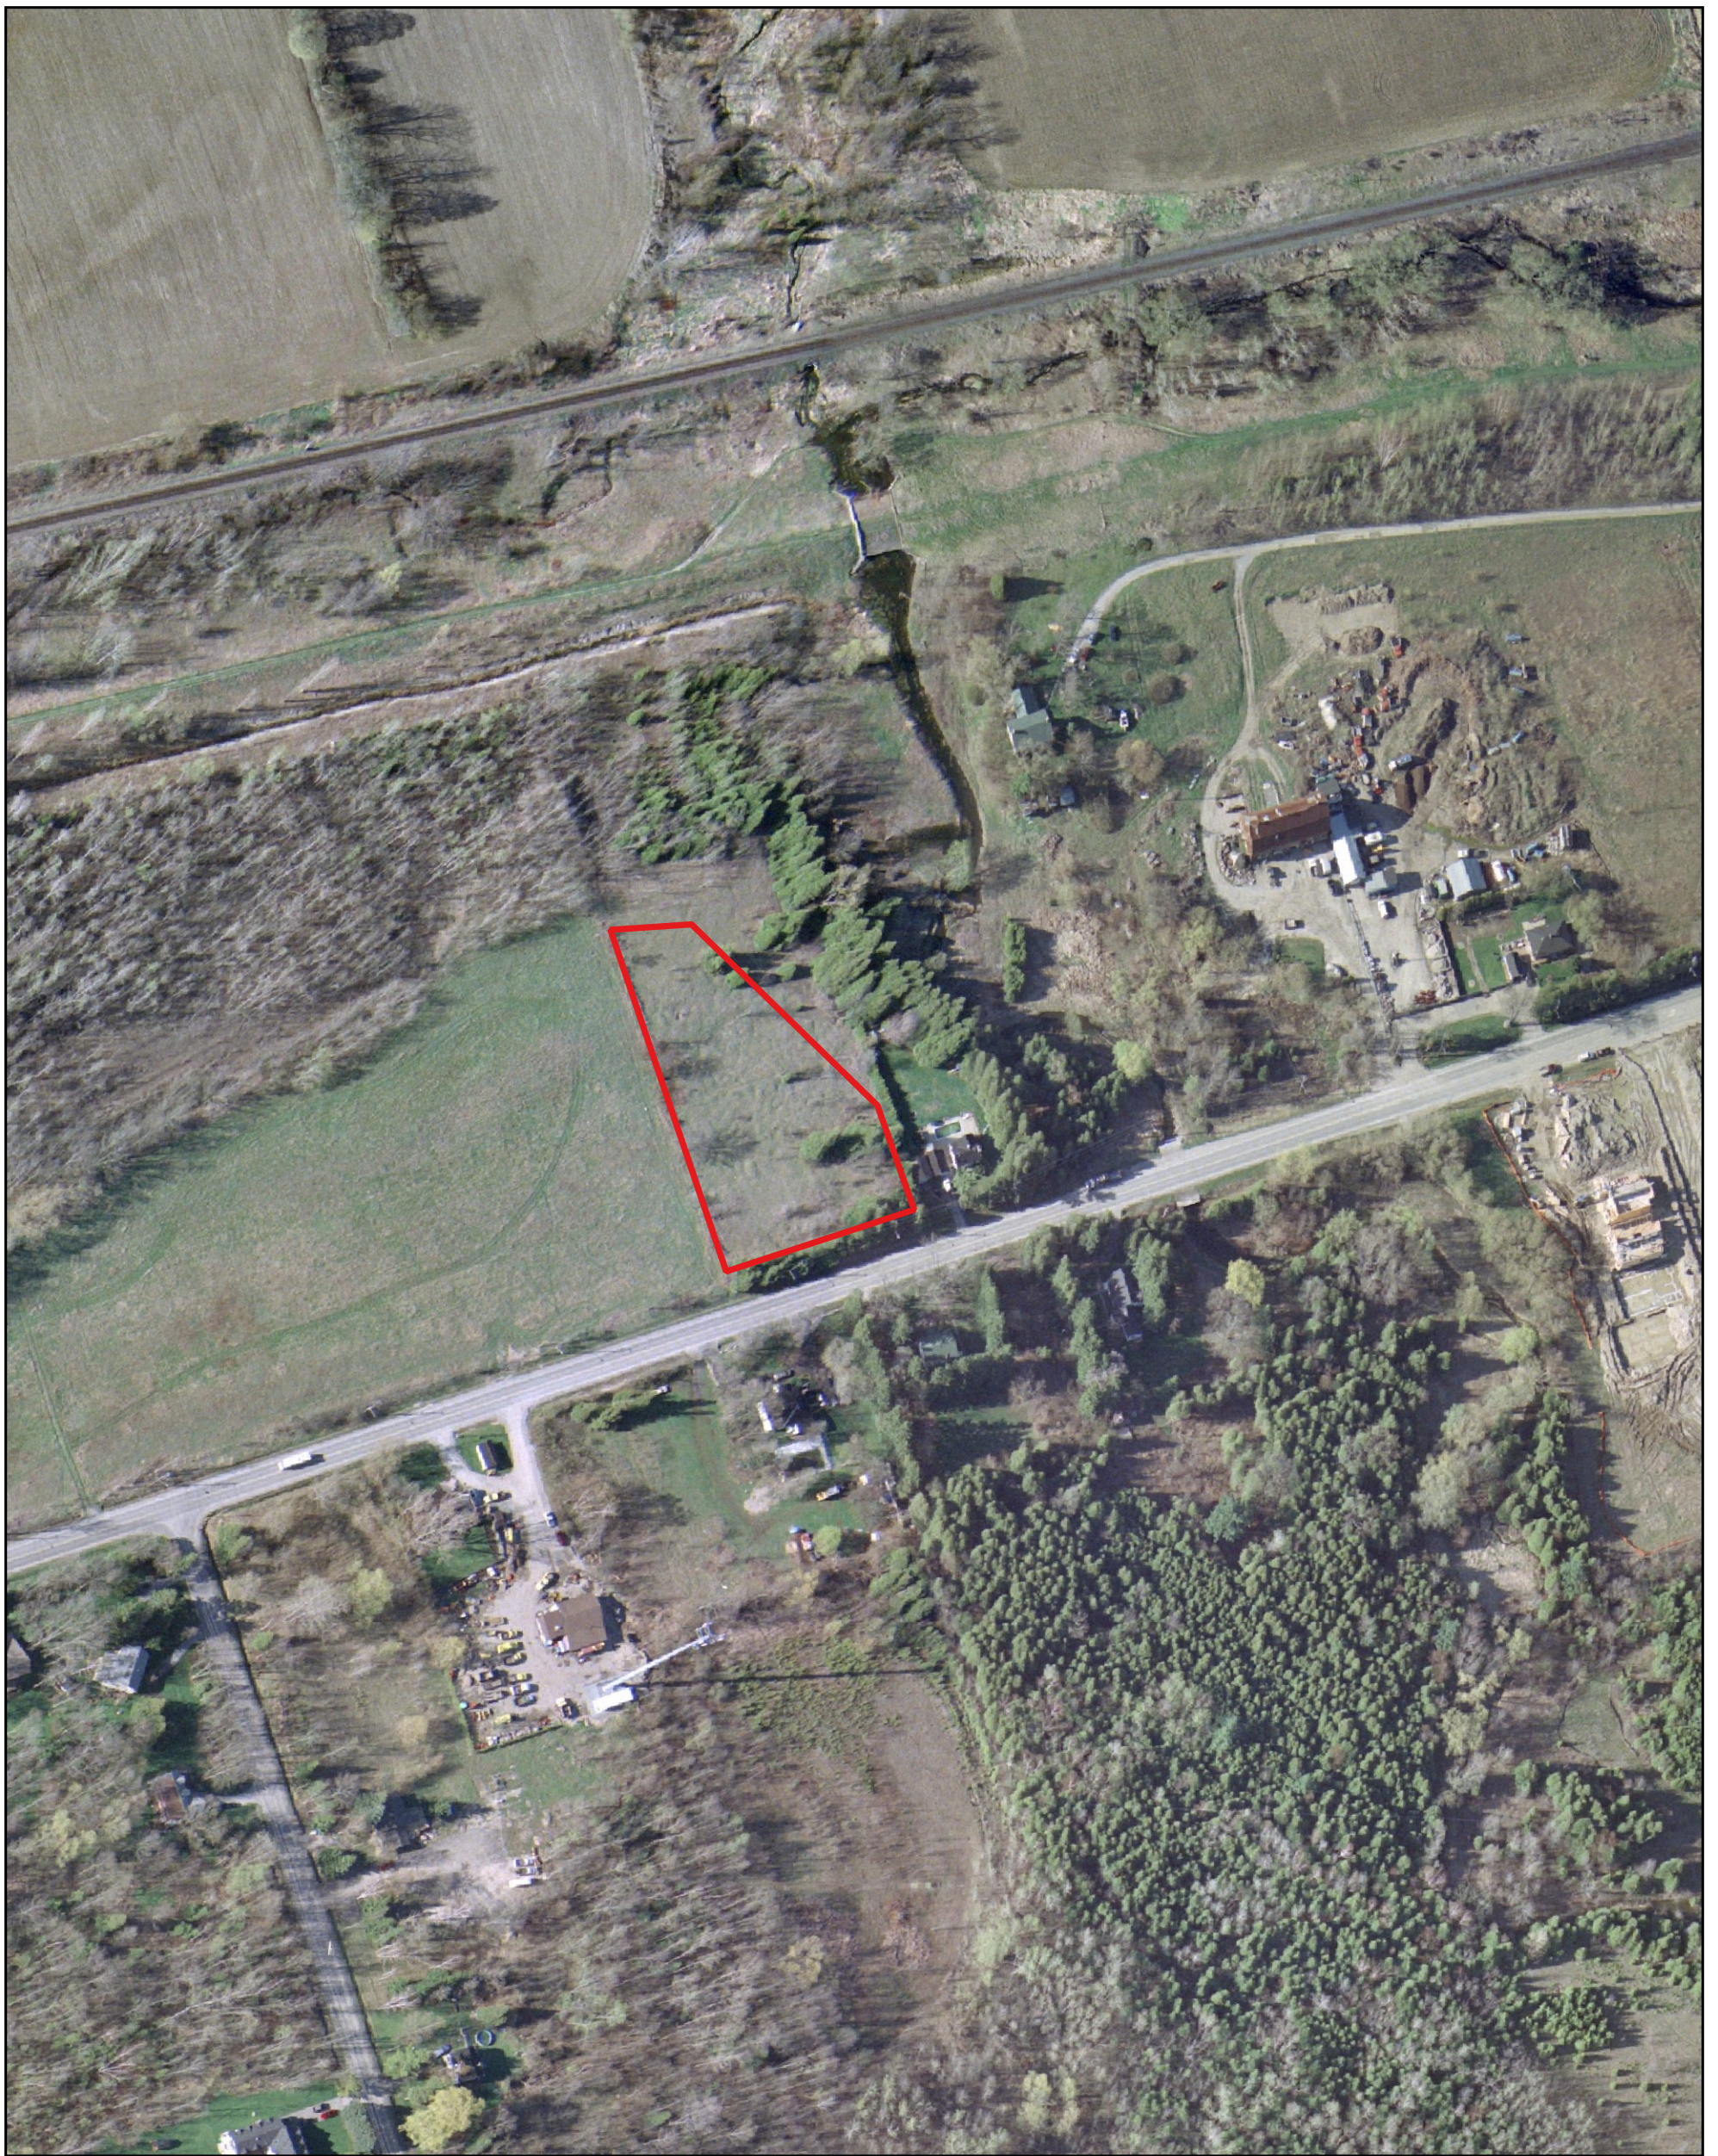
2002	1:2,000 First Base Solutions	Surrounding land use remained largely agricultural with no change in land use within the subject property. An increase in tree cover within the valley can be observed. Evidence of bank erosion (slumping) can be observed within the channel immediately downstream of the rail crossing and along meander bends upstream and downstream of Finch Avenue.
2022	1:2,000 First Base Solutions	Land use north of the rail line remains mainly agricultural. Residential subdivisions have been construction immediately west and south of the subject property, as well as east of Petticoat Creek both north and south of Finch Avenue. Land use within the subject property remains unchanged. Evidence of bank erosion (slumping) can be observed along meander bends.

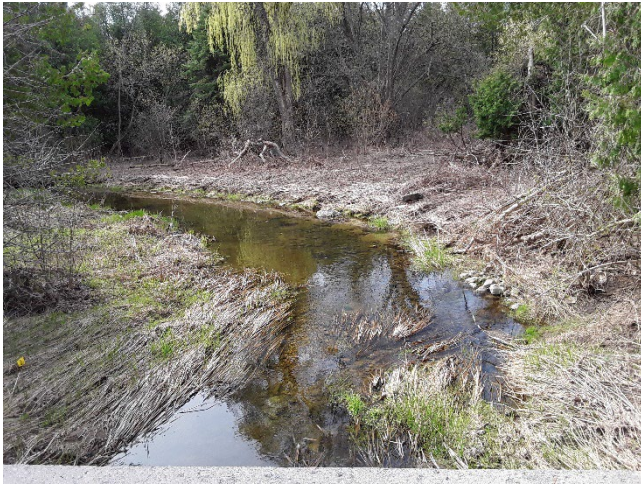
**Photograph 1. Location 1.
Reach PC-1 Petticoat Creek.**

Downstream view of channel conditions from Finch Avenue crossing.

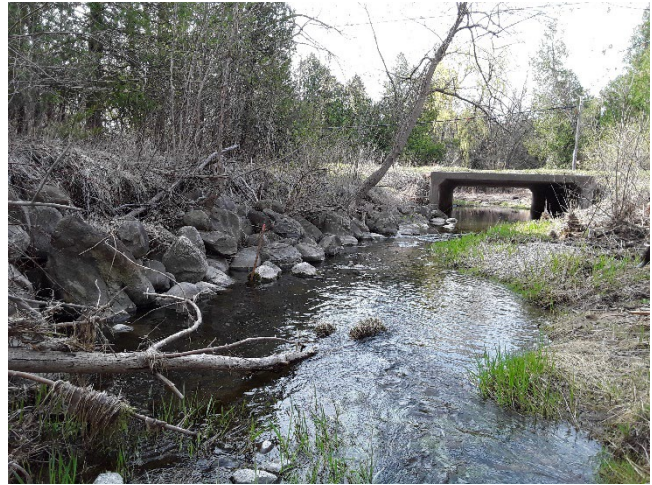
**Photograph 2. Location 2.
Reach PC-1 Petticoat Creek.**

Downstream view towards the Finch Avenue crossing. Stone bank protection observed on left bank.

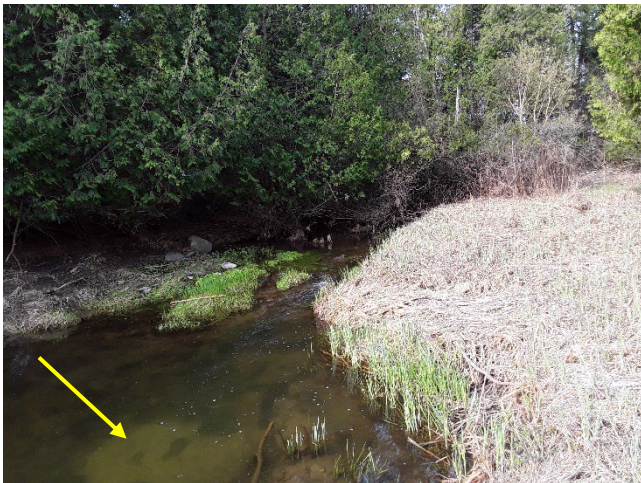
**Photograph 3. Location 3.
Reach PC-1 Petticoat Creek.**

Upstream view of general conditions. Note exposed till on the channel bed in pool feature (arrow).

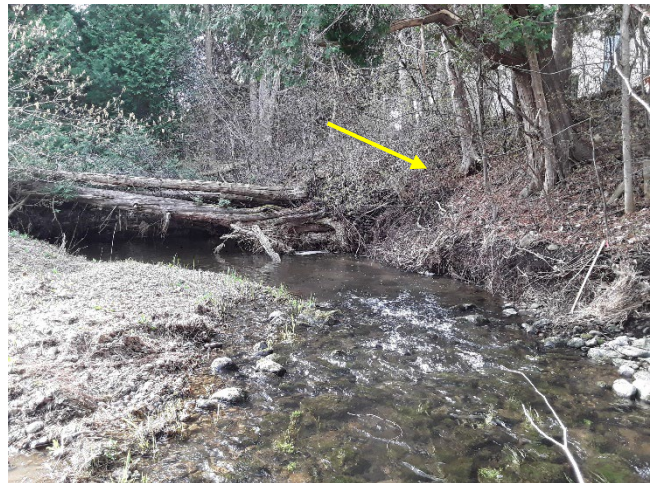
**Photograph 4. Location 4.
Reach PC-1 Petticoat Creek.**

Downstream view of riffle at valley wall contact (arrow). Note basal scour and fallen trees within channel.

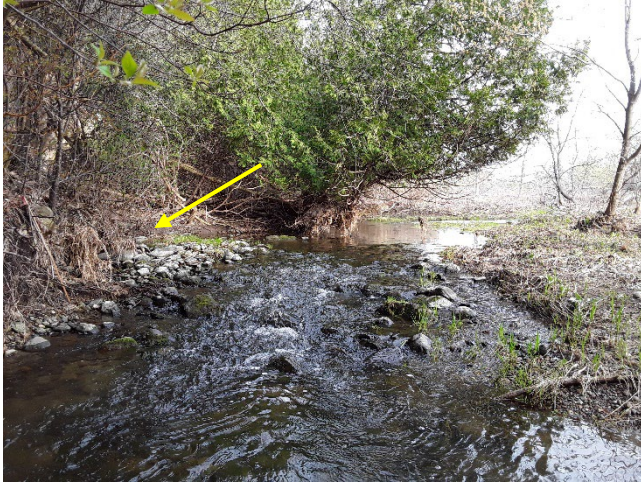
**Photograph 5. Location 4.
Reach PC-1 Petticoat Creek.**

Upstream view of riffle at valley wall contact on right bank (photo left; arrow).

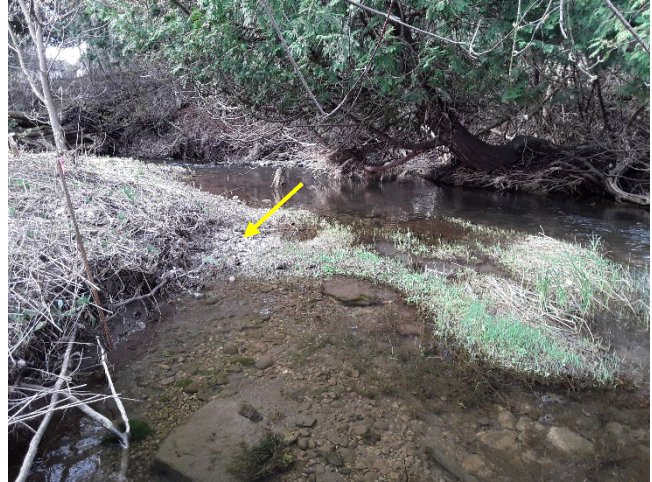
**Photograph 6. Location 5.
Reach PC-1 Petticoat Creek.**

Downstream view of meander bend at valley wall contact and leaning trees on right bank. Note scour on inside meander bend, with reworked gravel point bar (arrow).

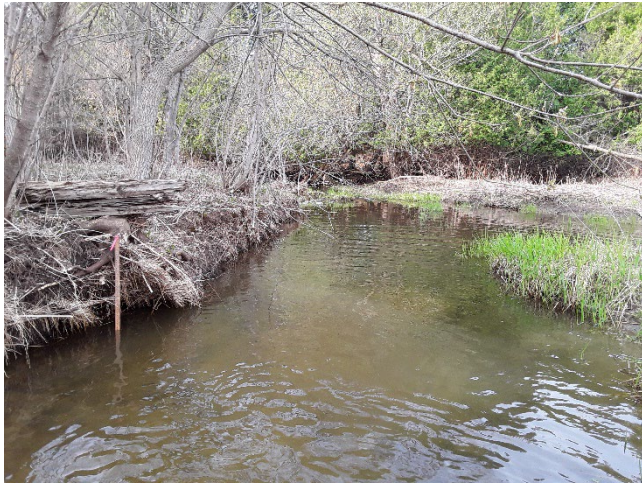
**Photograph 7. Location 6.
Reach PC-1 Petticoat Creek.**

Downstream view of channel conditions. Note undercutting on left bank.

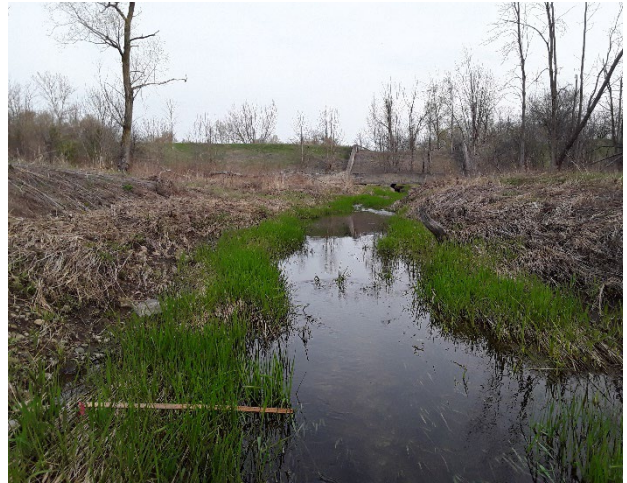
**Photograph 8. Location 7.
Reach PC-1 Petticoat Creek.**

Upstream view of channel conditions looking towards existing crossing structure south of rail line. Note channelized nature of creek and increase in entrenchment.
