PHASE I ENVIRONMENTAL
SITE ASSESSMENT

375 KINGSTON ROAD,
PICKERING, ON

Project No. FE-P 21-11141

March 30, 2021

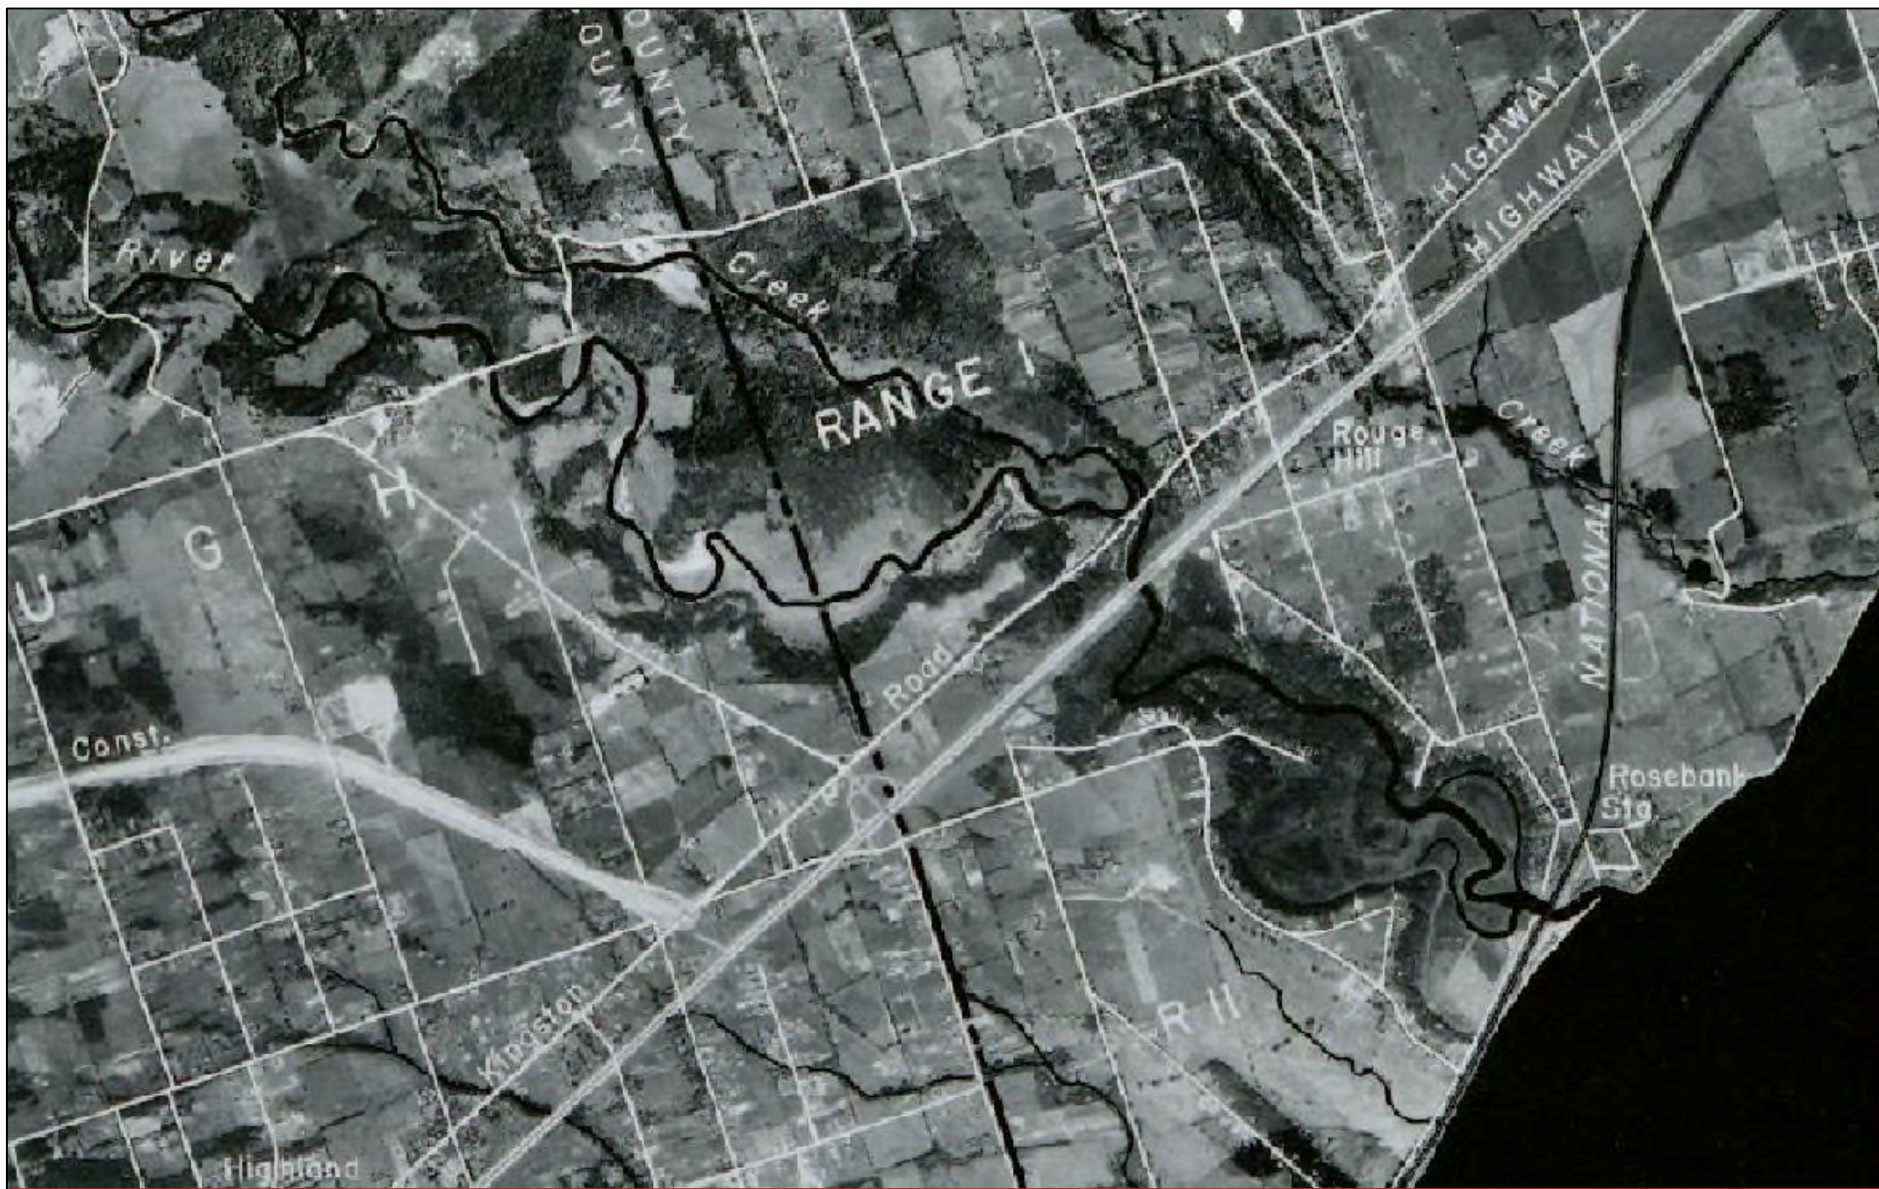
FIGURE 6:

Aerial photographs from 1954, 1978, 1988 and 2002 were obtained from LGI Copy Service Canada Inc. and Google Maps. The photographs were examined stereoscopically to assess Site conditions.

Aerial Photograph
 1954

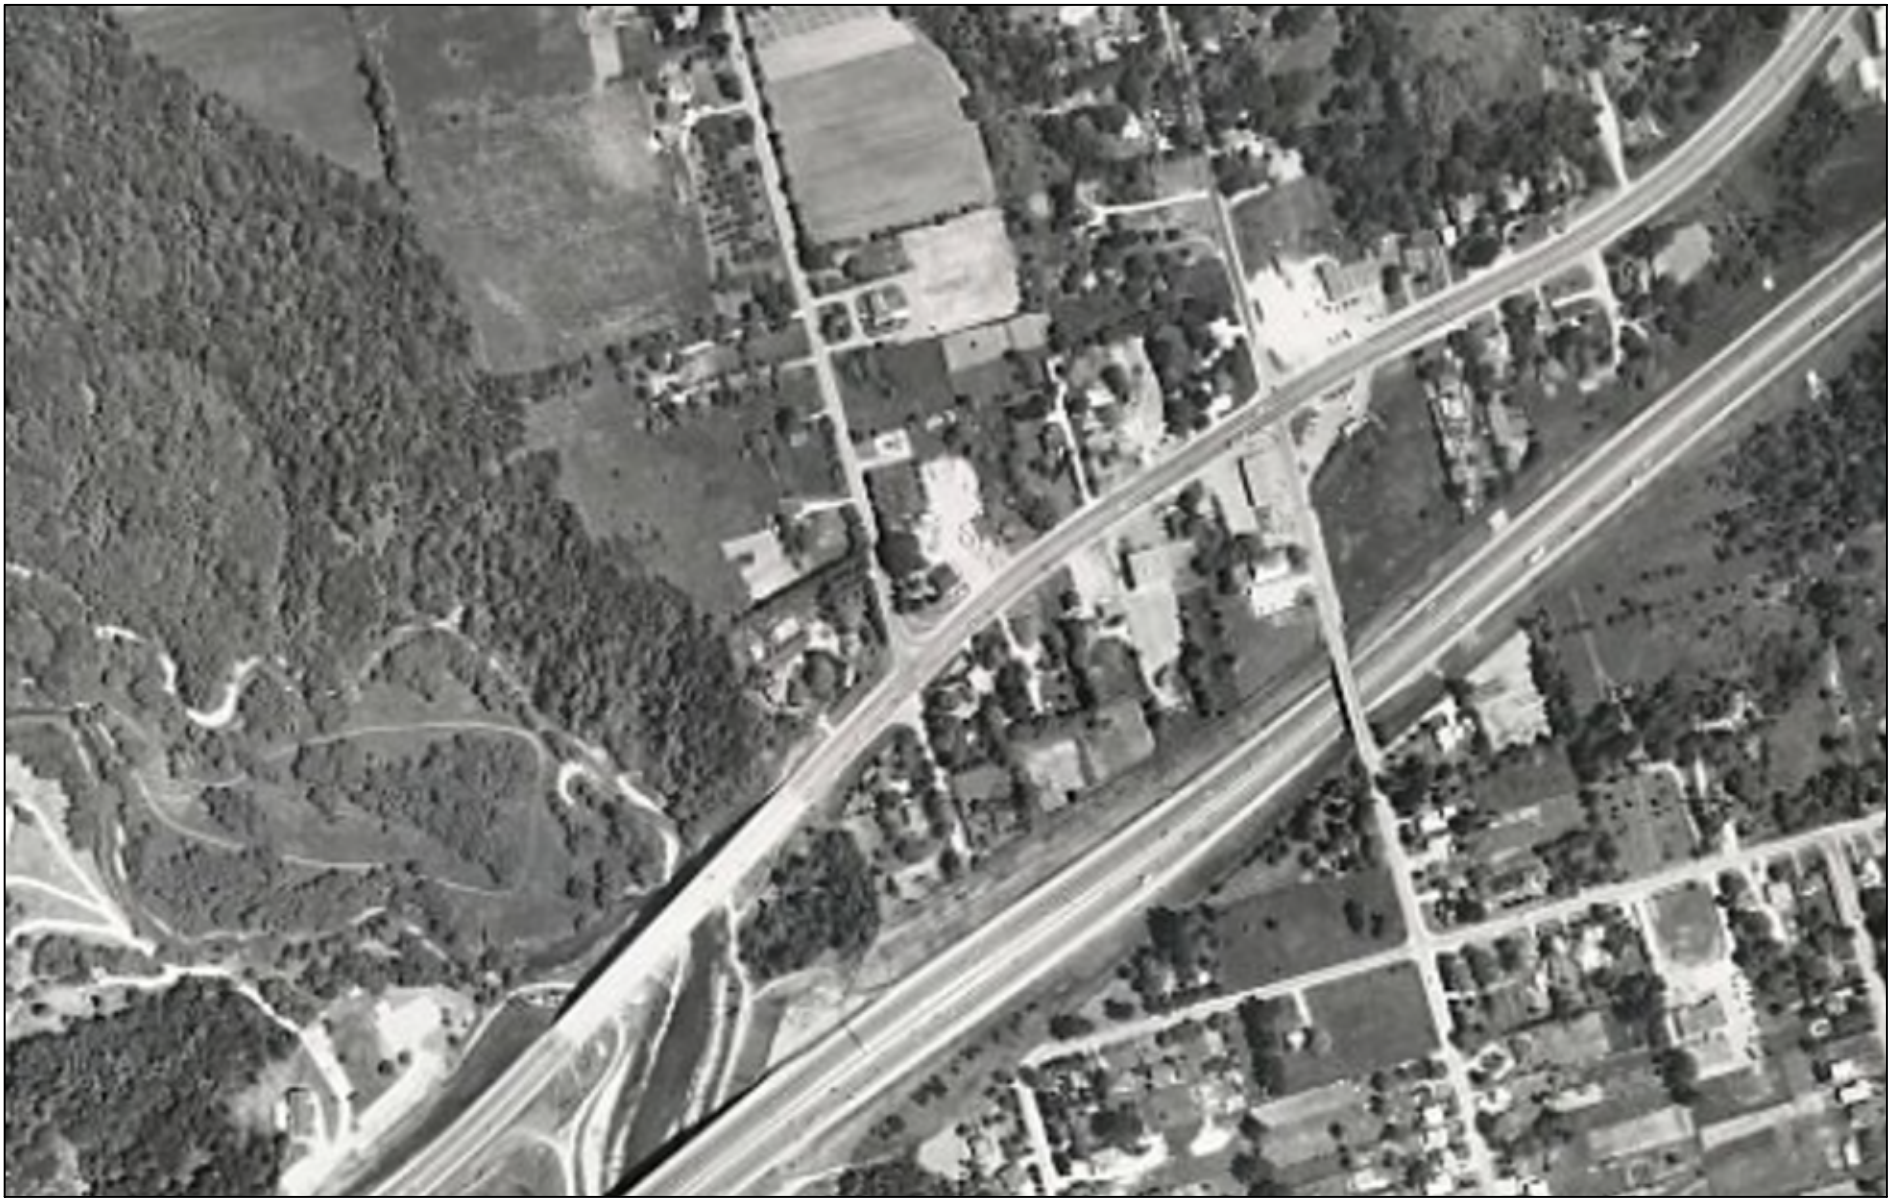
FIGURE 7:

Aerial Photograph
1978

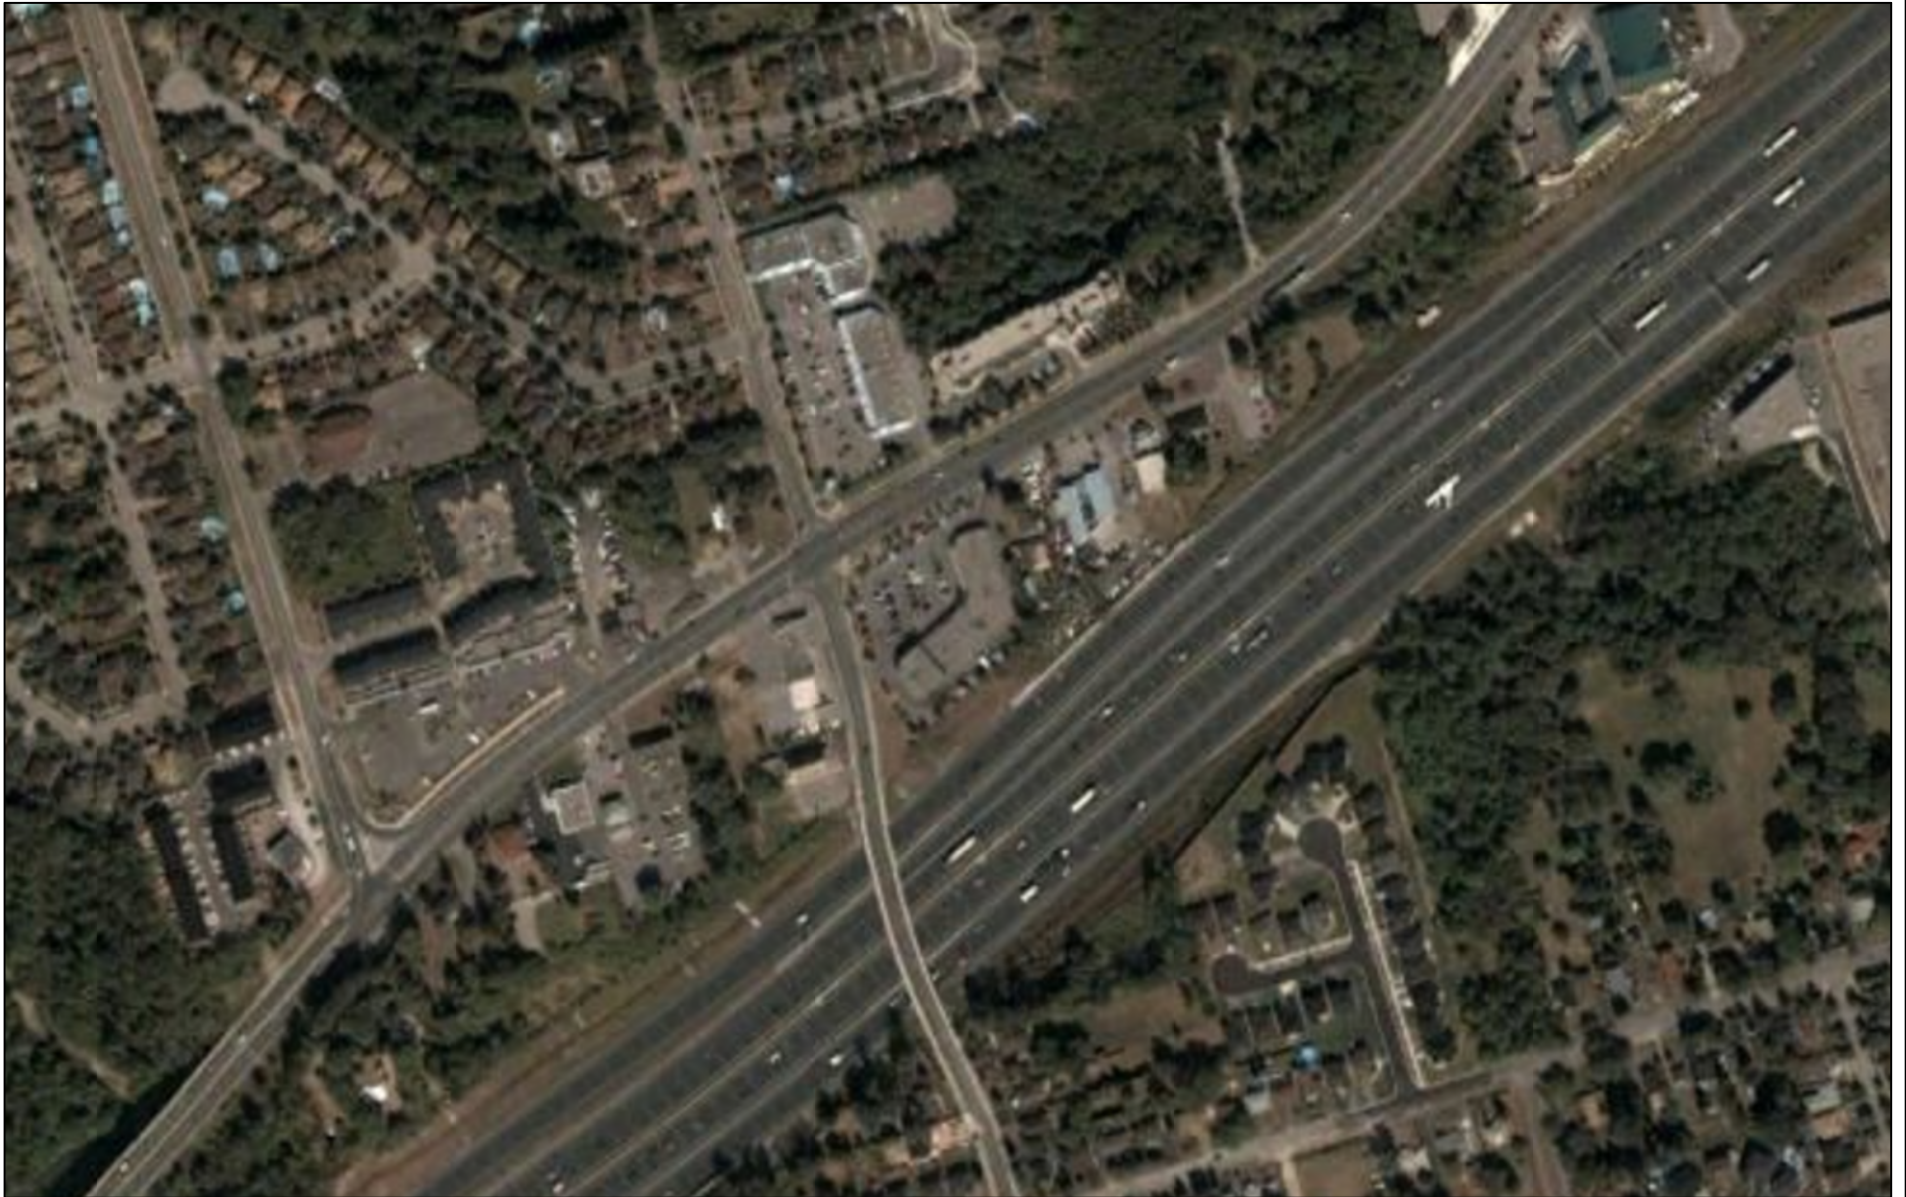
FIGURE 8:

Aerial Photograph
 1988

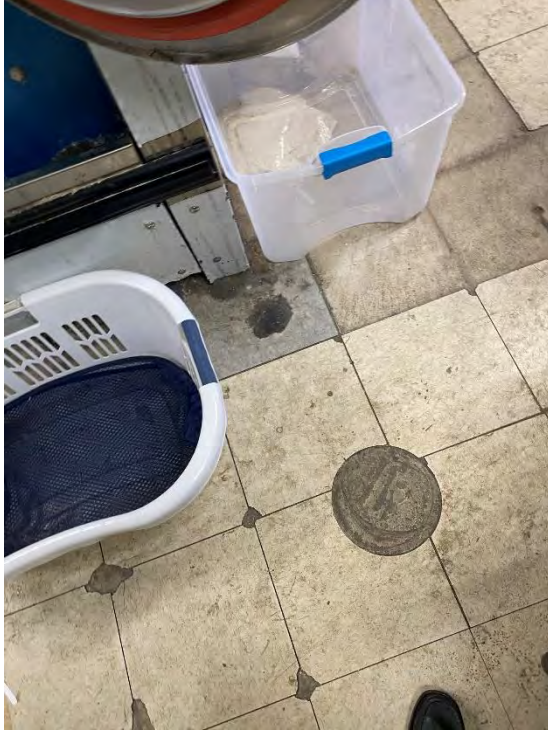
Photo 3: Dry Cleaners. View of Floor.

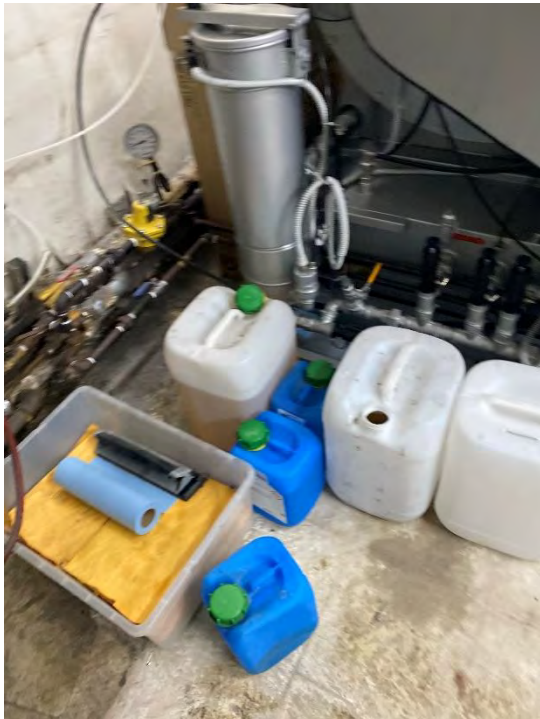
Hazardous Material	Storage Details	Location On-site
Solvents	20 L metal drum	Dry Cleaners

Photo 4: Chemicals Storage Area.

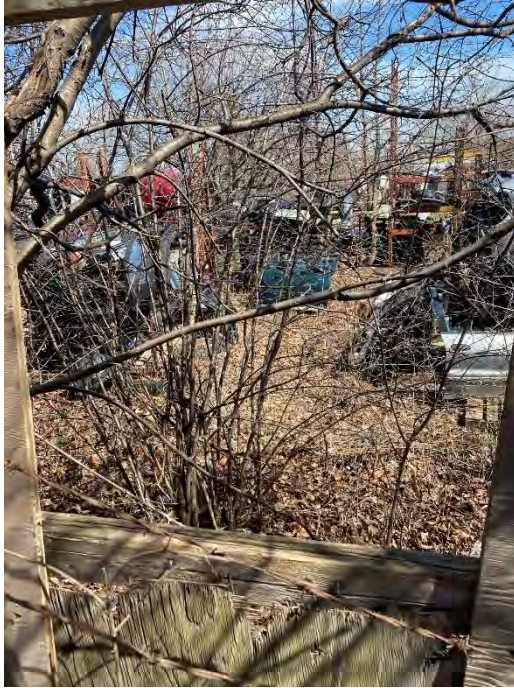
Address and Distance/ Direction from Site	Environmentally Significant Findings
395 Kingston Road – 68m/northeast	Allison Auto Wreckers was listed as a Hazardous Waste Generator for light fuels (221), aliphatic solvents (212), waste oils and lubricants (252) from 2007 to 2021. This Site was registered as a waste disposal site in 2016. Based on the groundwater flow direction (southwest) and the local stratigraphy, the presence of this operation may to represent a source of contamination on and/or under the Site.
345 Kingston Road- 176m/south-southwest	Dr. Hu and Dr. Liao DPC were registered as hazardous waste generators for photo processing wastes (264) and pathological wastes (312) from 2003 to 2021. Based on the anticipated groundwater flow direction (southwest) and the local stratigraphy, the presence of these operations is unlikely to represent a source of contamination on and/or under the Site.

Photo 7: East neighbouring property. Allison Auto Wreckers.
