Wetland Risk Evaluation

2055 Brock Road, Pickering, Ontario

December 13, 2021

Terrapex Environmental Ltd.

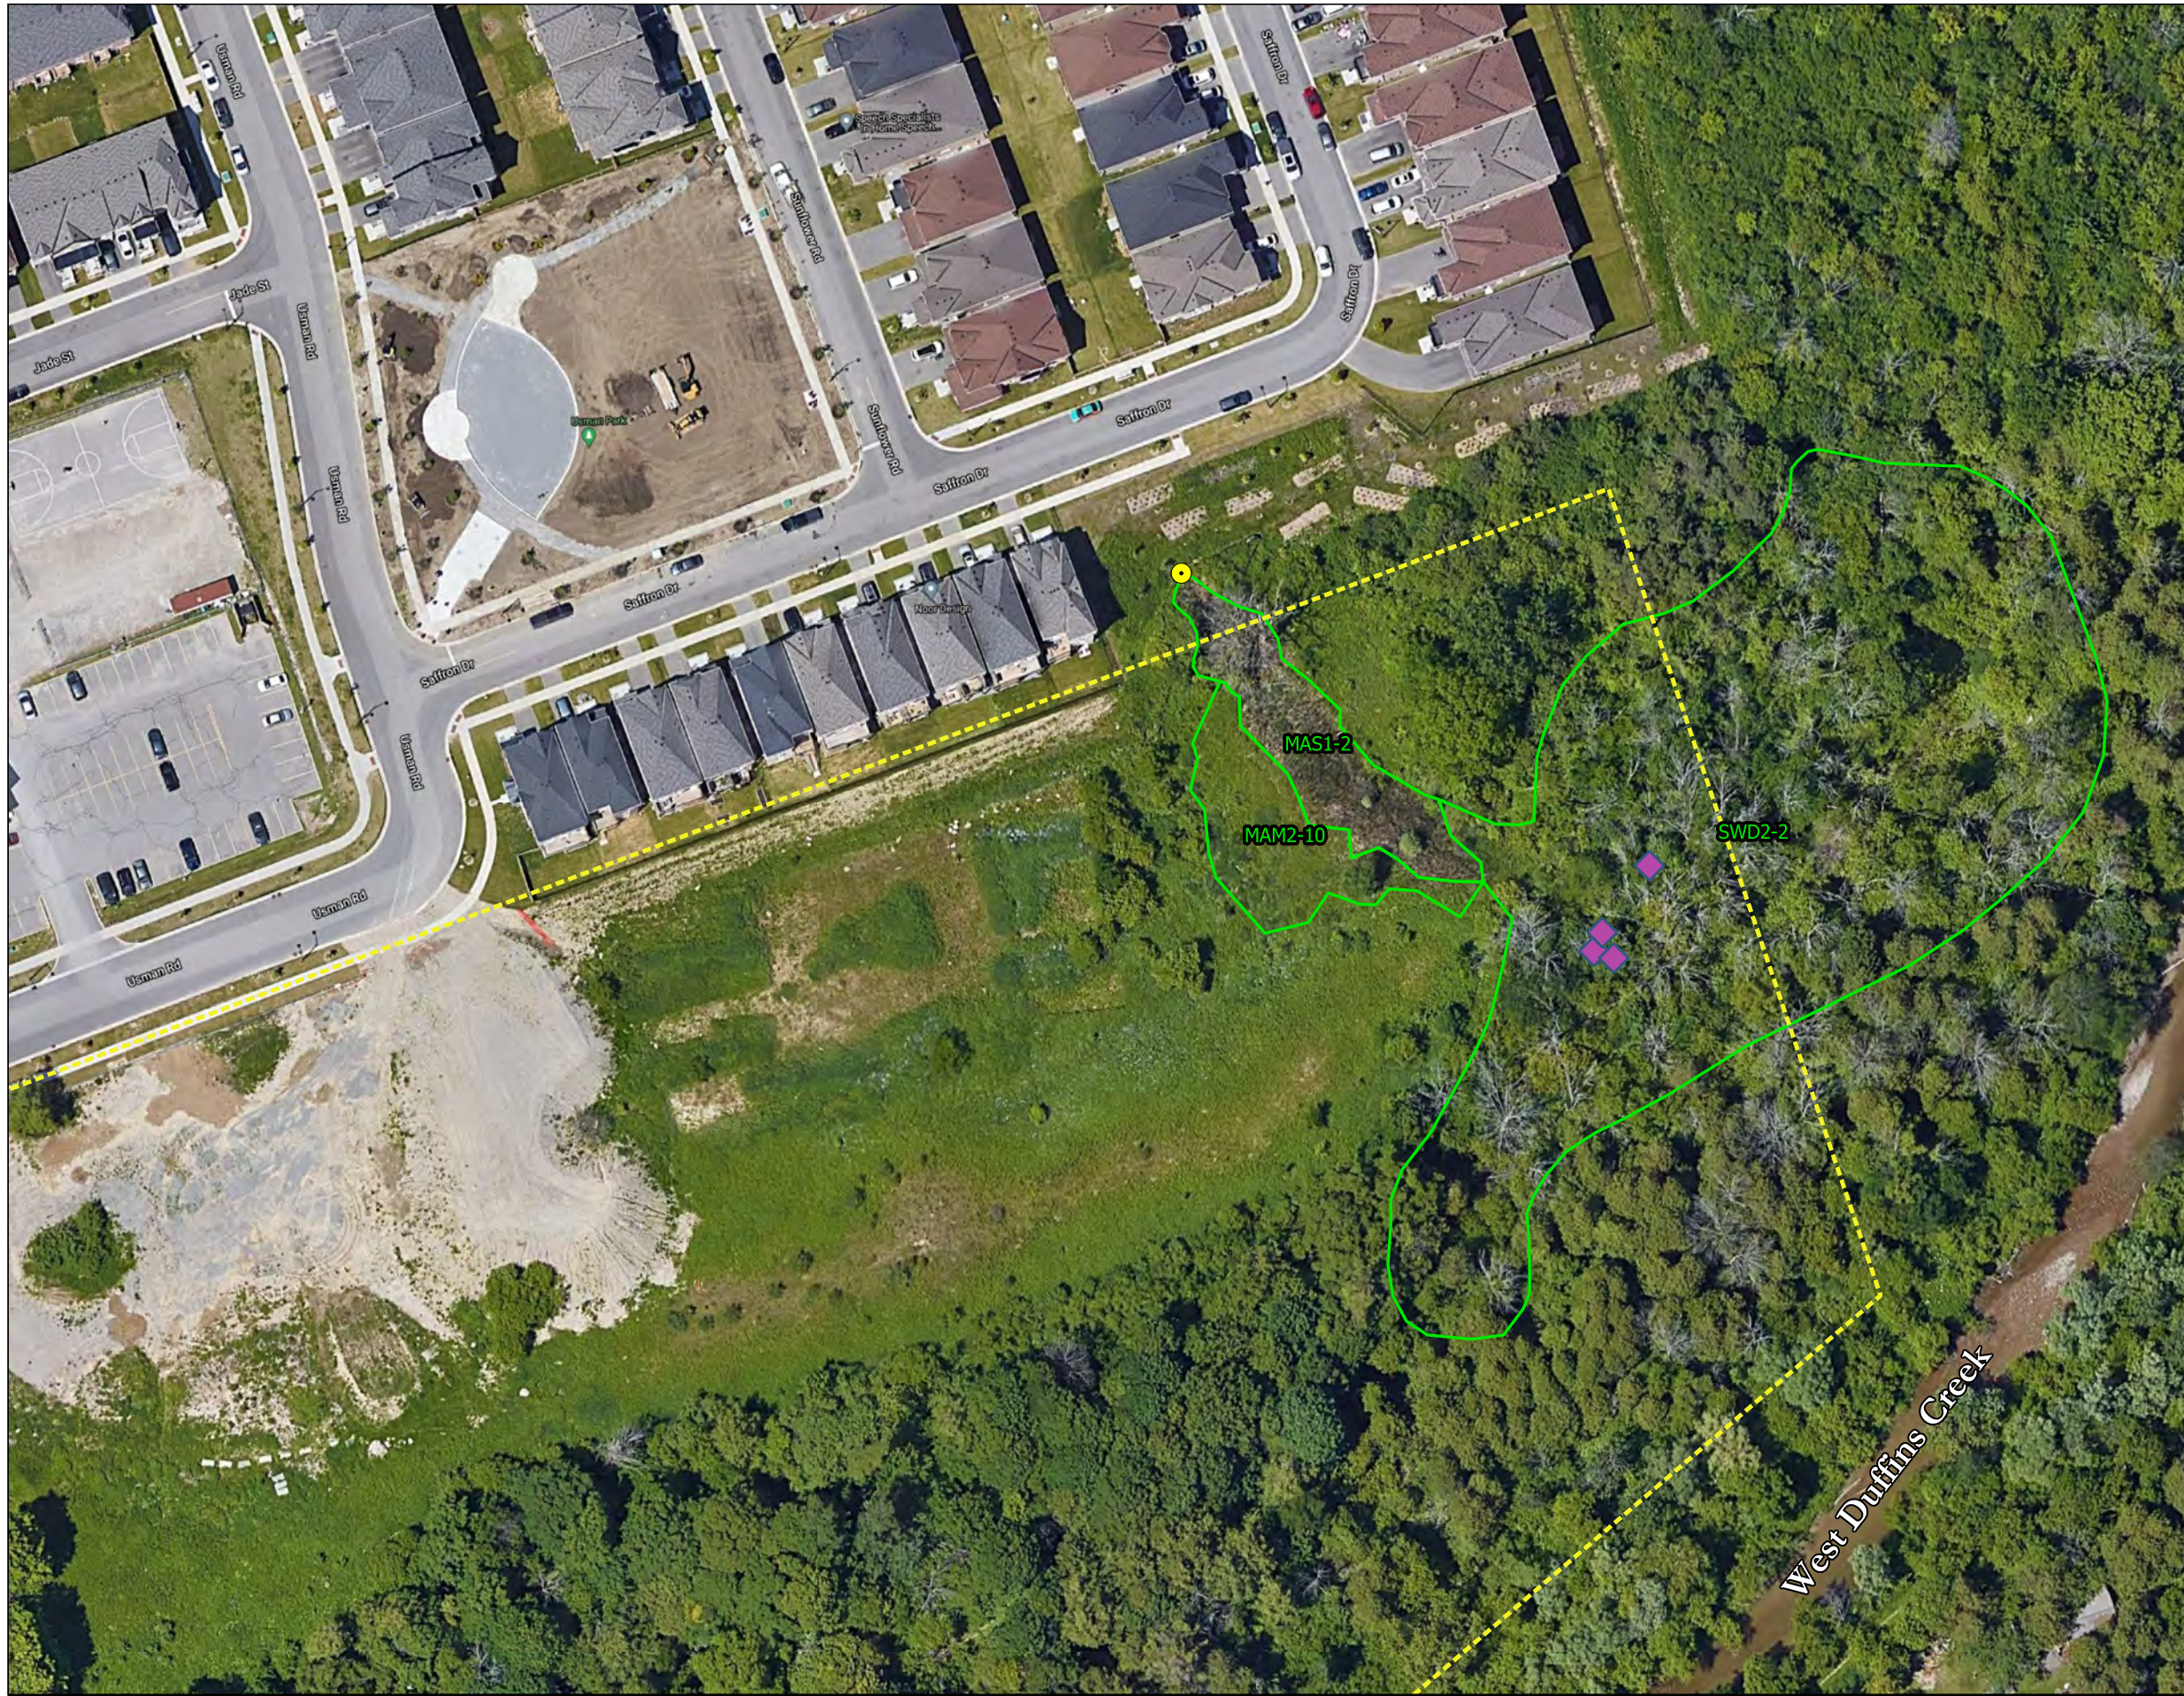
Figure 2:
 Biophysical
 Features and
 Conditions

Biophysical Conditions - Terrastory
 [Green outline] Wetland Vegetation Communities
 [Purple diamond] Black Ash

A clean water outlet associated with the residential development north of the subject property was observed in the northernmost portion of the wetland (for location see **Appendix A, Figure 2**).

The following is a description of the biophysical features and conditions of the Subject Property, which are shown spatially on **Figure 2** and **Figure 3**.

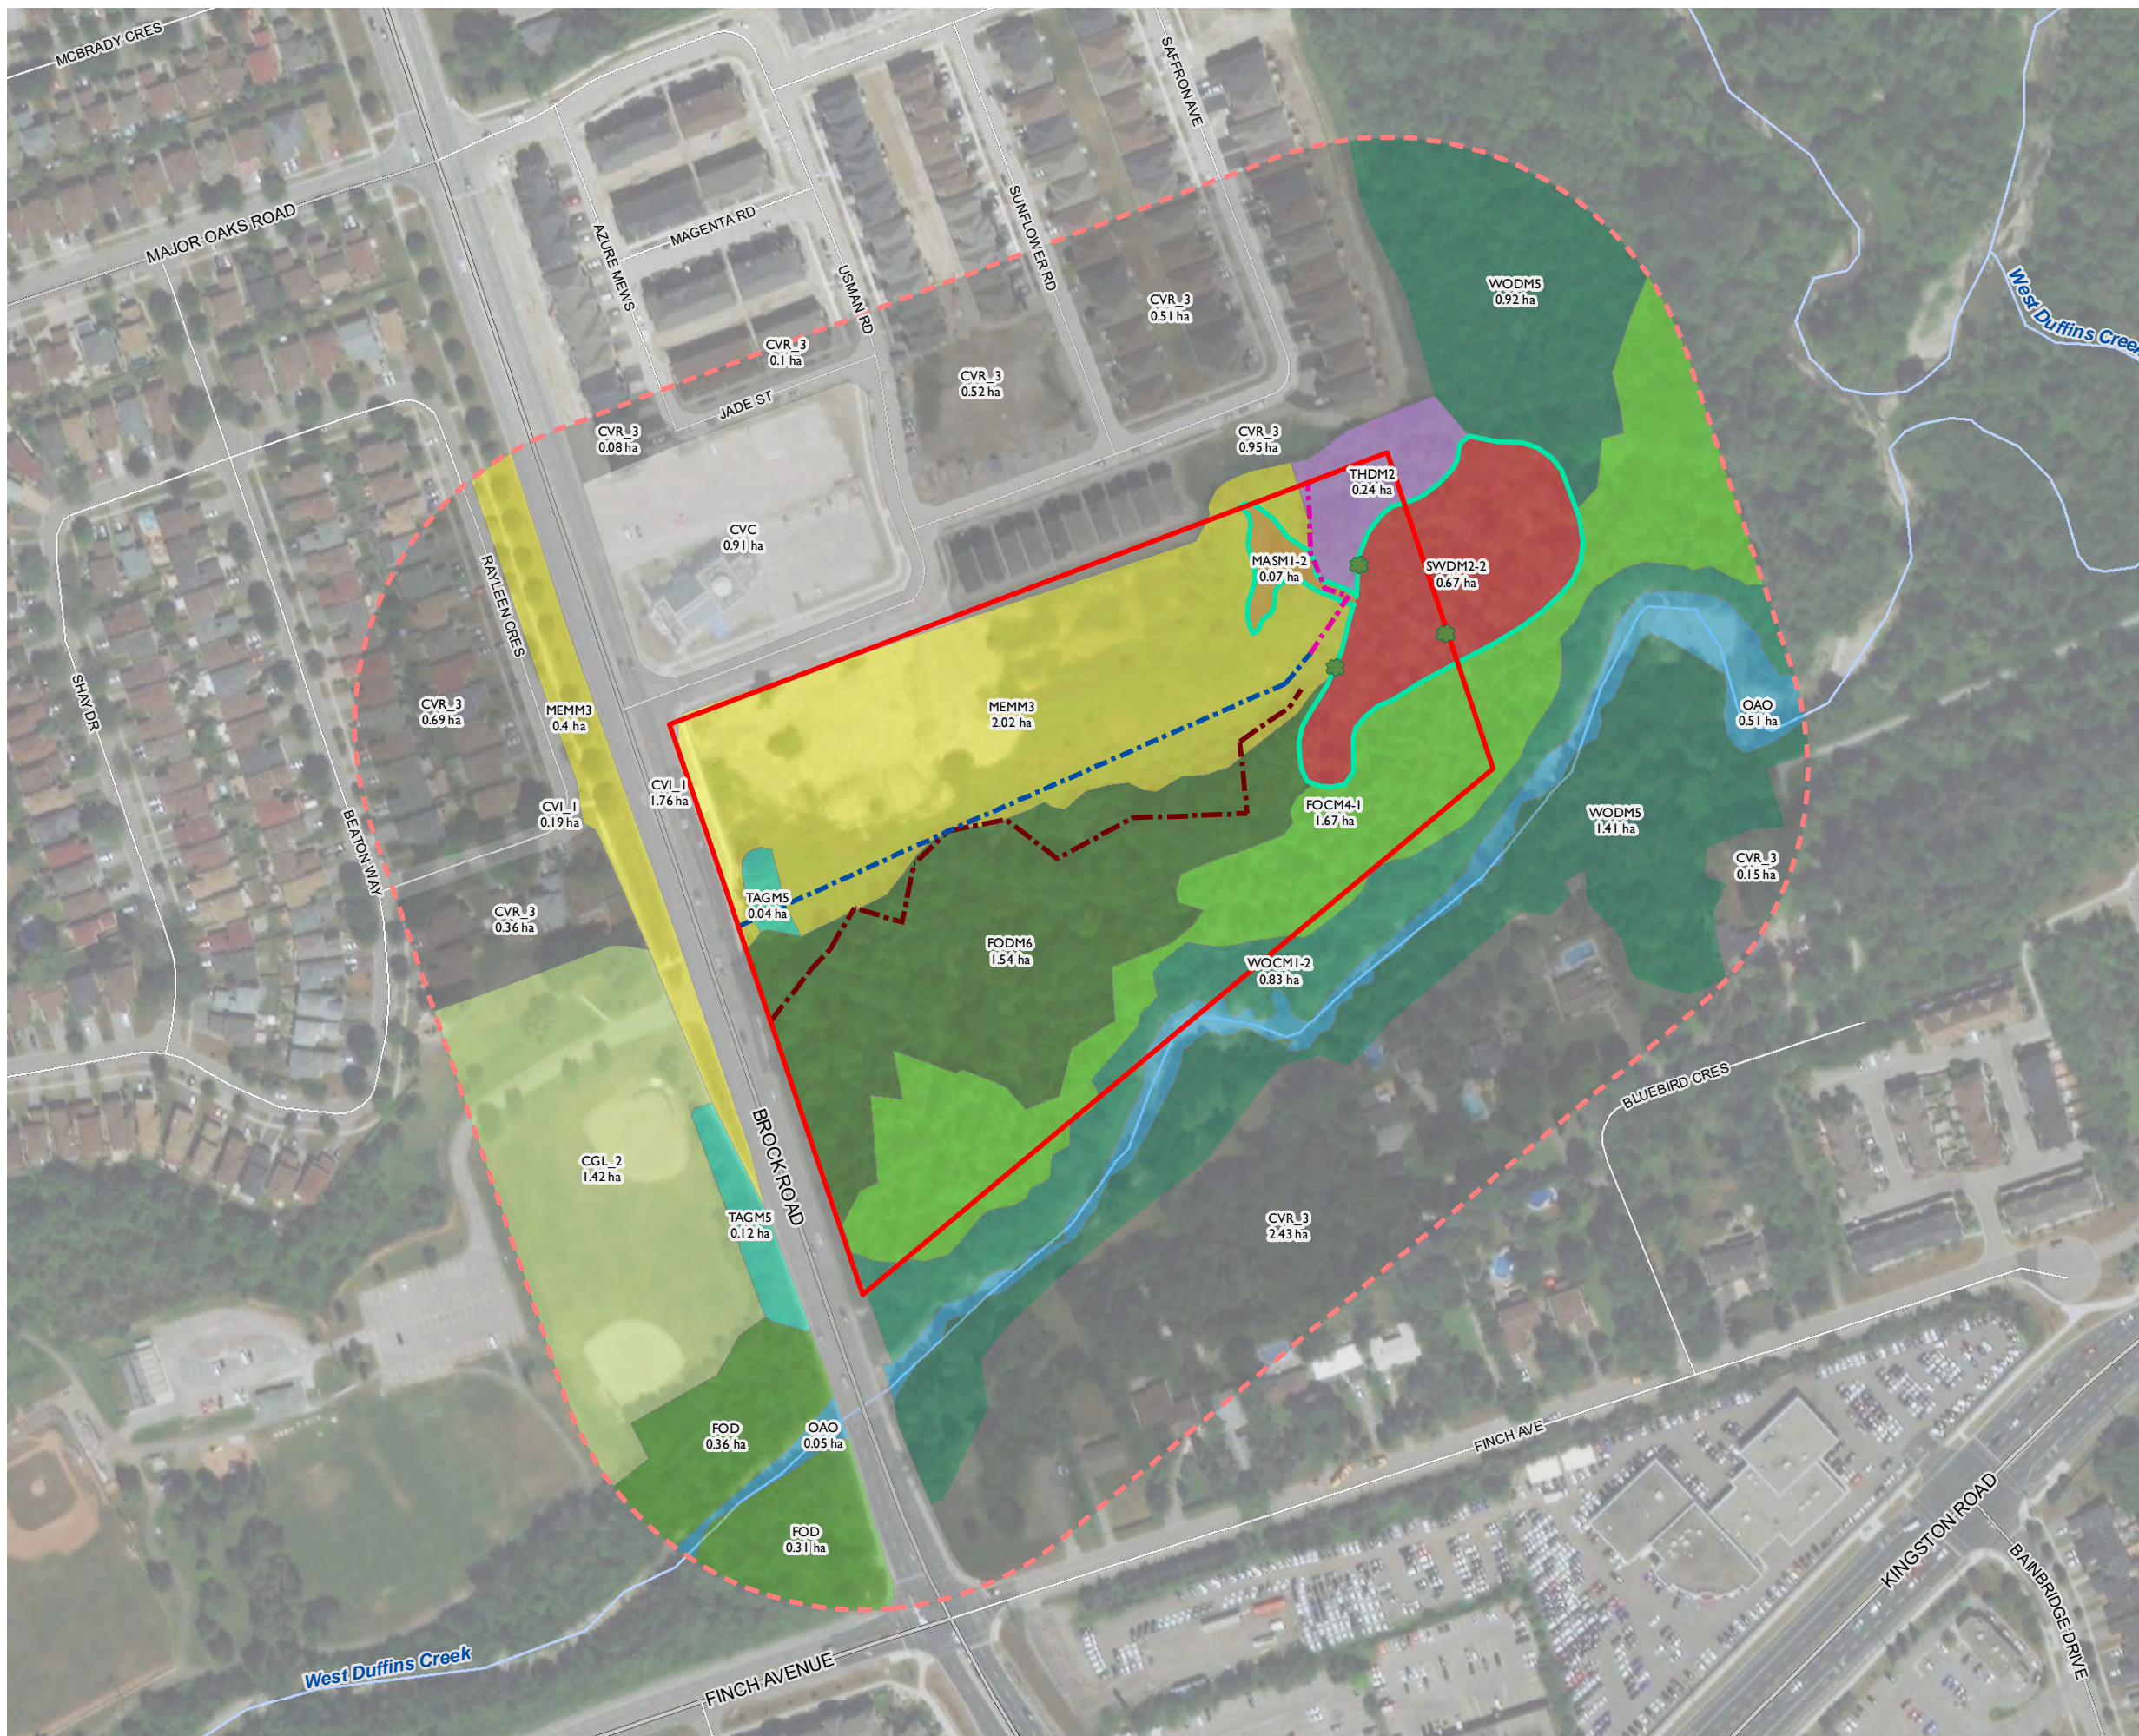
**FIGURE 3
FIELD INVESTIGATION RESULTS**

- Property Boundary
 - Study Area
 - Watercourse
 - Butternut
 - Staked ESA (April 2009)
 - Staked ESA (May 2006)
 - Staked Top of Bank (November 1990, rev April 2009)
 - Wetland Boundary (Beacon and TRCA; ESPU, 2011)
- Ecological Land Classification**
- CGL_2: Parkland
 - CVC: Commercial and Institutional
 - CVL_1: Transportation
 - CVR_3: Single Family Residential
 - FOCM4-1: Fresh Moist White Cedar Coniferous Forest
 - FOD: Deciduous Forest
 - FODM6: Fresh Moist Sugar Maple Deciduous Forest
 - WOCM1-2: Dry Fresh Cedar Coniferous Woodland
 - WODM5: Fresh Moist Deciduous Woodland
 - MEMM3: Dry Fresh Mixed Meadow Ecosite
 - MASM1-2: Bulrush Mineral Shallow Marsh
 - SWDM2-2: Green Ash Mineral Deciduous Swamp
 - OAO: Open Aquatic
 - TAGM5: Treed Hedgerow
 - THDM2: Deciduous Shrub Thicket
