# **Frisque Lands Geomorphic Assessment 3225 5<sup>th</sup> Concession Road (Part of Lots 3 and 4), City of Pickering Carruthers Creek Watershed**

**869547 Ontario Inc.**

**Beacon Environmental Limited**

**October 2023    221050.1**

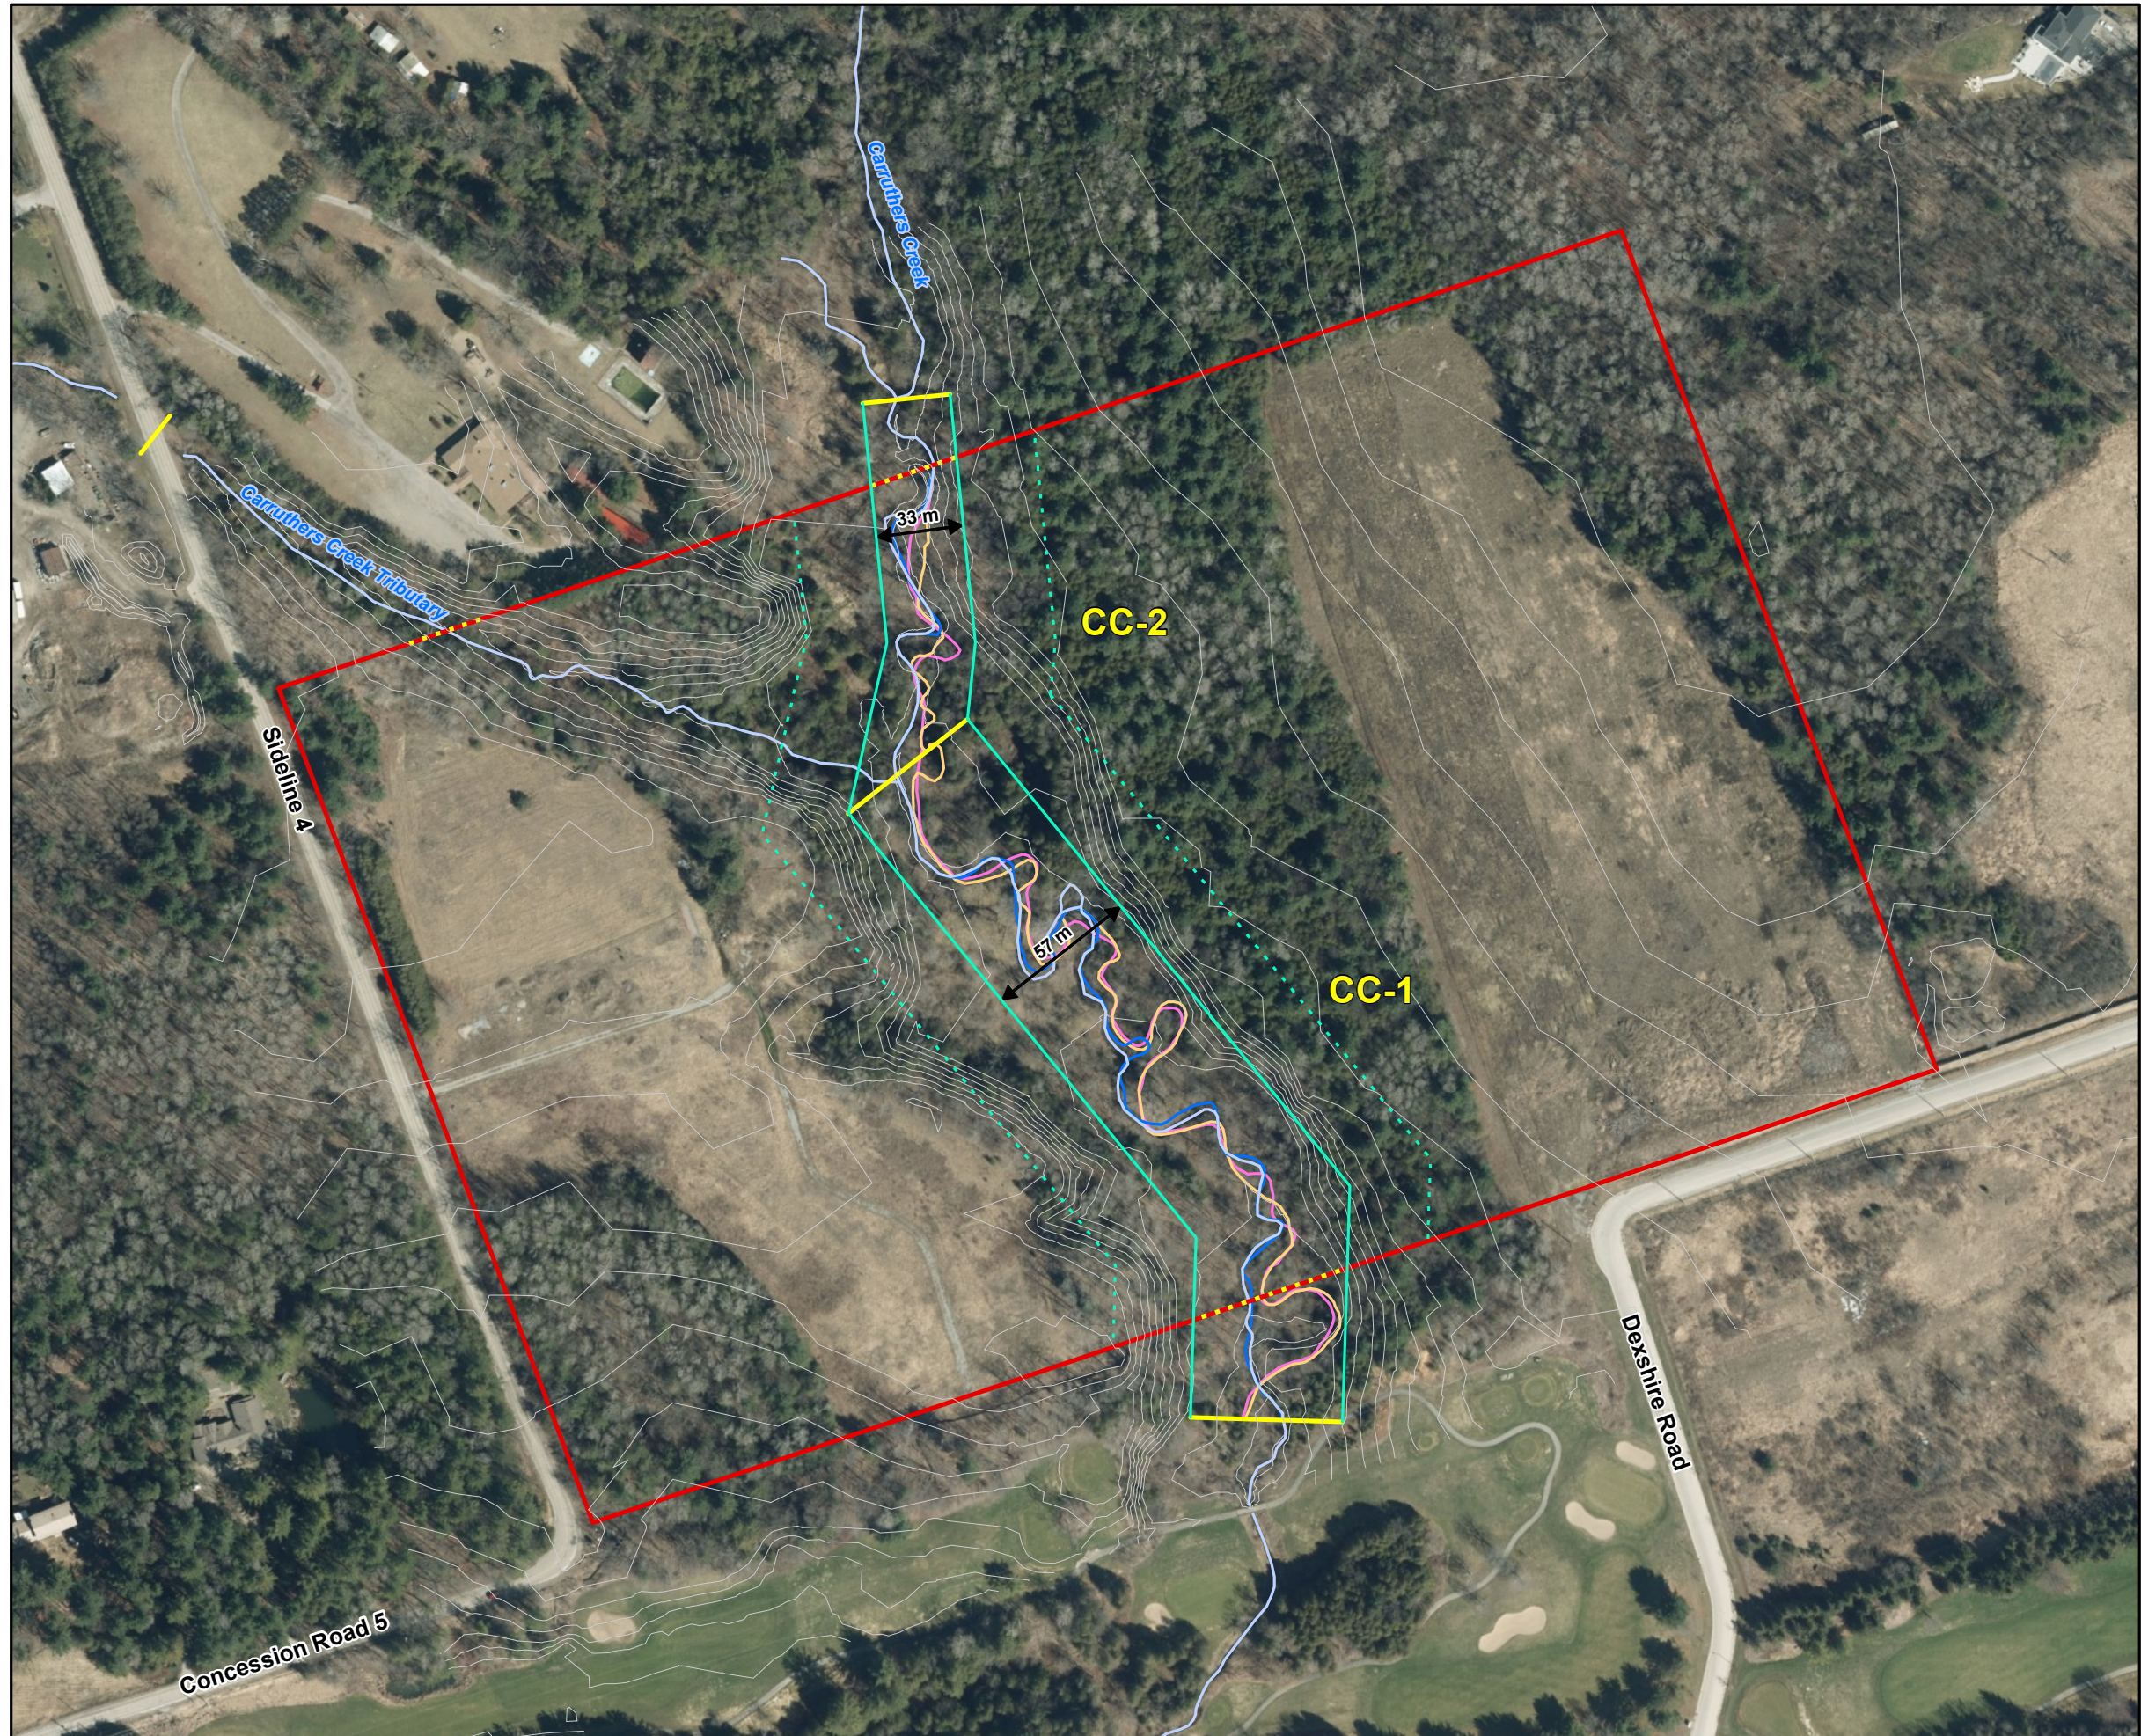
dimensions and was sufficient to capture the active (bankfull) channel as well as evidence of lateral occupation of the floodplain at the reach scale. **Figure 3** illustrates the recommended meander belt dimensions of 57 m and 33 m for Reaches CC-1 and CC-2, respectively, as they pertain to the subject property.

- To determine the extent of occupied Redside Dace habitat limits, meander belt widths were recommended for confined reaches of the Carruthers Creek (eastern tributary) following the TRCA (2004) guidelines and referencing field observations (existing channel planform), available mapping, and valley floor dimensions (57 m for Reach CC-1 and 33 m for Reach CC-2);

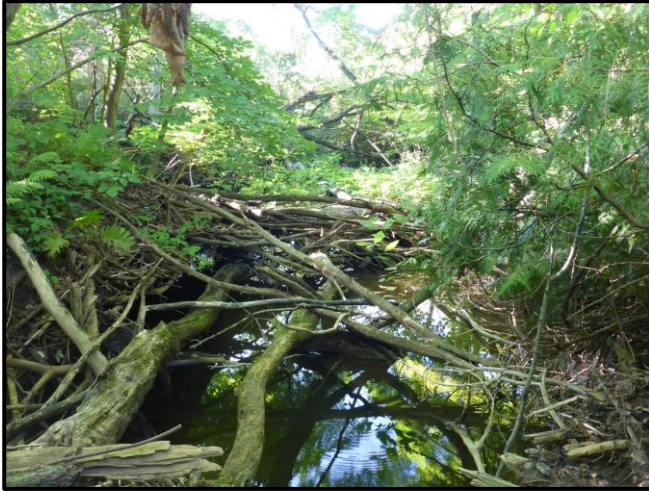
**Photo 1**  
**Reach CC-1**

Looking downstream from property limit at downstream reach extent of CC-1.

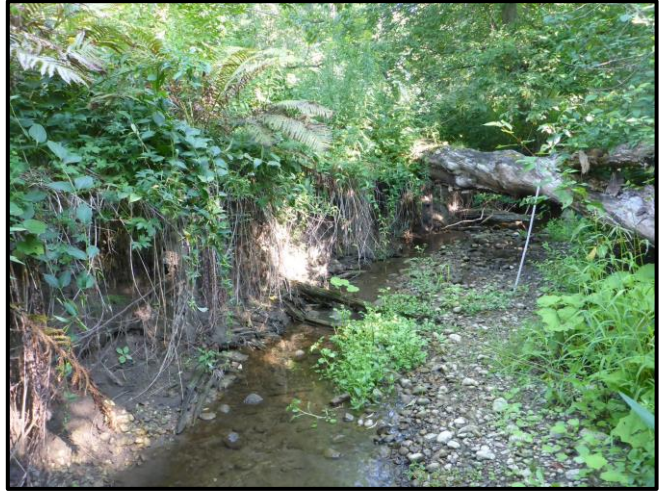
**Photo 2**  
**Reach CC-1.**

Looking upstream at erosion and undercutting on outer bank and gravel bar on inside bank.

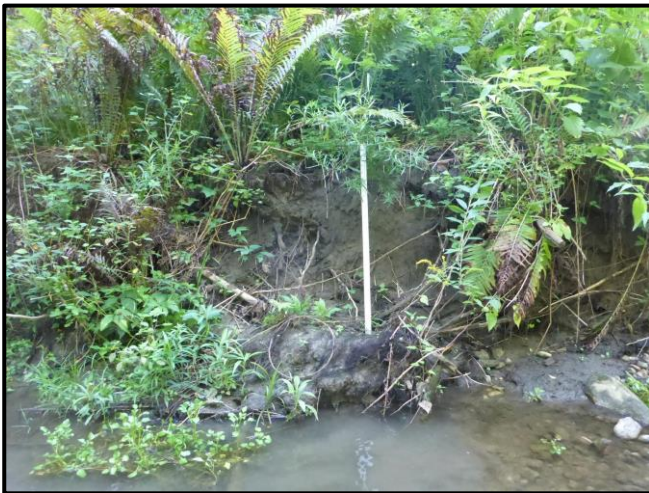
**Photo 3**  
**Reach CC-1.**

Erosion (slumping) on right bank.

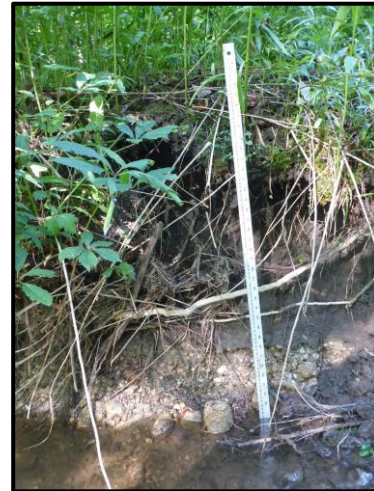
**Photo 4**  
**Reach CC-1.**

Erosion on right bank, exposing gravel armour layer in lower bank.

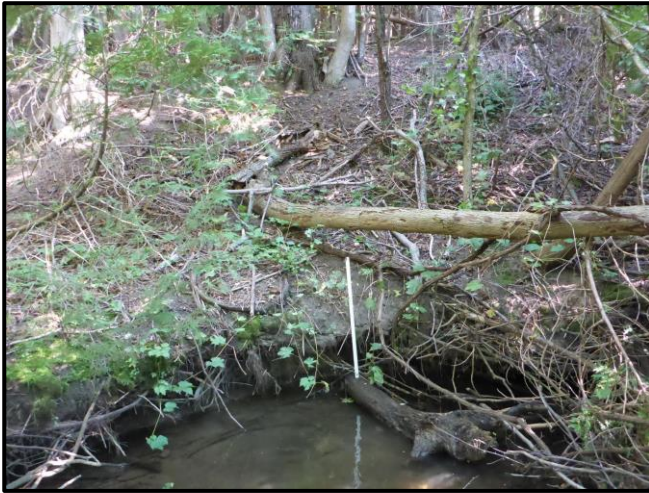
**Photo 5**  
**Reach CC-1.**

Left bank valley wall contact on meander bend. Note: undercut bank and instream woody debris.

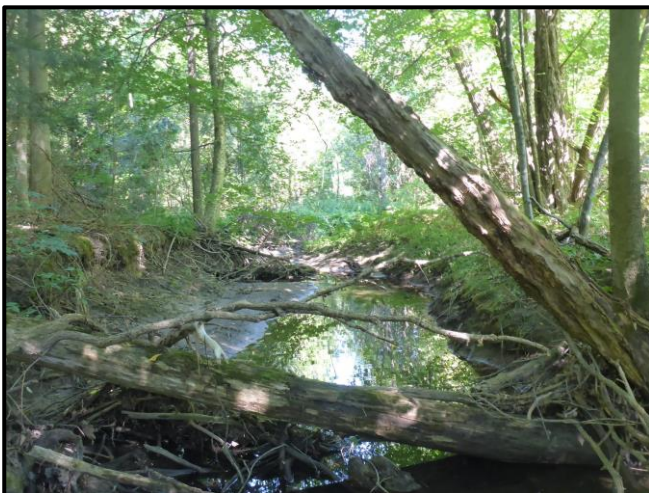
**Photo 7**  
**Reach CC-1.**

Looking upstream at general conditions. Note leaning and fallen trees and erosion along both banks.

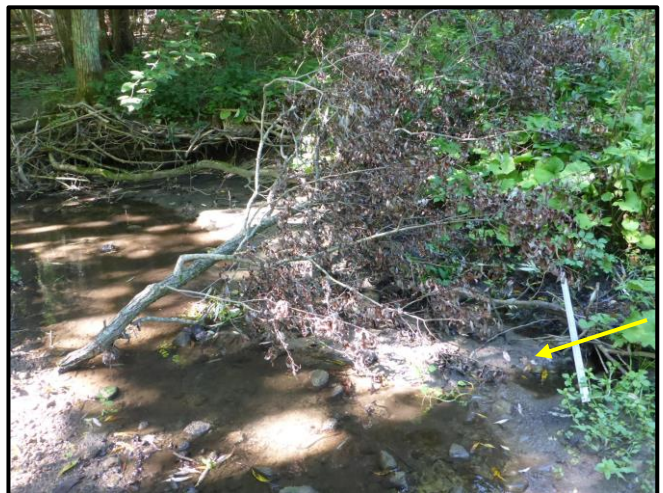
**Photo 8**  
**Reach CC-1.**

Looking downstream at the confluence with CCT-1 (arrow) and upstream reach extent.

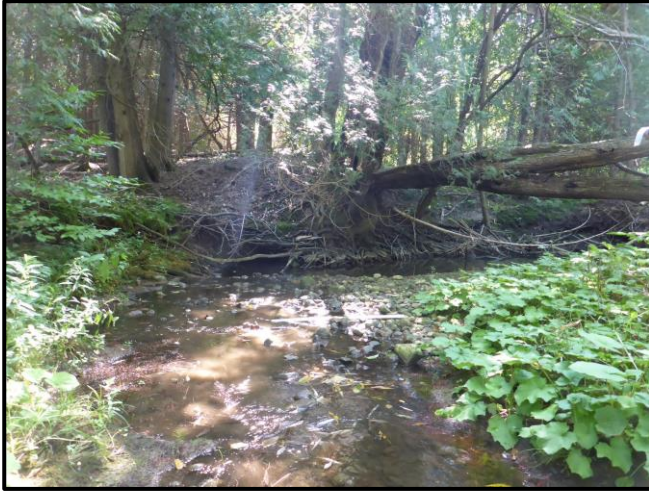
**Photo 9**  
**Reach CC-2.**

Looking downstream at meander bend with fallen trees and exposed tree roots.

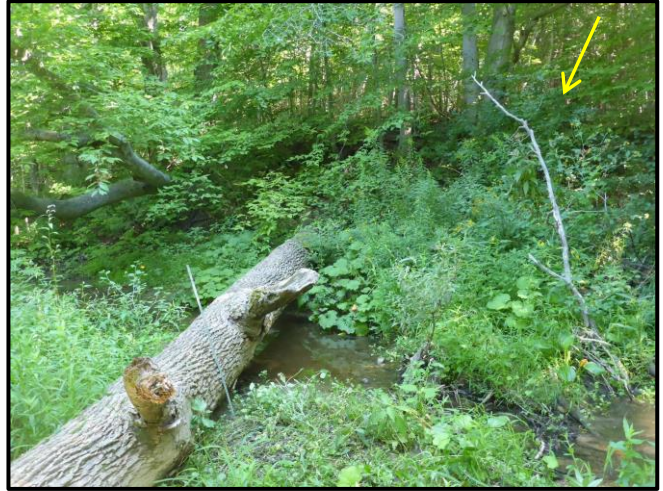
**Photo 10**  
**Reach CC-2.**

Looking upstream at meander bend and valley wall contact (left bank, arrow). Note fallen trees.

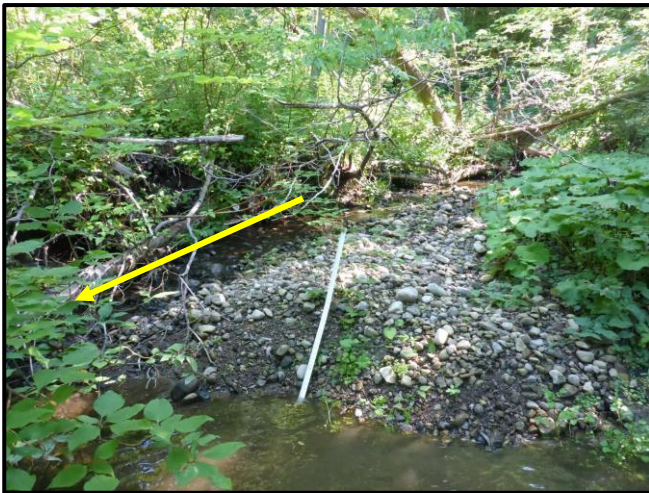
**Photo 11**  
**Reach CC-2.**

Looking upstream at gravel lateral bar formation. Note: thalweg misaligned along outer bank (photo left, arrow).

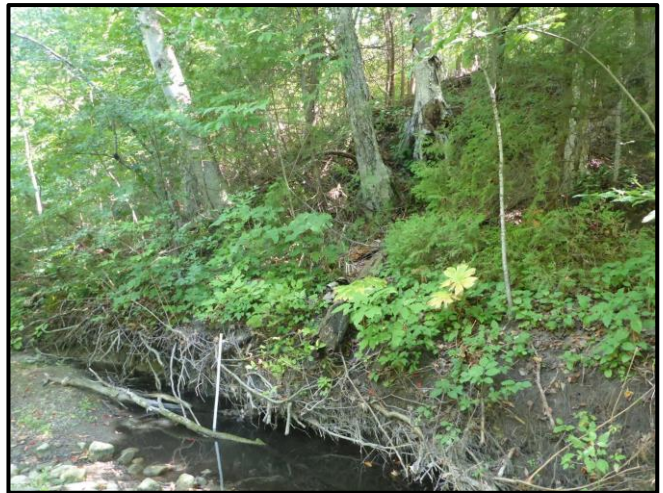
**Photo 12**  
**Reach CC-2.**

Looking upstream at undercut bank and exposed tree roots.

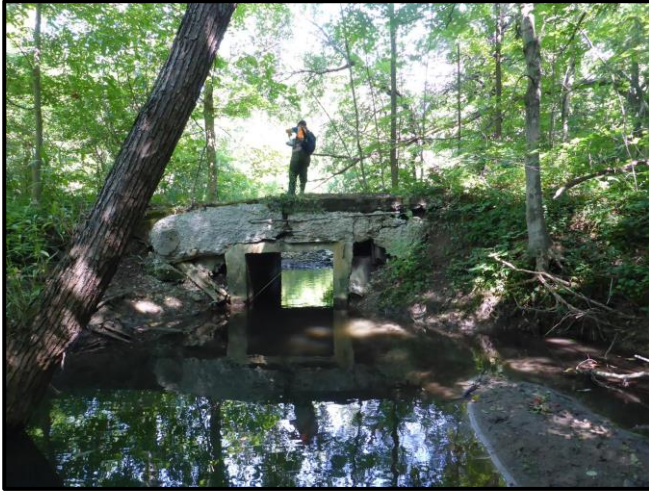
**Photo 13**  
**Reach CC-2.**

Looking upstream at concrete culvert farm crossing at property limit and upstream reach extent. Reach break was determined by an increase in channel entrenchment and gradient.

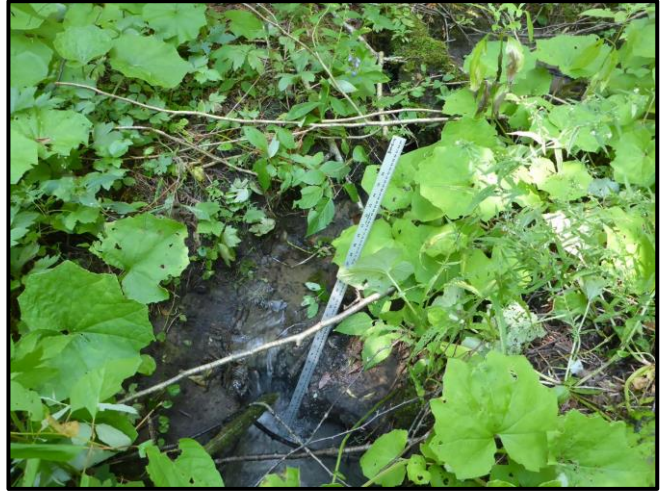
**Photo 14**  
**Reach CCT-1.**

Looking upstream at knickpoint formation.

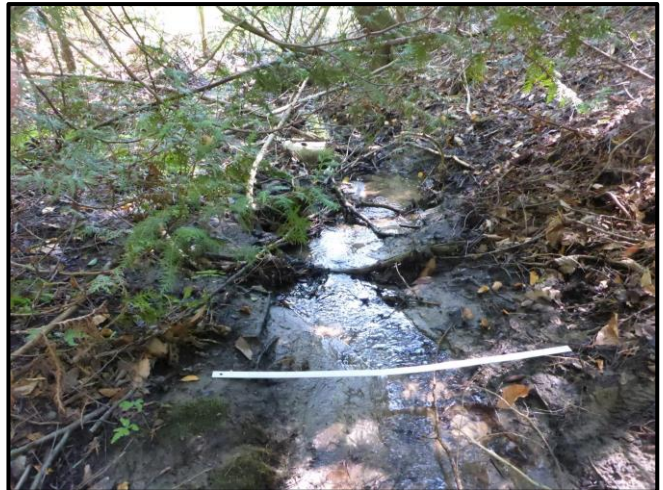
**Photo 16**  
**Reach CCT-1.**

Looking upstream near property limit. Note poorly defined bed and banks and lack of riffle-pool morphology.

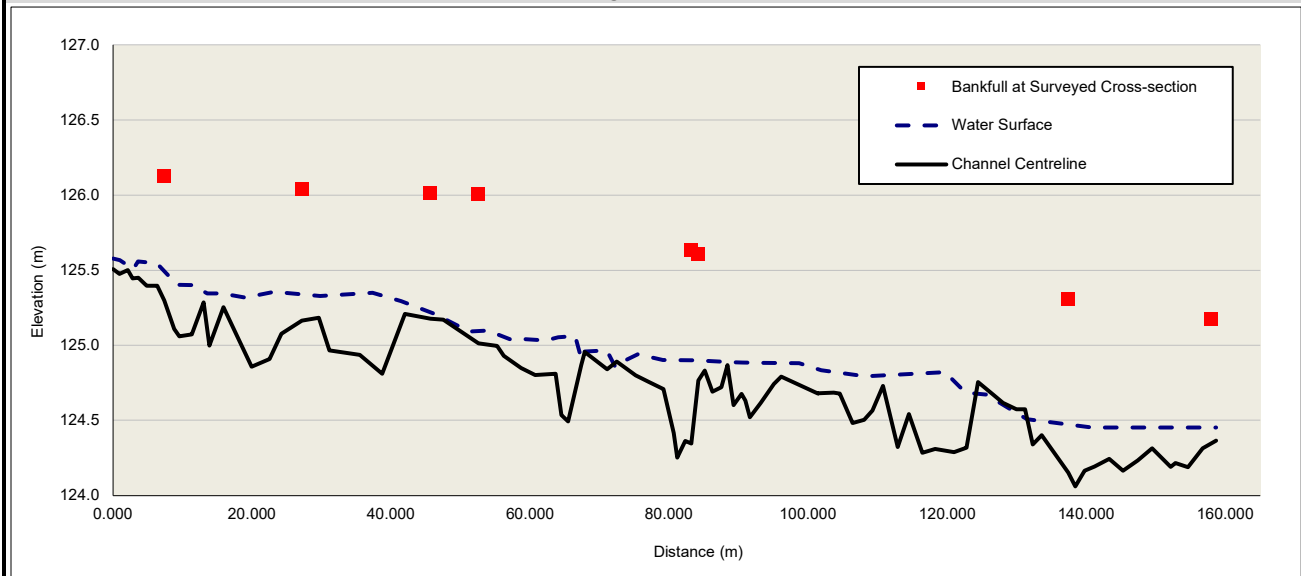
### Longitudinal Profile

Bankfull Gradient: <b>0.69 %</b>	Channel Bed Gradient: <b>0.71 %</b>
----------------------------------	-------------------------------------

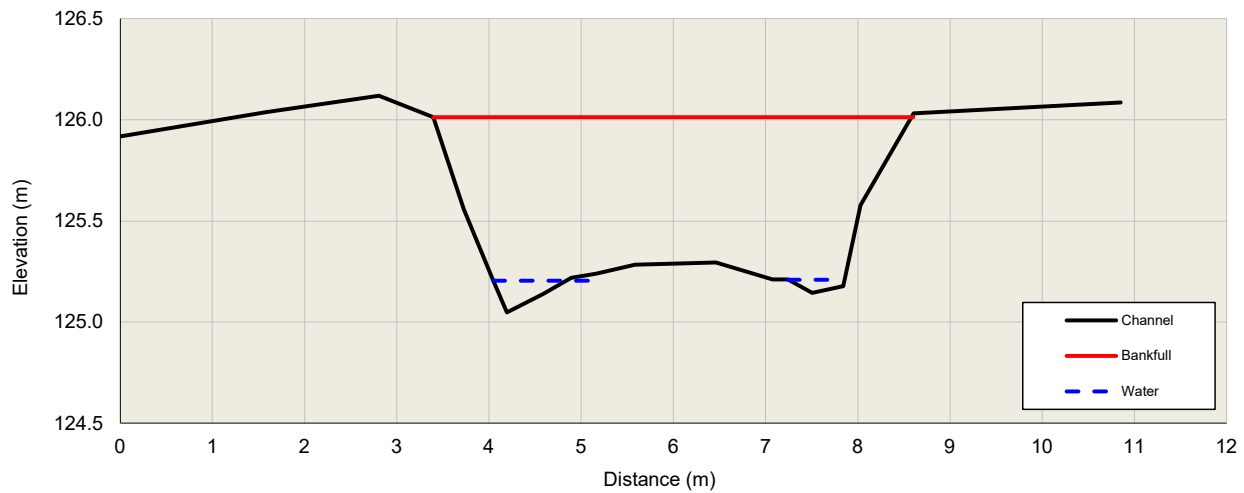
### Representative Cross-Section (#3)

Minimum	Maximum	Average
Bankfull Width (m):	4.0	6.3	5.0
Average Bankfull Depth (m):	0.38	0.66	0.49
Bankfull Width/Depth:	7.0	14.5	10.6
Wetted Width (m):	0.0	3.8	2.3
Average Water Depth (m):		0.08	
Manning's n:		0.038

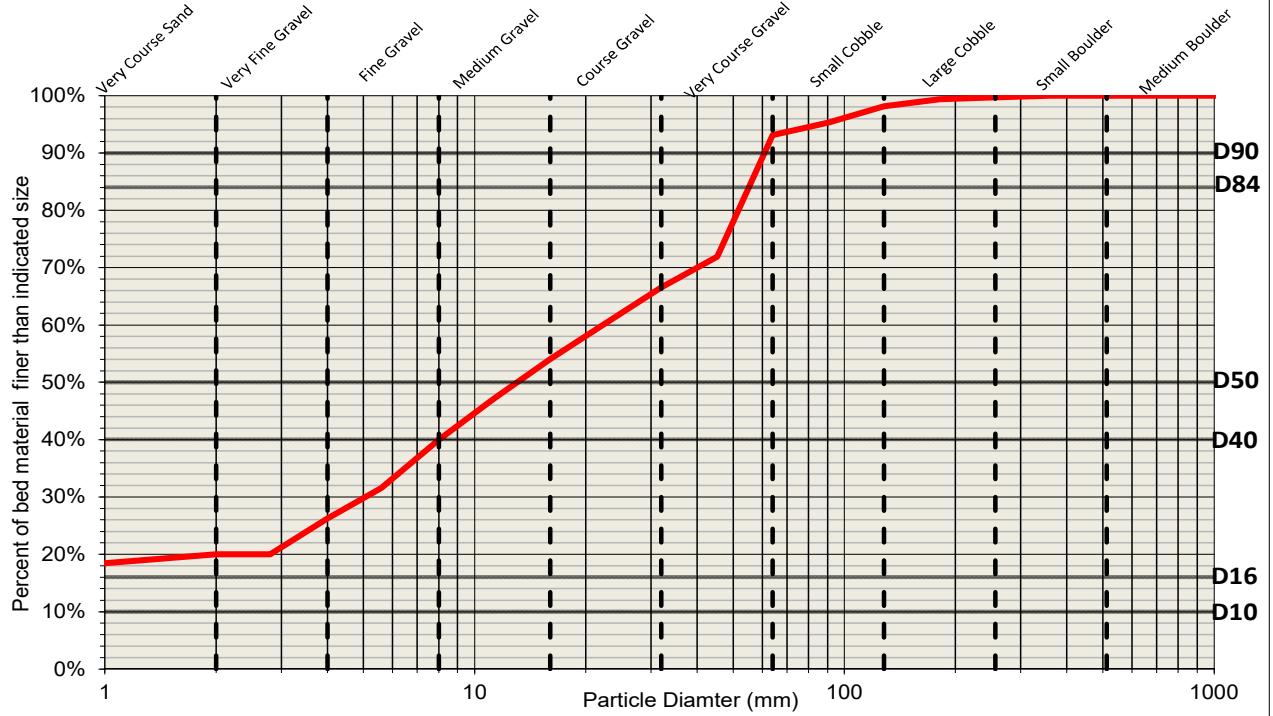
### Cumulative Particle Size Distribution

**Particle size (mm)**  
D<sub>10</sub>      **Fines**  
D<sub>50</sub>      **16**  
D<sub>84</sub>      **56**
