HYDROGEOLOGICAL ASSESSMENT

**705 Kingston Road
Pickering, Ontario**

Grounded Engineering Inc.

Issued October 24, 2024

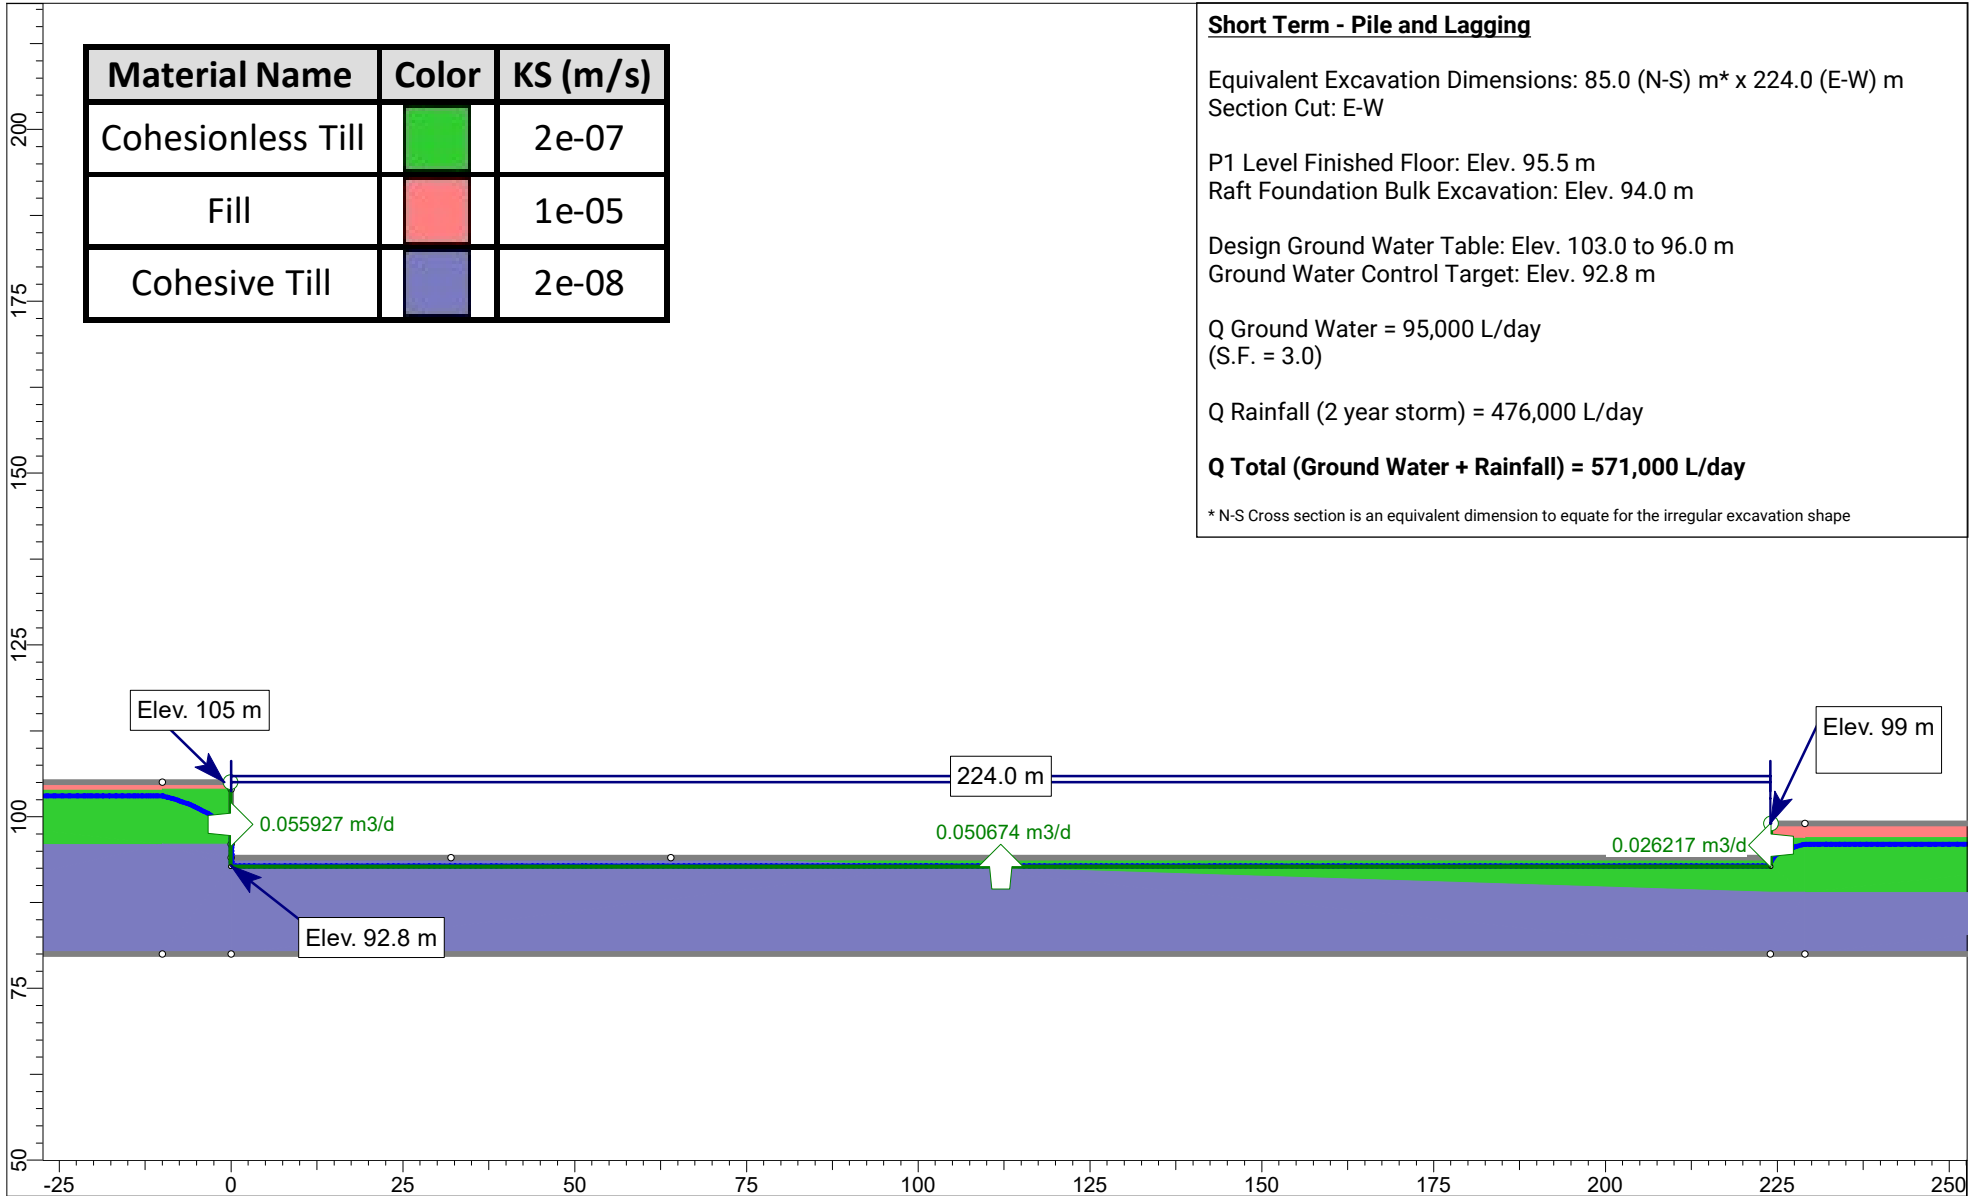
File	705 Kingston Rd		
Analysis	Steady State FEM: 23-197, Short Term Dewatering		
Ref.			
RS2 File	23-197 705 Kingston Rd FEM.slmd	Scale	1:1100
		Eng	RS

Material Name	Color	KS (m/s)
Cohesionless Till	Green	2e-07
Fill	Red	1e-05
Cohesive Till	Purple	2e-08

The quantity estimates for both short- and long-term conditions are presented below and in Appendix N.

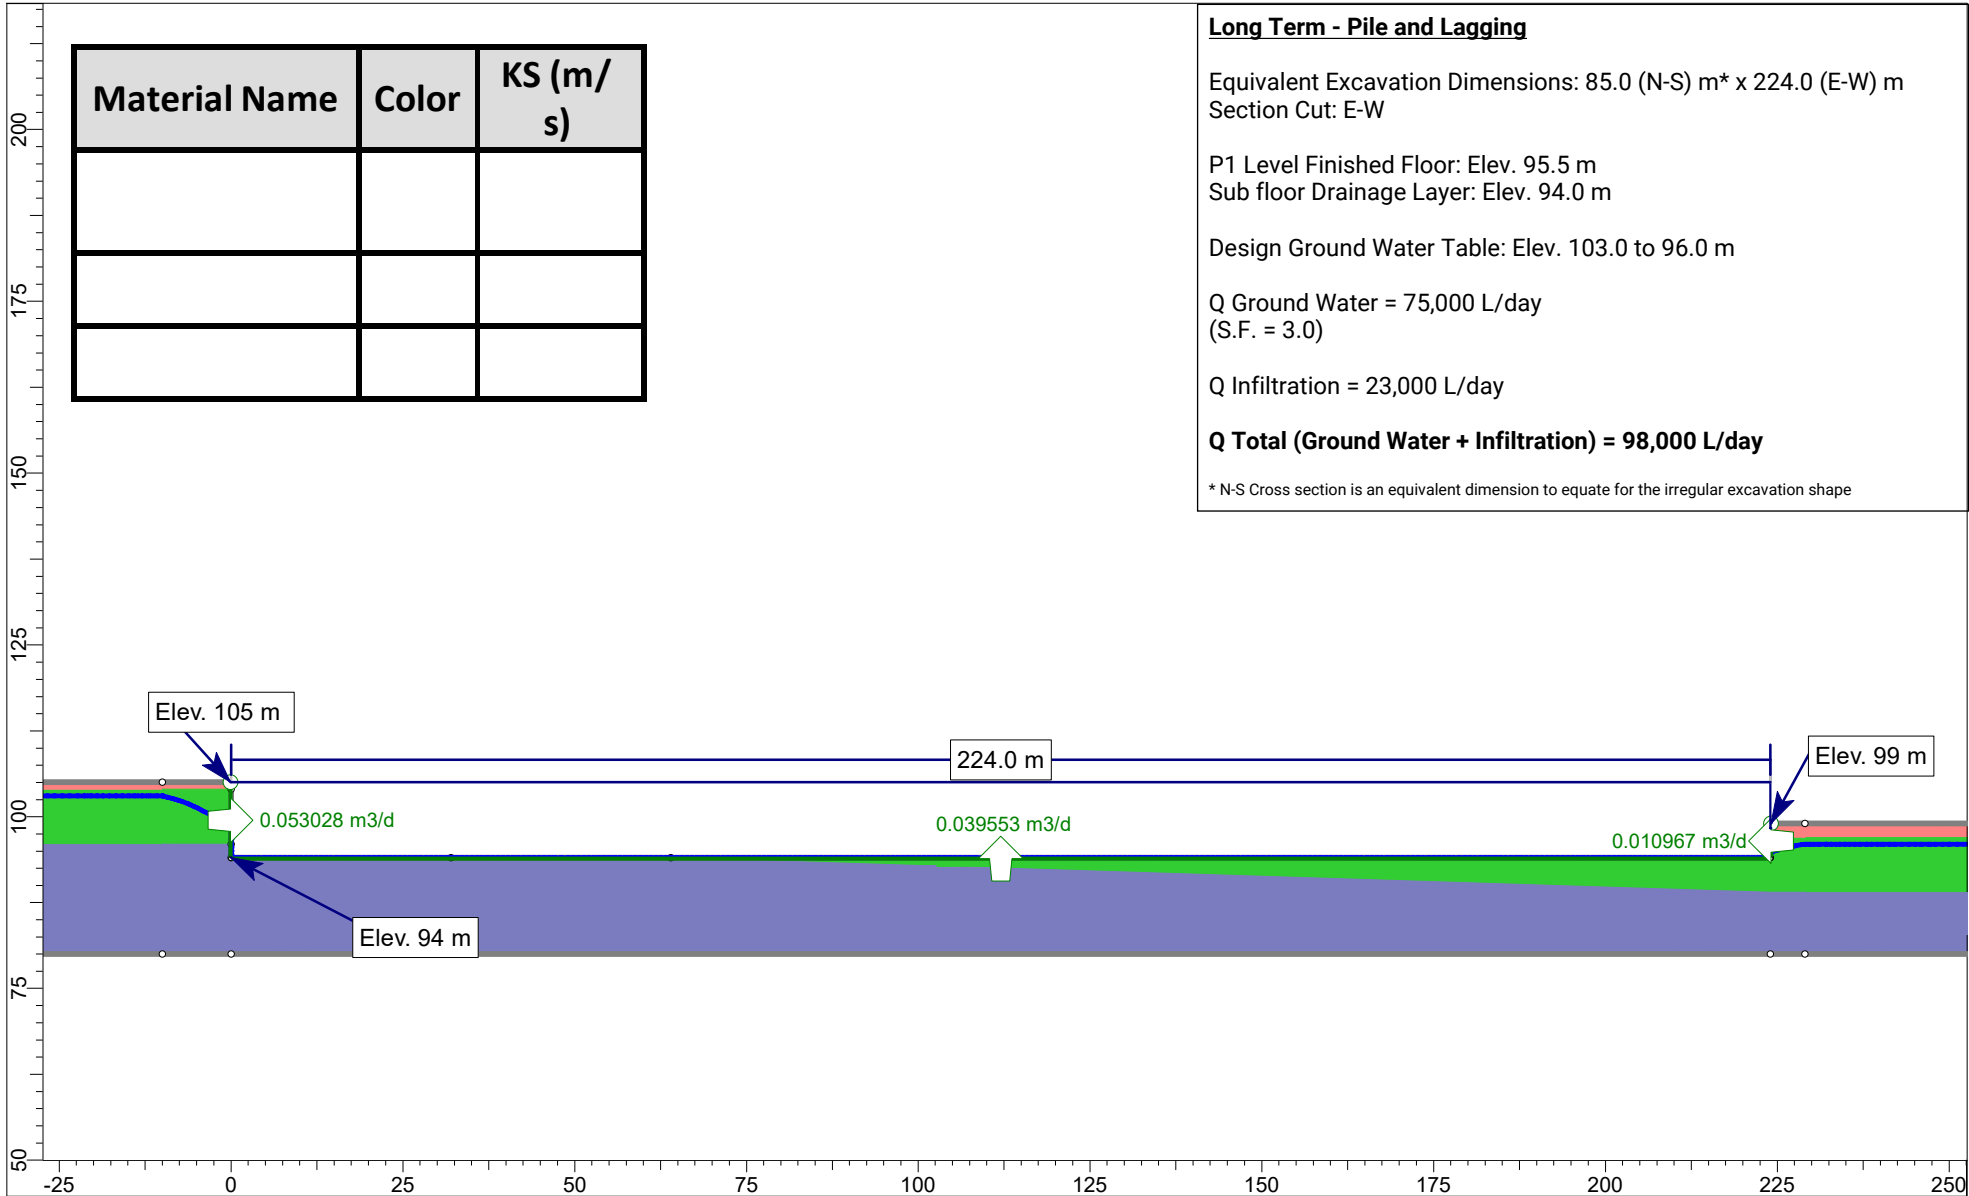
File	705 Kingston Rd		
Analysis	Steady State FEM: 23-197, Long Term Dewatering		
Ref.			
RS2 File	23-197 705 Kingston Rd FEM.slmd	Scale	1:1100
Eng			RS

* N-S Cross section is an equivalent dimension to equate for the irregular excavation shape
