Phase One Environmental Site Assessment

3225 Balsam Road (Concession 5 Road), Pickering, ON

GeoPro Project No.: 17-1780GHE3

Report Date: September 10, 2021

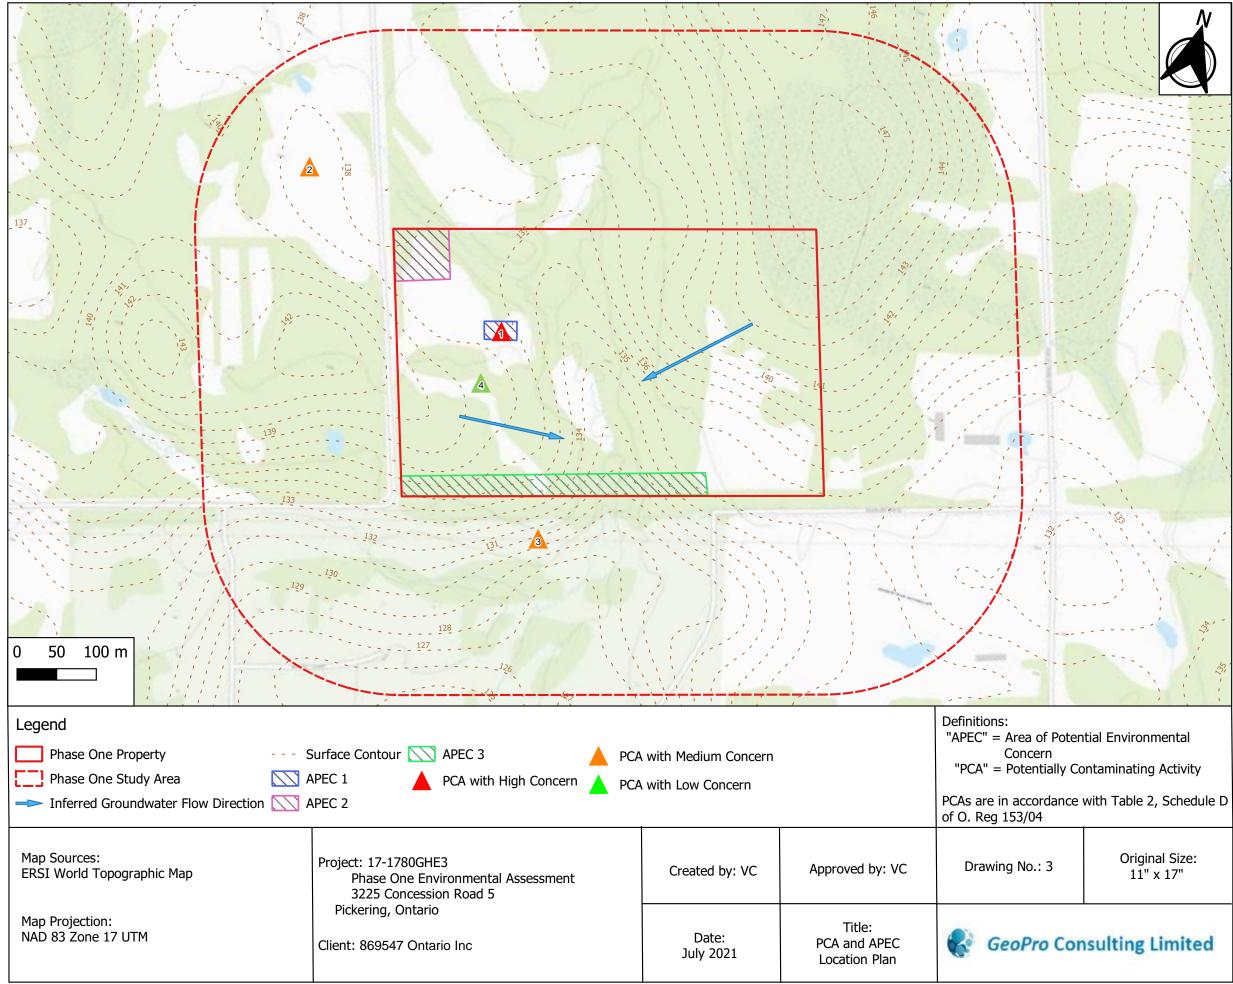
Based on the analyses of the indicated PCAs and associated environmental concerns, APECs were found in three (3) areas on the Phase One Property. The APECs and associated PCAs and contaminants of potential concern ("COPCs") are shown in Drawing No. 3 and summarized in Table 11.

MAP ID	FIGURE ID	Location	PCA
1	AP3	Former residential house	30
2	E1,AP2,SN1	3330 Balsam Road	40,52
3	AP1,CD1,SN2	2700 Audley Road North	40

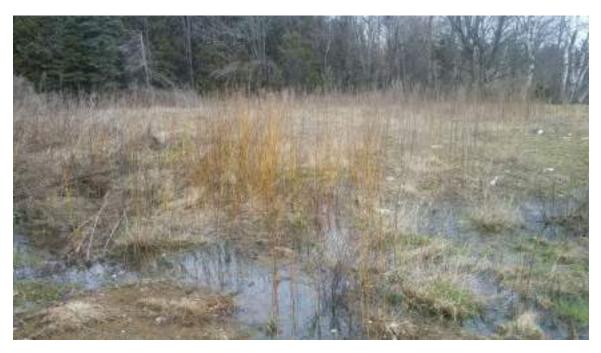
Photo 3 - View of the approximate area of the former residential house (looking northeast).

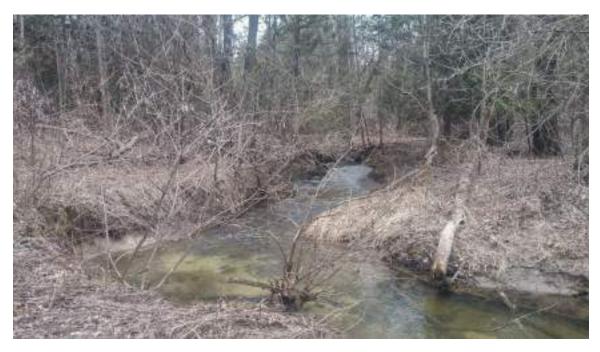
Photo 5 – View of the Carruthers Creek and the outlying floodplains noted near the center of the Phase One Property.

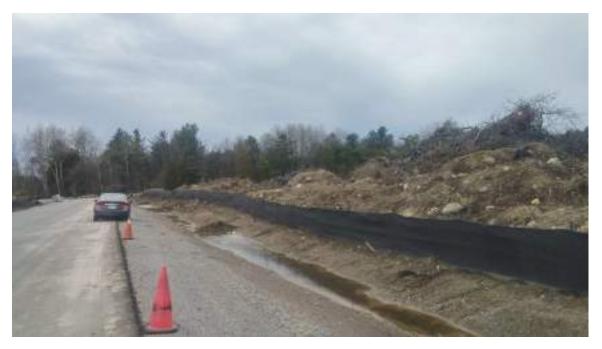
Photo 8 – View of the south property boundary of the East Portion of the Site with Dexshire Drive (looking west). A ditch and piles of the soil, fill, and could be seen near the boundary area.

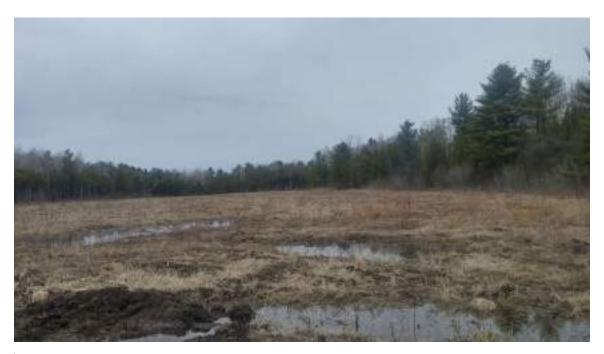
Photo 9 – View of the East Portion of the Phase One Property (looking north). Water puddles were noted.

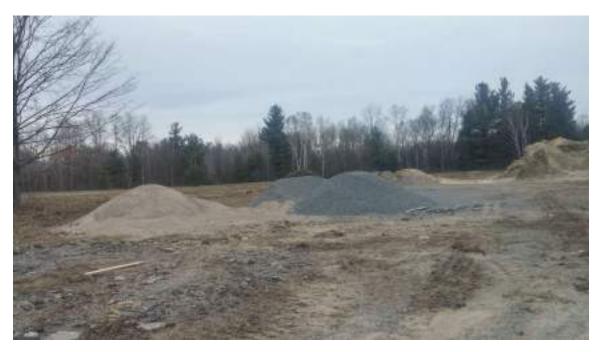
Photo 10 – View of stockpiles of gravel, sand and soil materials noted near the entrance of the West Portion of the Phase One Property (looking northeast).

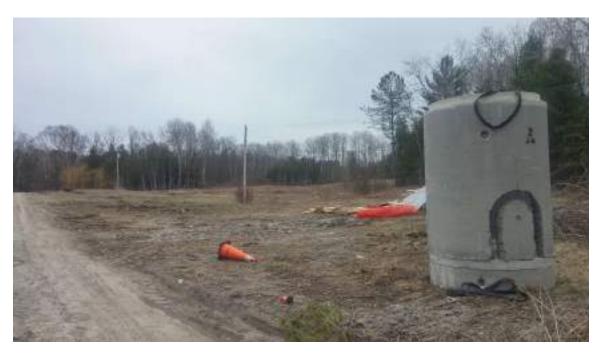
Photo 11 – View of a pre-cast concrete cylinder object noted near the entrance of the West Portion of the Phase One Property (looking southeast)

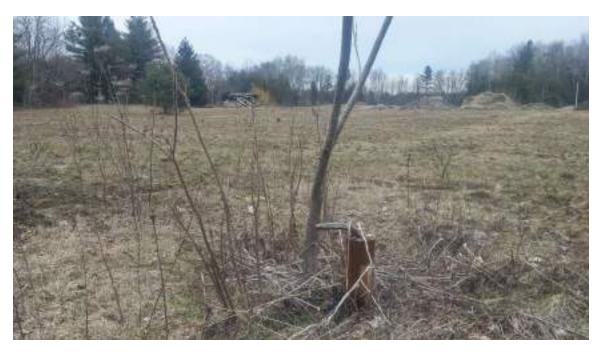
Photo 12 – View of a water well noted in the northwest corner of the West Portion of the Phase One Property (looking southeast)

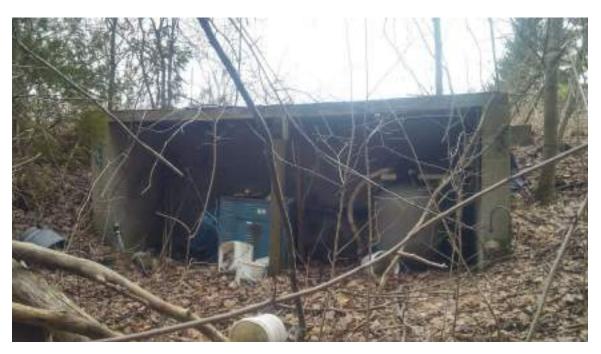
Photo 14 – View of a pool heater and filter storage area near the east edge of the West Portion of the Phase One Property (looking west)

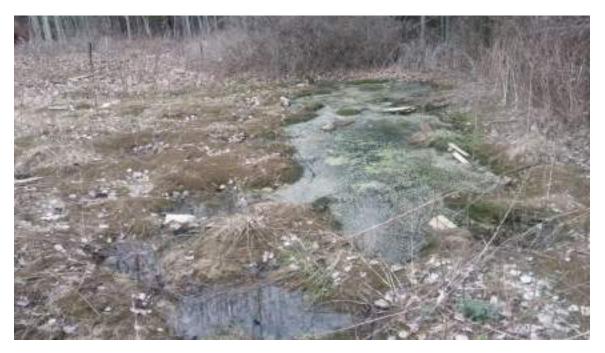
Photo 15 – View of poorly drained area(s) noted in the West Portion of the Site

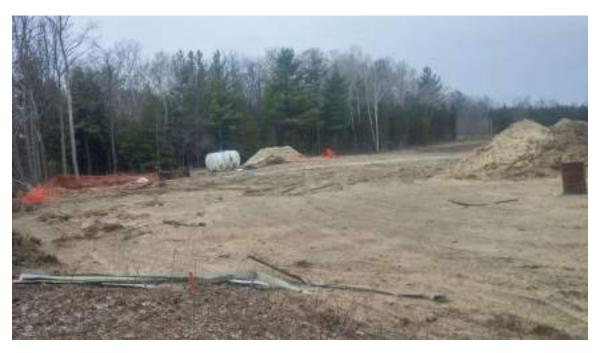
Photo 16 – View of soil stockpiles generated from two (2) excavated pits in the West Portion of the Site. A plastic storage tank was noted.

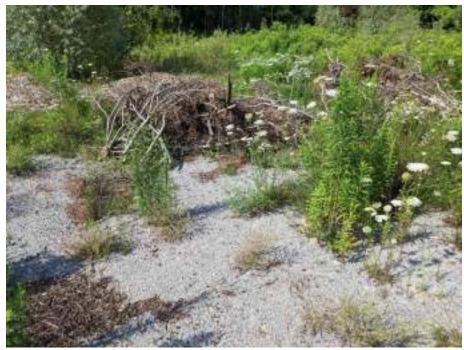
Site Photo 6. Area of formal residential house located in the western portion of the Site. Gravel present, no evidence of building structures or basements.

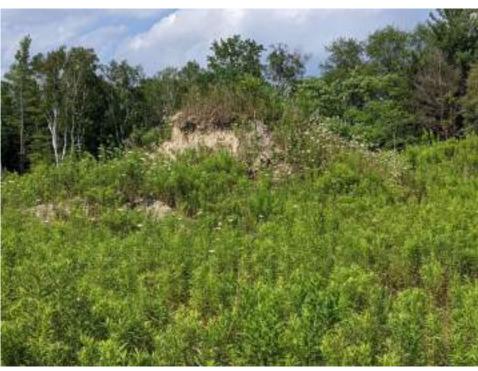
Site Photo 7.

-	Rail Spurs	No rail spur was observed at the Site on the day of site reconnaissance.
-	Stressed Vegetation	No stressed vegetation was observed at the Site on the day of site reconnaissance.
SS1	Fill and Debris Material	Fill material and debris were noted in the western portion of the Site on the day of site reconnaissance.
On-site	Buildings or Structures

Piles of fill material and debris were noted in the western portion of the Site

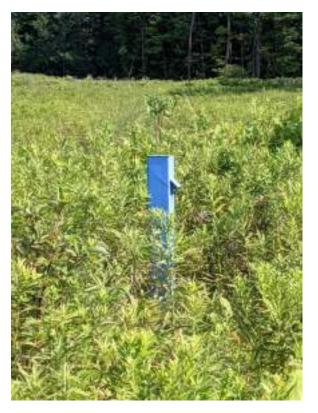
-	Storage Tanks	No underground/above the ground storage tank ("USTs/ASTs") was observed at the Site on the day of site reconnaissance.
-	On-Site Wells	Monitoring wells were observed at the Site on the day of site reconnaissance.

Site Photo 8. Monitoring wells noted throughout the Site

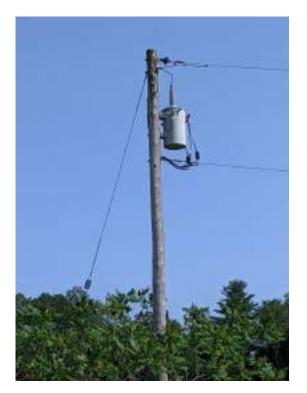
-	Other observation	Transformer was noted on a telephone pole in the western portion of the Site. No staining, spills, or discolouration was noted.
-		Woodland covers the central portion, southwest portion, and northern portion of the Site, access to the woodland was limited
Addition	al Potential Environment	al Concerns – Designated Substances

Site Photo 9. Transformer located on a telephone pole in the western portion of the Site. No spills, staining, discoloration or leaks observed.

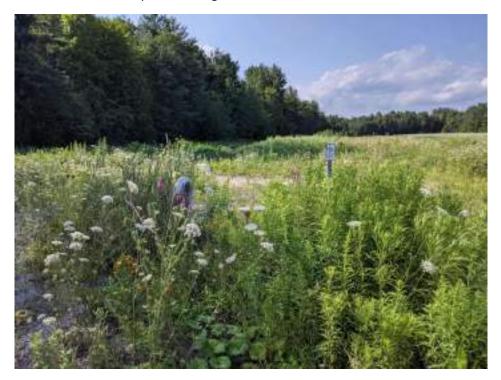
-	Underground Utilities	No gas meters or buried gas lines were observed on the Site. A high pressure watermain was observed on the day of site reconnaissance.

Site Photo 10. Underground water utilities present in the eastern portion of the Site

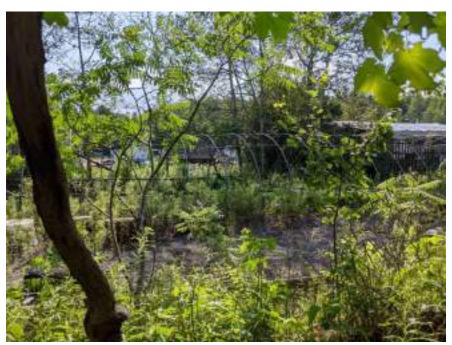
Study Area Photo 1. Industrial Storage at 3330 Balsam Road. Photo taken facing west.

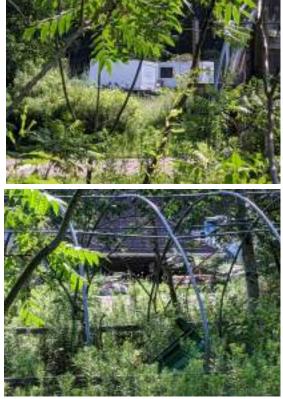
Study Area Photo 2. Alternative views of the Industrial Storage at 3330 Balsam Road.

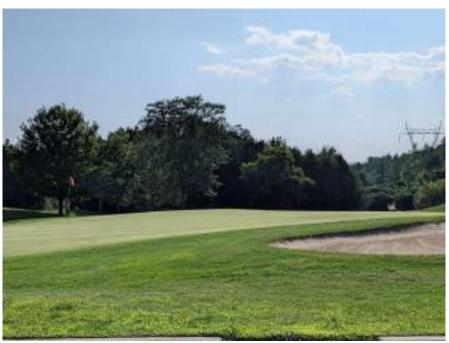
Study Area Photo 3. Golf Course observed at 2700 Audley Road North. Photo taken facing west.

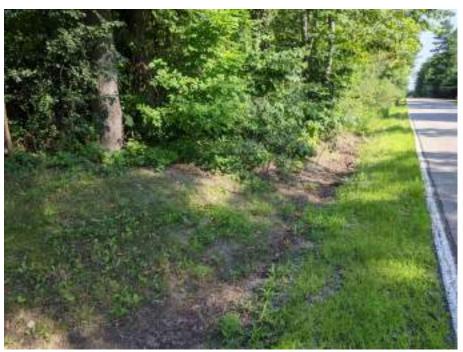
Study Area Photo 4. Ditches observed running along Balsam Road.
