# PHASE ONE ENVIRONMENTAL SITE ASSESSMENT

2660-2680 Brock Road, Pickering, Ontario

**FINAL REPORT**

May 26, 2022

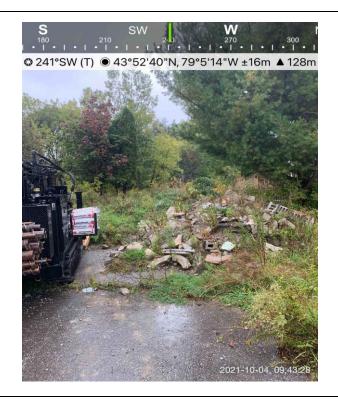
View of driveway for 2660 Brock Road (south of building). Pile of construction debris located at end of driveway.

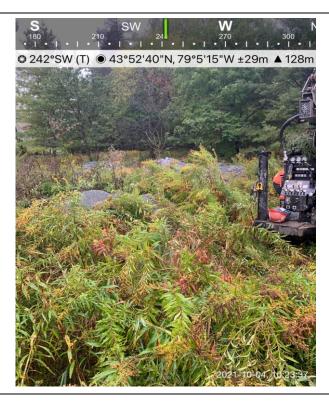
Photo No: 2

View of southwest portion of backyard taken from west end of building. Fill piles and construction debris located in amongst overgrown vegetation.

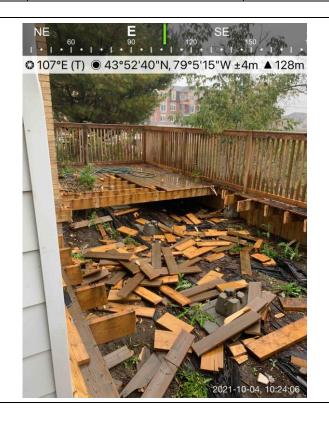
View of south deck area of 2660 Brock Road residence. Deck wood is discarded within the deck area and the backyard (west end of building).

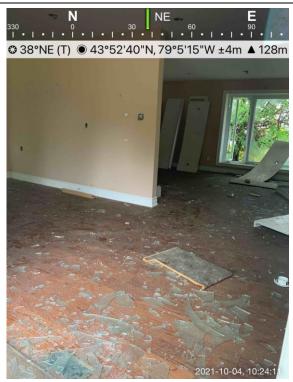
Photo No: 4

View of 2660 Brock Road building interior, taken from backyard entrance (west end of building). Broken glass and building debris is spread across the floor.

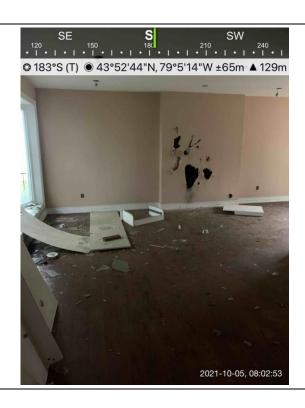
View of 2660 Brock Road building interior, taken from front entrance. Glass and building debris are located on the floor. There are multiple holes in the walls and lighting fixtures are not present.

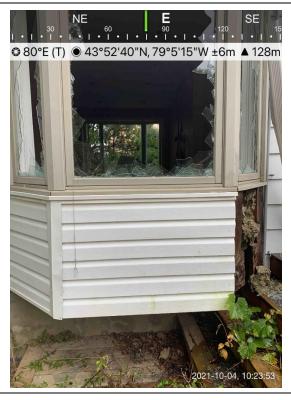
Photo No: 6

View of window located at west end of 2660 Brock Road building. Note the windows are broken, glass is located outside and inside the building.

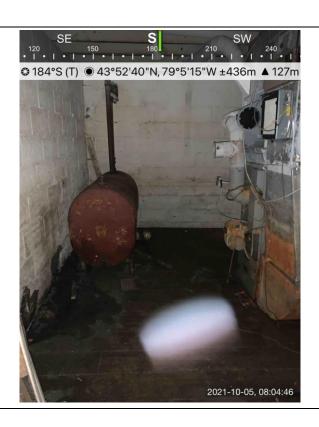
View of a room in south end of the 2660 Brock Road building basement. There is a heating oil AST and oil-fired furnace located in the southeast portion of the residence basement (exiting in the deck area).

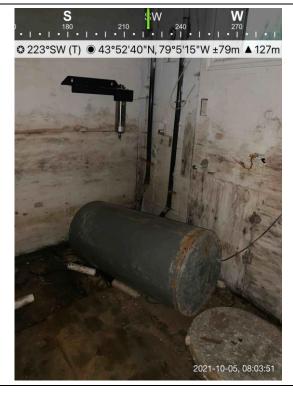
Photo No: 8

View of a hot water tank within the 2660 Brock Road building basement.

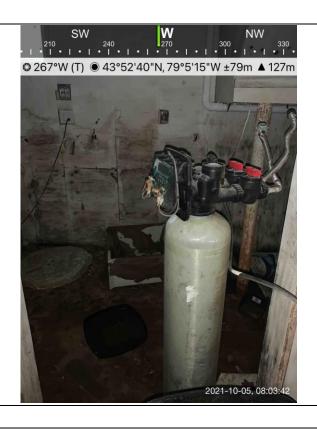
View of part of a water treatment system in the basement of the building at 2660 Brock Road.

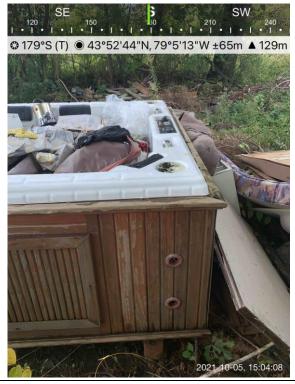
Photo No: 10

View of discarded hot tub and other household materials outside the residence at 2680 Brock Road.

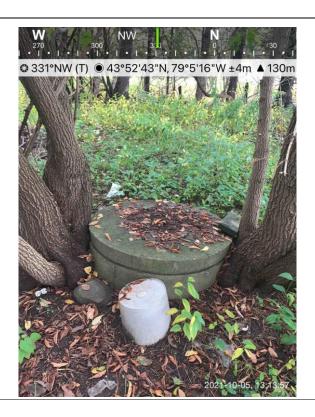
Water supply well located north of the building 2680 Brock Road residence.

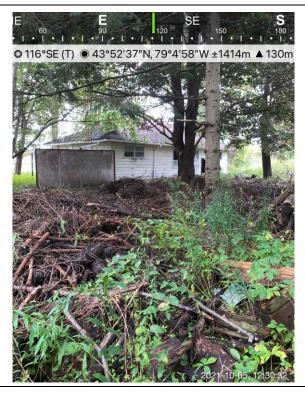
Photo No: 12

View of debris (tree branches and discarded items) located at 2680 Brock Road.

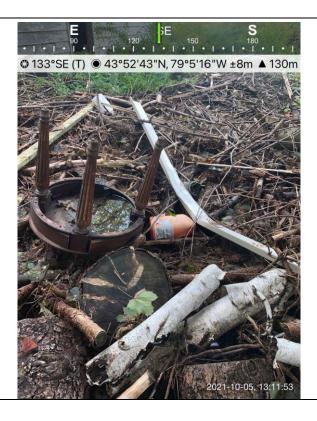
View of further debris located west end of the residence at 2680 Brock Road.

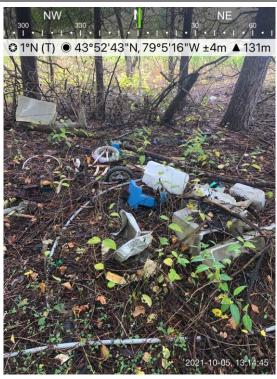
Photo No: 14

View of discarded waste and debris located north of the building at 2680 Brock Road. Similar discarded items are located around the residence.

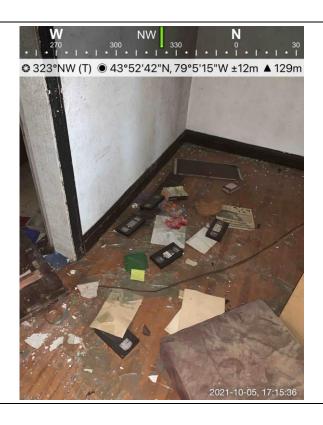
View of discarded waste and broken glass in the first floor, east end, of the building located at 2680 Brock Road.

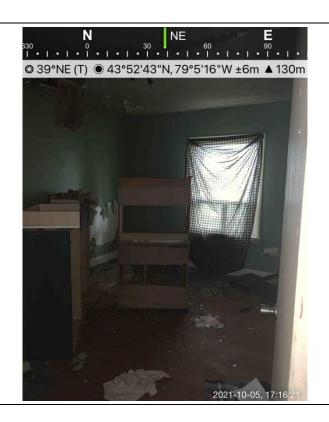
View of room at the east end of the building at 2680 Brock Road. Note the broken glass/window, torn ceiling, and discarded waste.

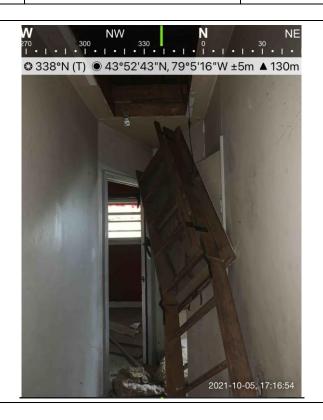
View of hallway facing north in the building at 2680 Brock Road. Discarded house materials and insulation was observed on the ground.

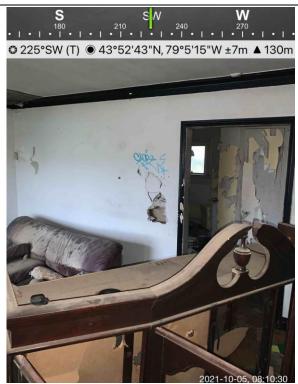
Photo No: 20

View of interior of the building at 2680 Brock Road, photo taken from entrance. Discarded and broken glass/furniture observed throughout the building.

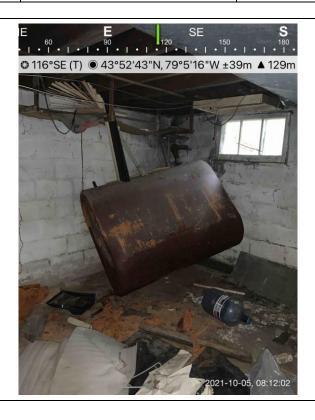
View of heating oil AST located at the southwest corner of the residence basement at 2680 Brock Road. Debris and building waste materials were observed in the room;

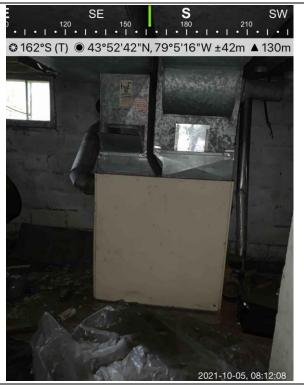
Photo No: 22

View of basement and furnace in the building at 2680 Brock Road West.

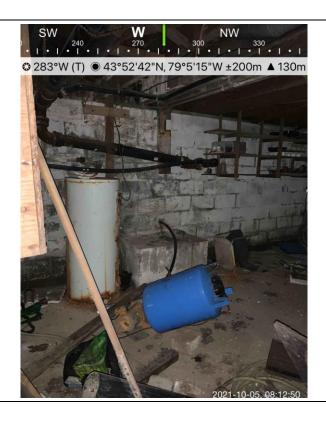
View of basement and hot water tank in the residence basement at 2680 Brock Road West.
