September 16, 2022

Report No. 210189-E1

**PHASE ONE ENVIRONMENTAL SITE ASSESSMENT  
EXISTING RESIDENTIAL PROPERTY  
1942 WOODVIEW AVENUE, PICKERING, ONTARIO**

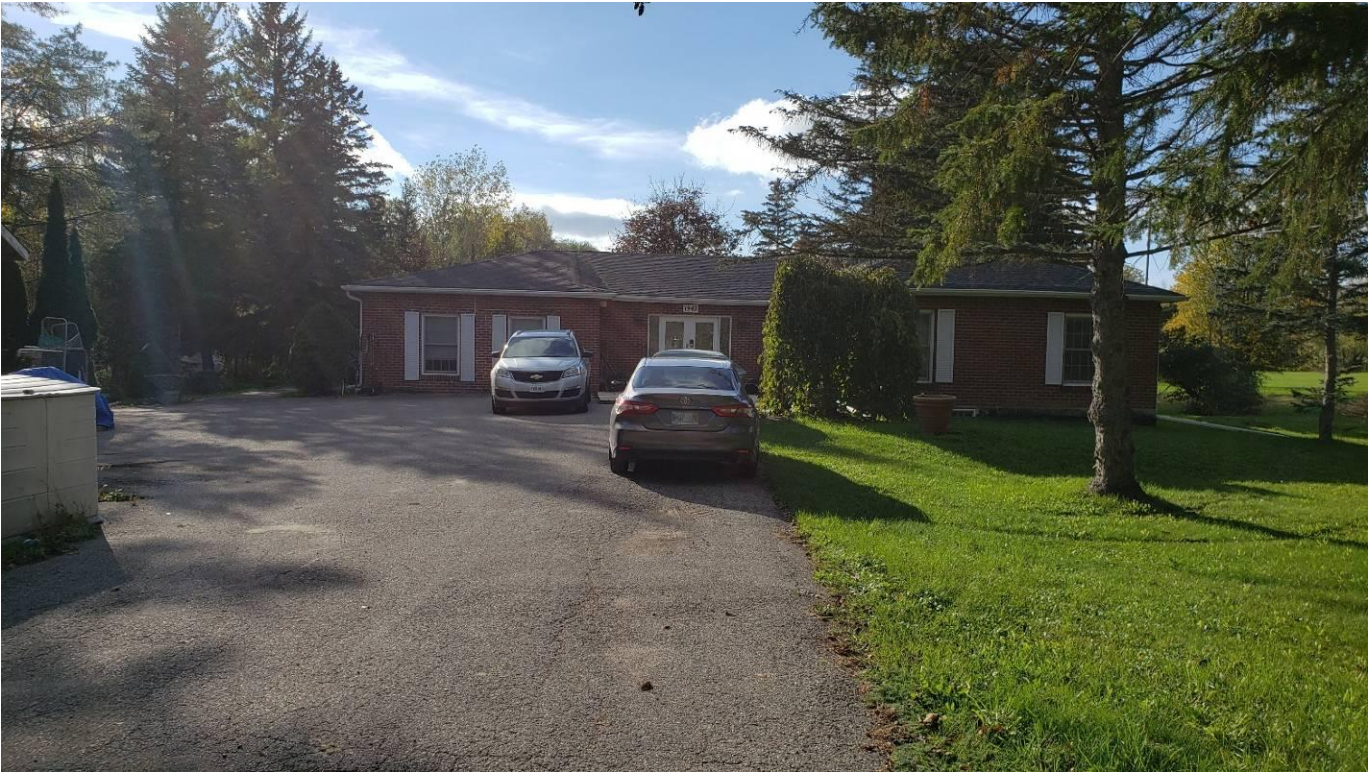
There was a one-storey residential building found on the east portion of the site, fronting Woodview Avenue. The one-storey building consisted of concrete foundations and brick veneer walls.

Photograph 1: Facing west on the east side of the property showing the existing house on the subject property.

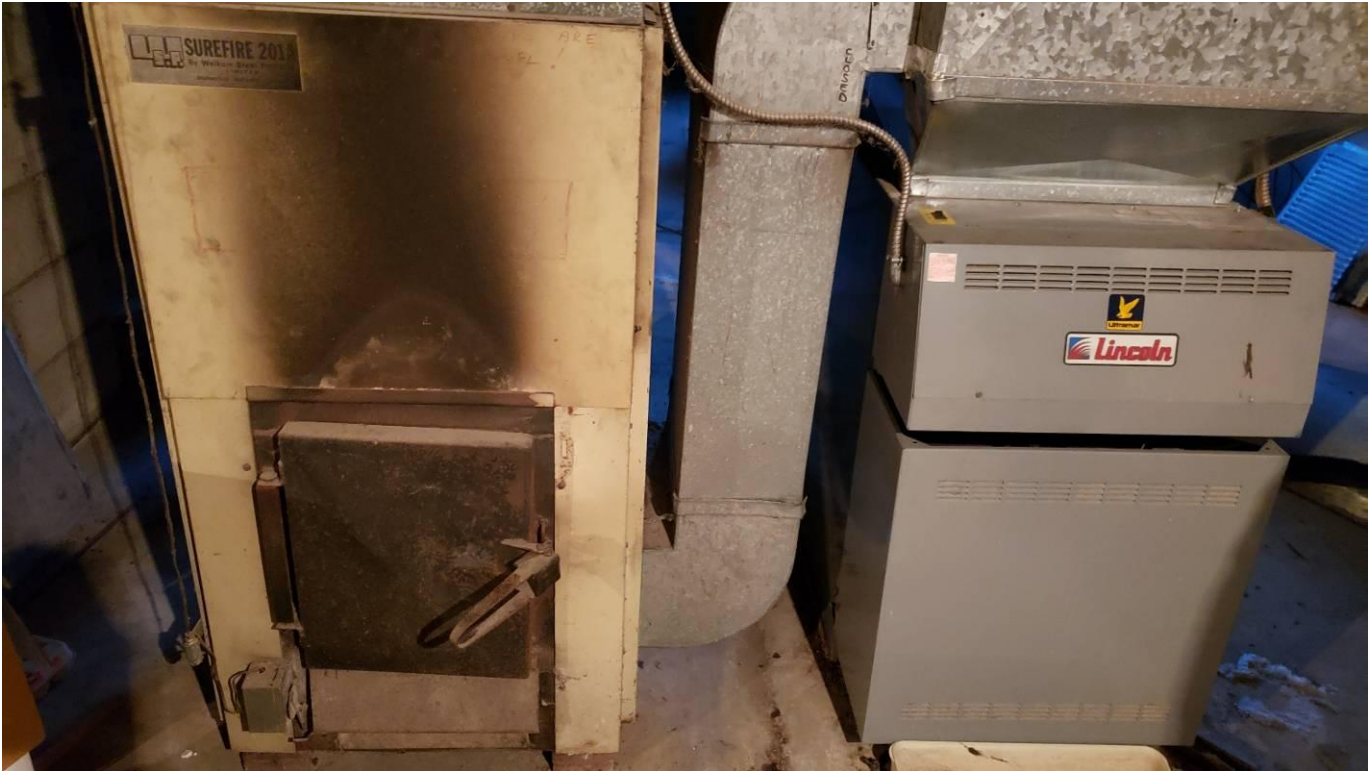
There was a natural gas furnace in the basement of the one-storey building. However, it was reported that there was an above-ground oil fuel storage tank in the basement of the building and it was emptied when it was converted into natural gas heating. No underground storage tanks were found on the Phase One property.

Photograph 7: In the basement of the house on subject property, showing the natural gas furnace.

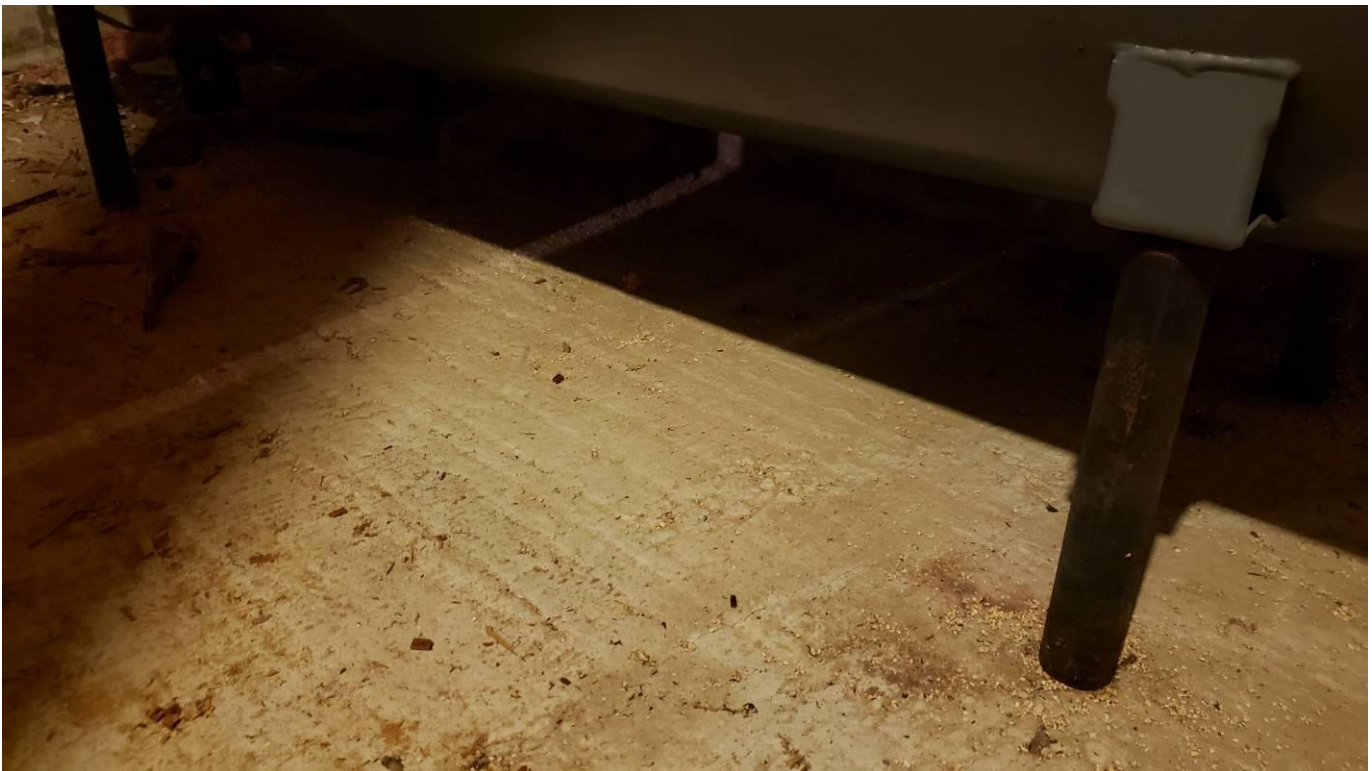
One APEC was found on the Phase One property. The APEC was found within the basement of the building and consisted of an above ground storage tank. This AST was used for storage of heating oil for heating the residential building, but was converted into natural gas heating recently.

The existing basement concrete slab of the building was in a fairly good condition, and so were the conditions around drains, sumps, sump pits in the basement.

Photograph 8: View of the concrete slab in basement directly below the location of the empty oil fuel tank.

In summary, based on the findings of our soil sampling and testing program, we conclude that no contaminated soils were found in the area of the AST. Our conclusion is that the site is free of contaminants and no further action or investigation is required.
