ICON HOMES

**PHASE ONE
ENVIRONMENTAL SITE ASSESSMENT**

**PART 2 AND 3 OF PLAN 40R-25822, ADJACENT TO THE WEST
OF 2680 BROCK ROAD NORTH, PICKERING, ON**

CT2694.05

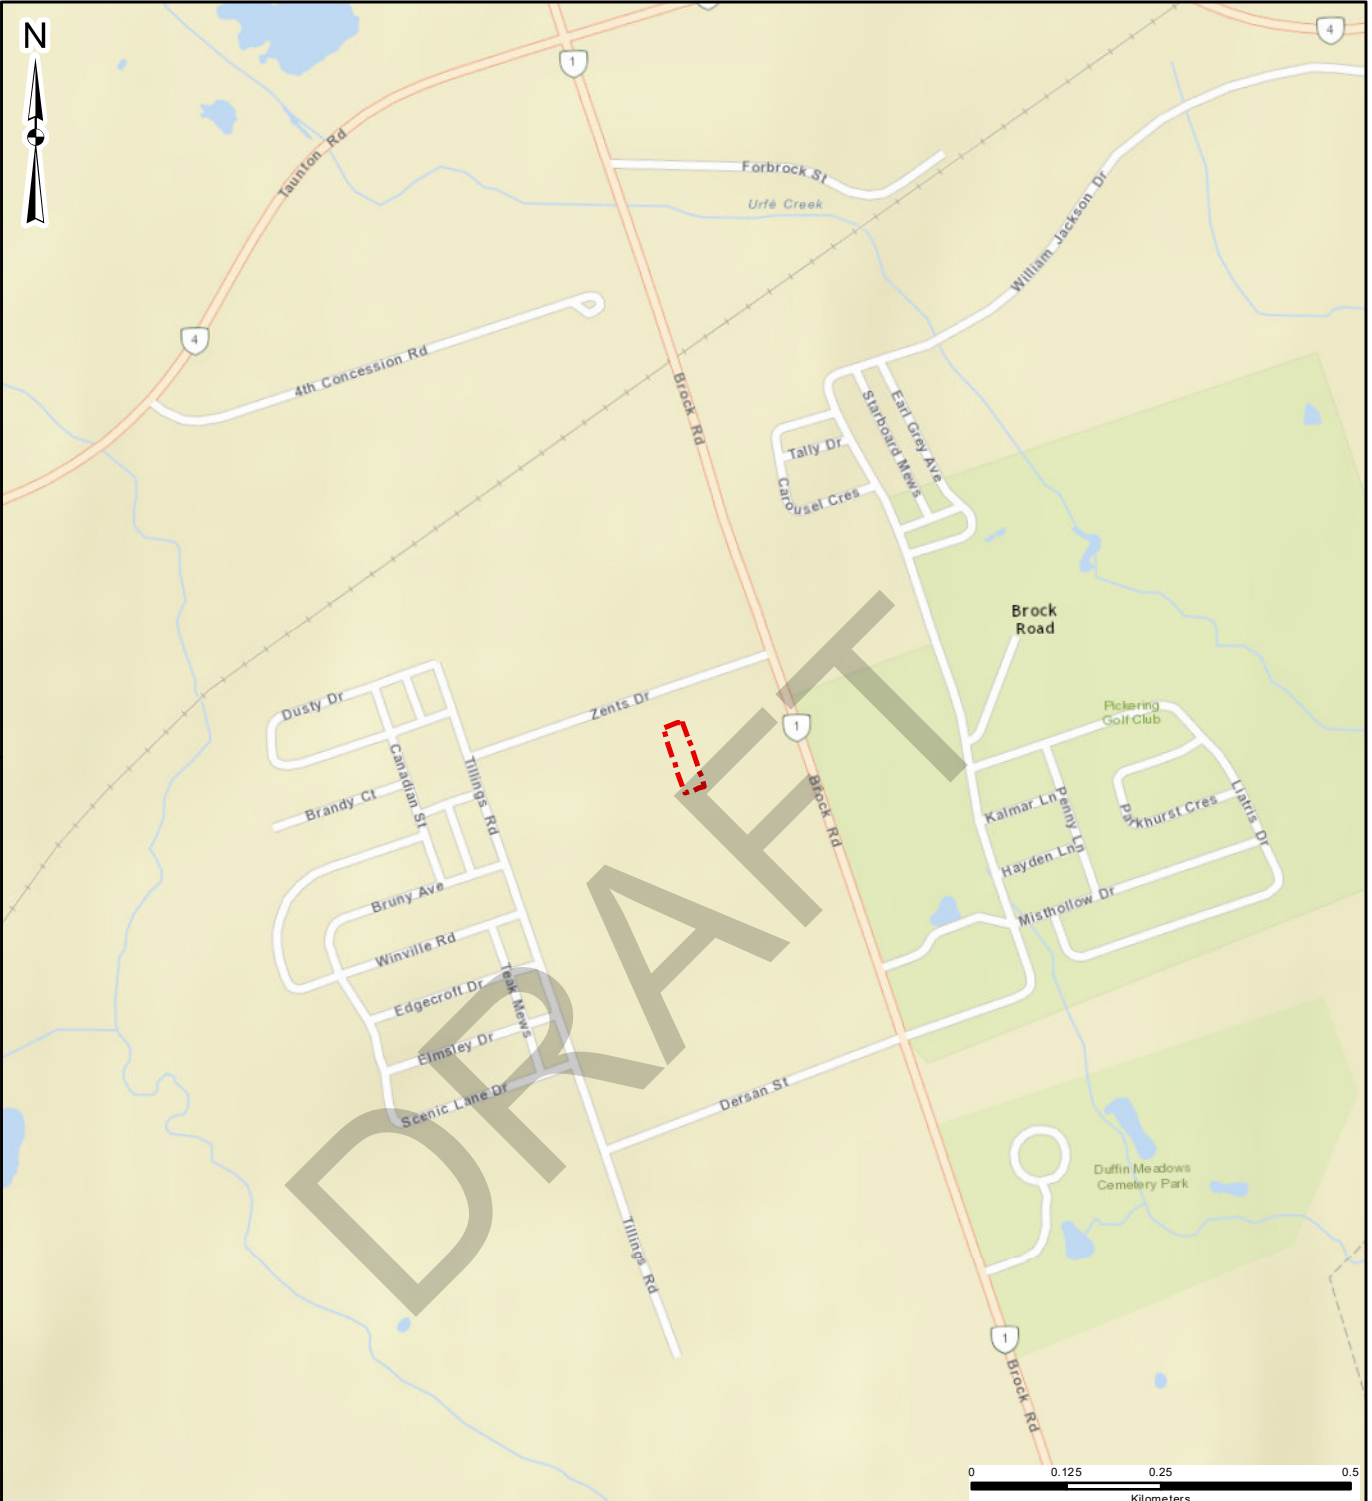
REVISION: 00	DATE: JANUARY 2024	FIGURE: 1
--------------	--------------------	------------------

Information regarding the location and identification of the Phase One Property and the party authorizing this study is provided in the table below. Refer to Figure 1 for the location of the Site, and to Figure 2 for the general layout of the Site at the time of the site reconnaissance.

The Site location plan is shown on Figure 1. The site layout is shown on Figure 2. Selected photographs including general descriptions are provided in Appendix VIII.

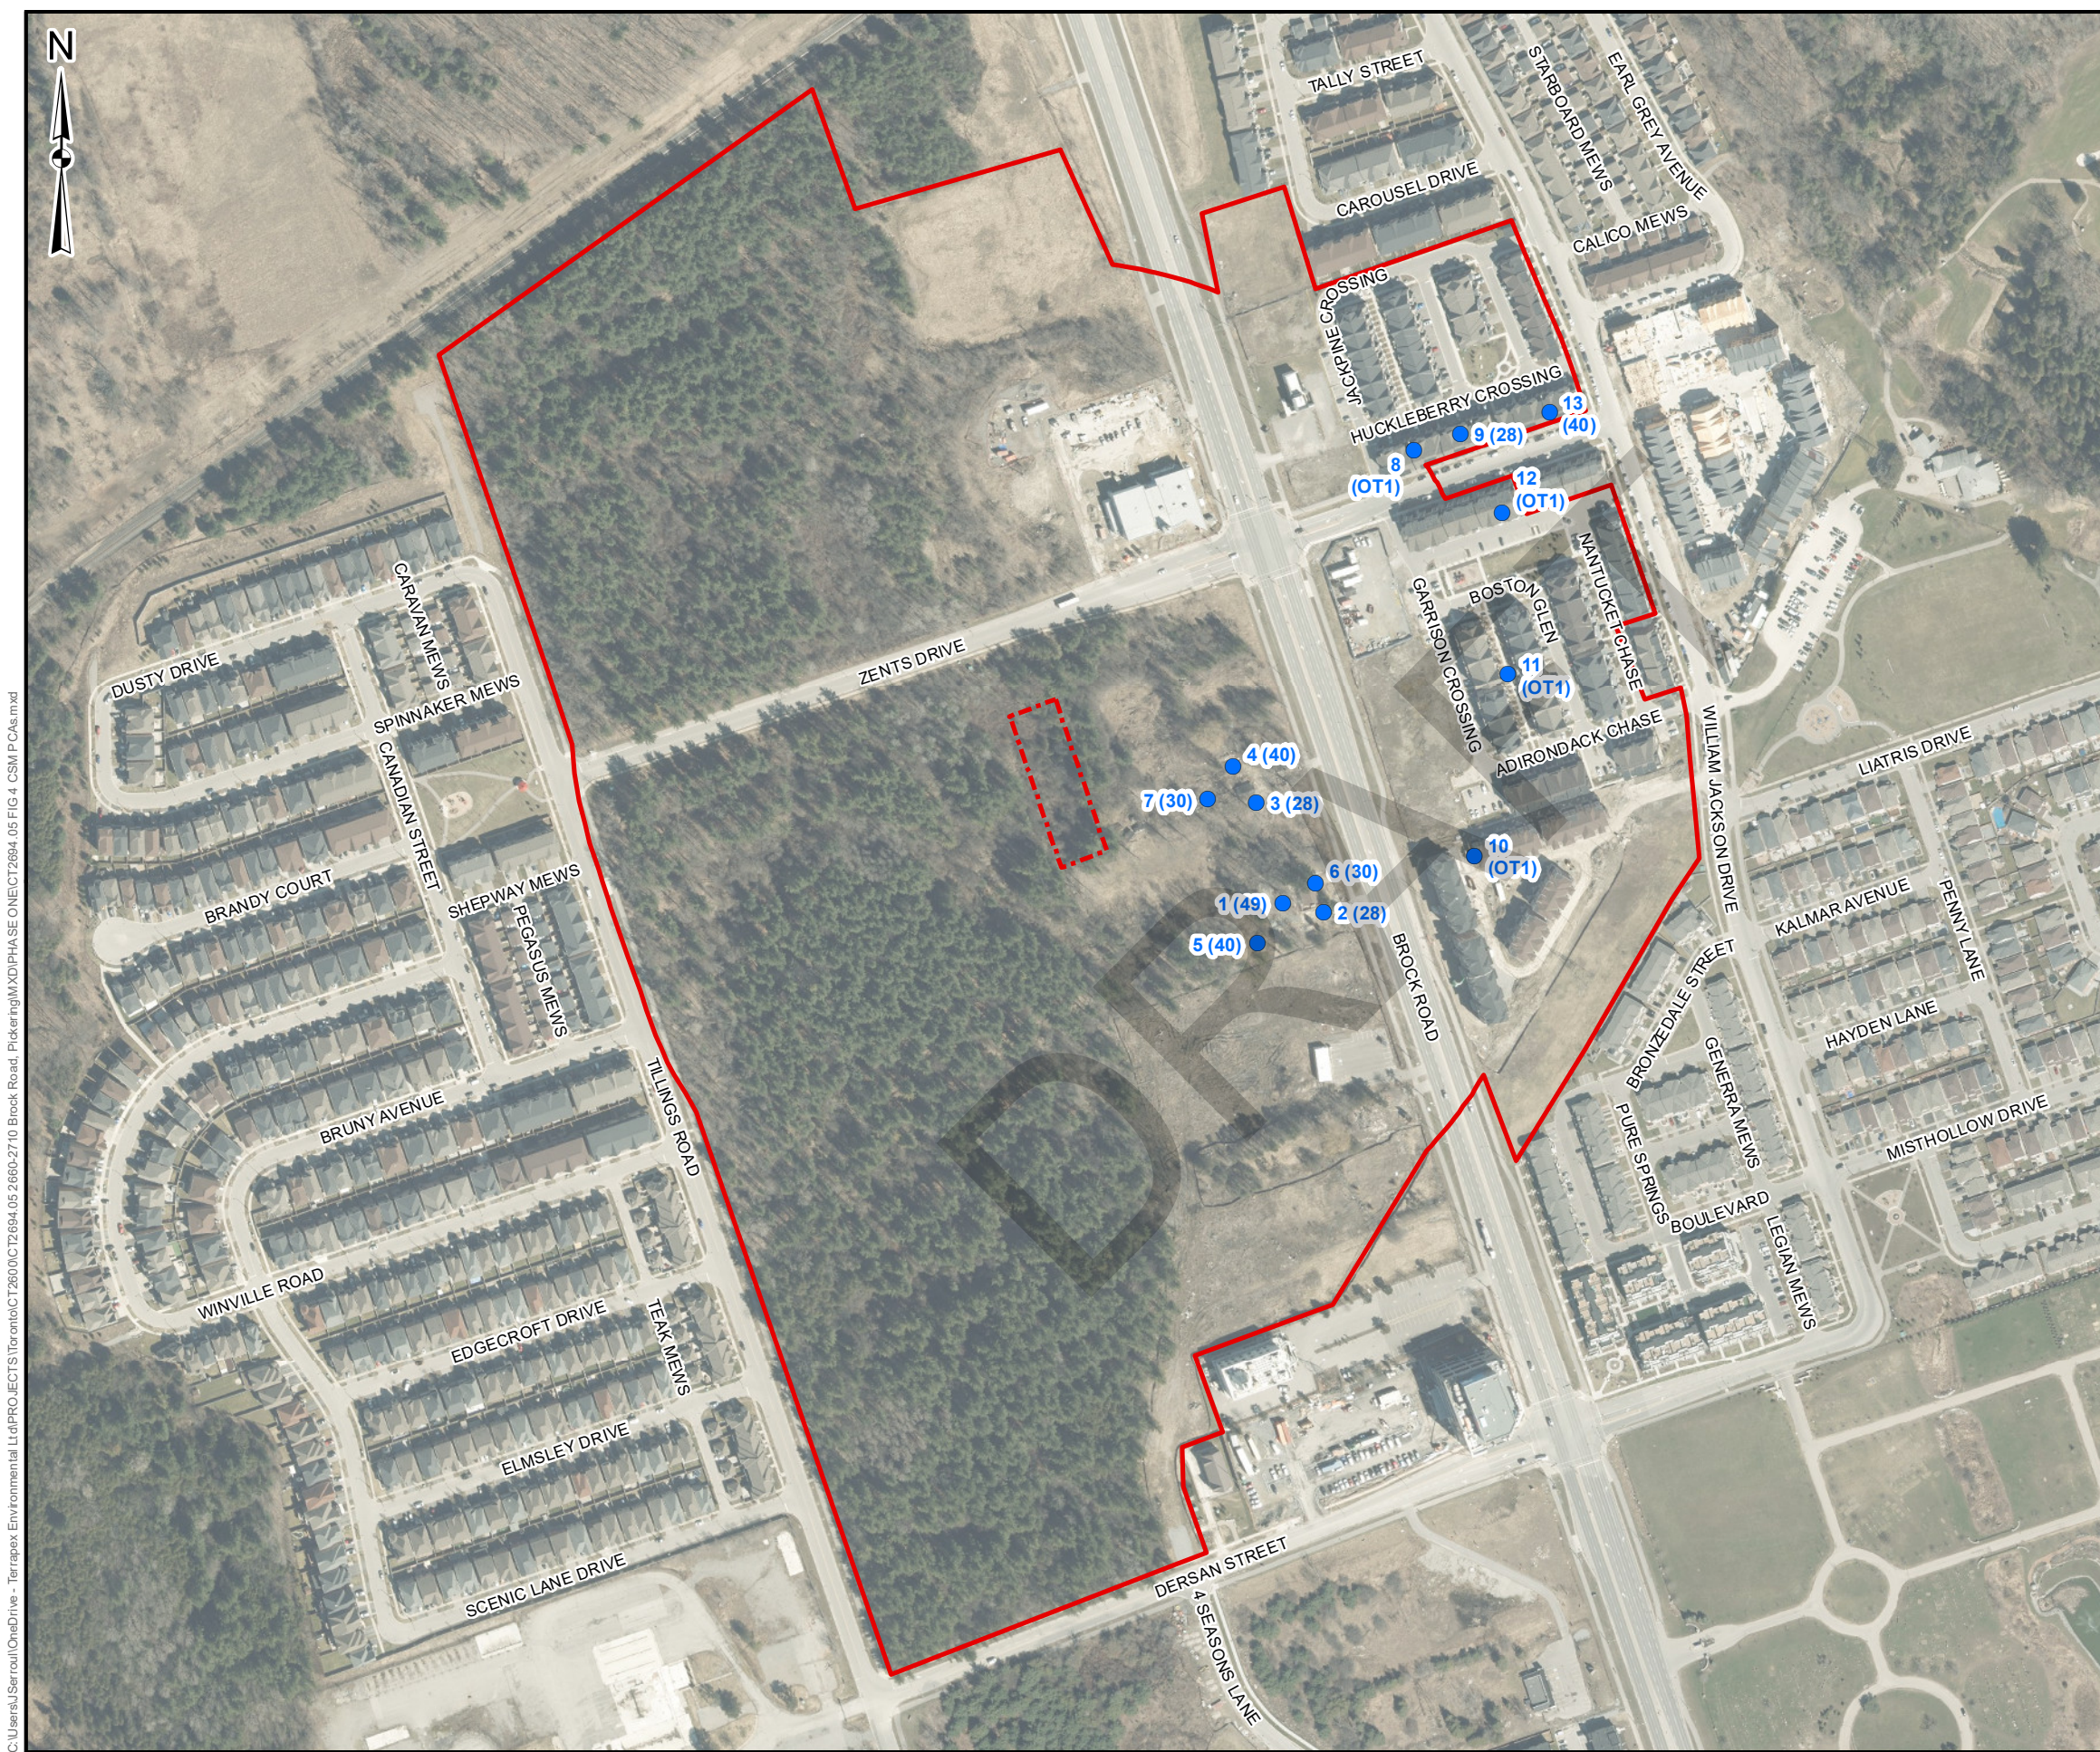
DRAWN BY: SW/JS	PROJECT NO.: CT2694.05	CHECKED BY: SS
REVISION: 00	DATE: JANUARY 2024	FIGURE: 3

The boundary of the Phase One Study Area is depicted in Figure 3. Note that all distances are calculated from the nearest property boundary of the Site to the nearest boundary of the feature/property in question and are approximate.

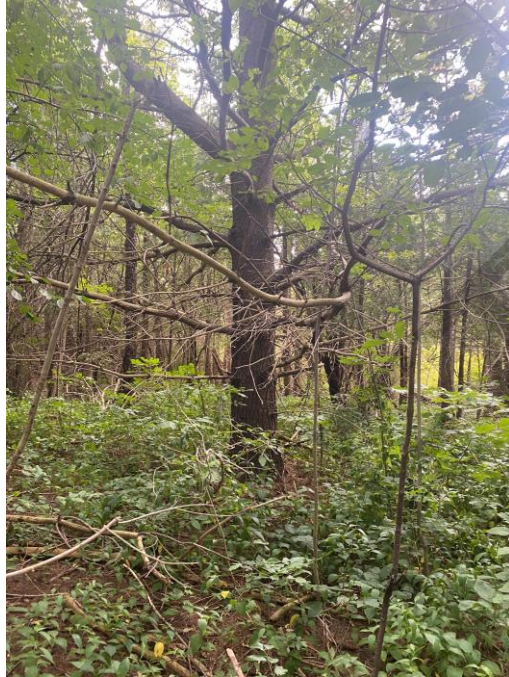
Client: ICON Homes**Site Location:**Part 2 and 3 of Plan 40R-25822,
Pickering, ON**Project No:** CT2694.05**Photo No:** 1**Date:** September 14,
2023**Viewing Direction:** South**Description:**View of the Site from the
northeast corner.

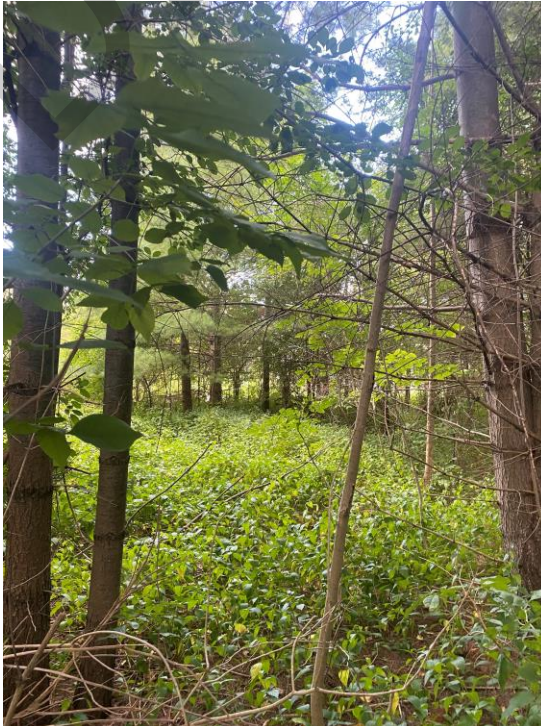
**Photo No:** 2**Date:** September 14,
2023**Viewing Direction:** West**Description:**East side of the Site
adjacent to the boundary
with 2680 Brock Street
North.

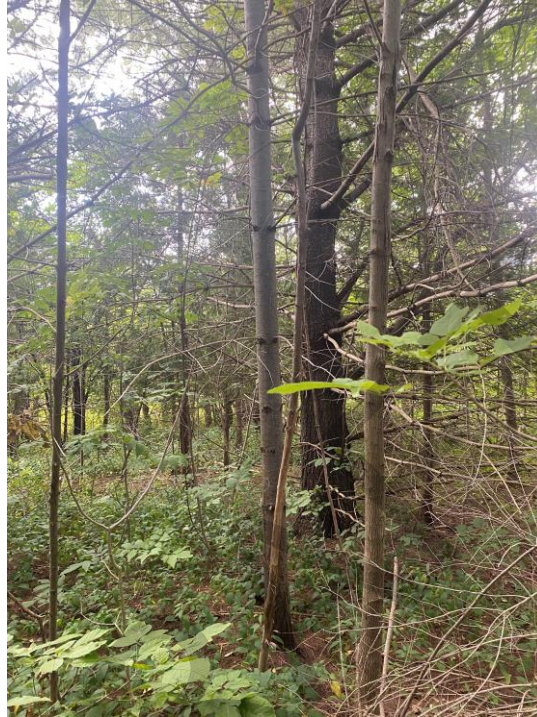
Client: ICON Homes**Site Location:** Part 2 and 3 of Plan 40R-25822,
Pickering, ON**Project No:** CT2694.05**Photo No:** 3**Date:** September 14,
2023**Viewing Direction:** North**Description:** View of the
northern portion of the
Site.

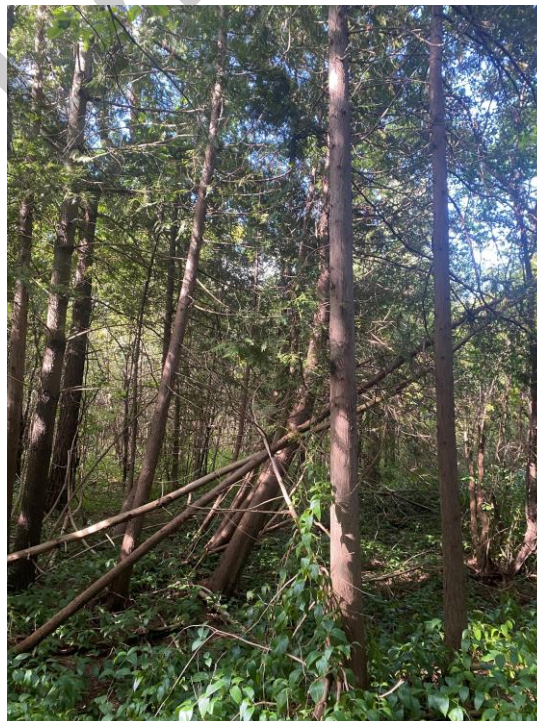
**Photo No:** 4**Date:** September 14,
2023**Viewing Direction:** North**Description:** View of the
southern portion of the
Site.

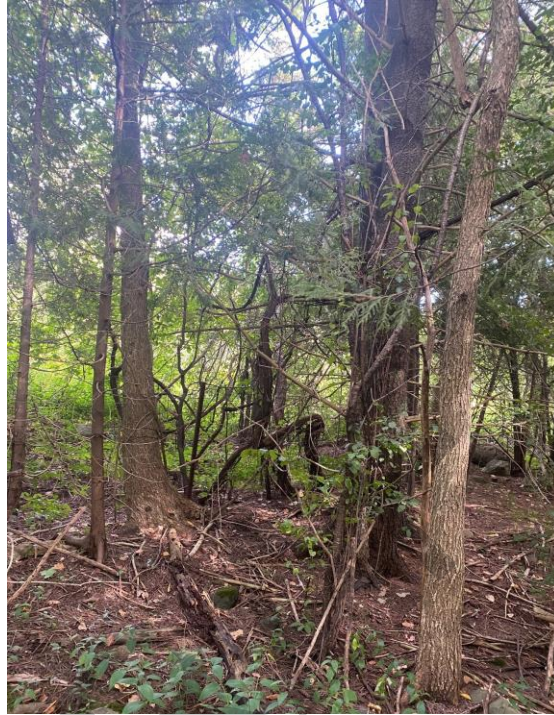
Client: ICON Homes**Site Location:**Part 2 and 3 of Plan 40R-25822,
Pickering, ON**Project No:** CT2694.05**Photo No:** 5**Date:** September 14,
2023**Viewing Direction:** West**Description:** View of the
east central portion of the
Site.

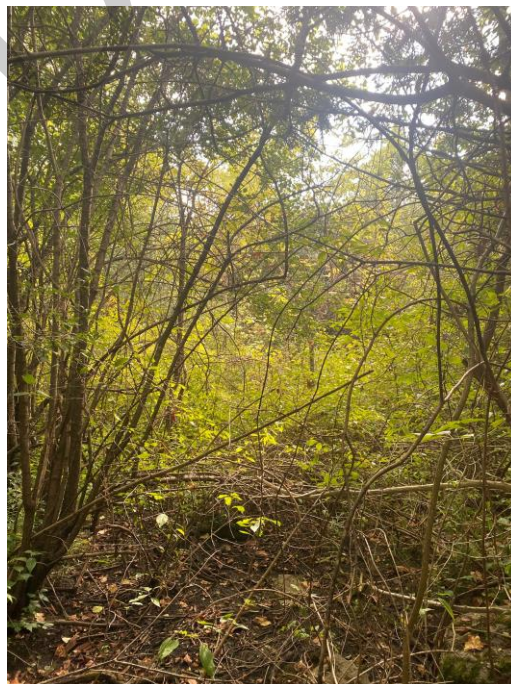
**Photo No:** 6**Date:** September 14,
2023**Viewing Direction:** West**Description:** Dense
vegetation located on the
western side of the Site.

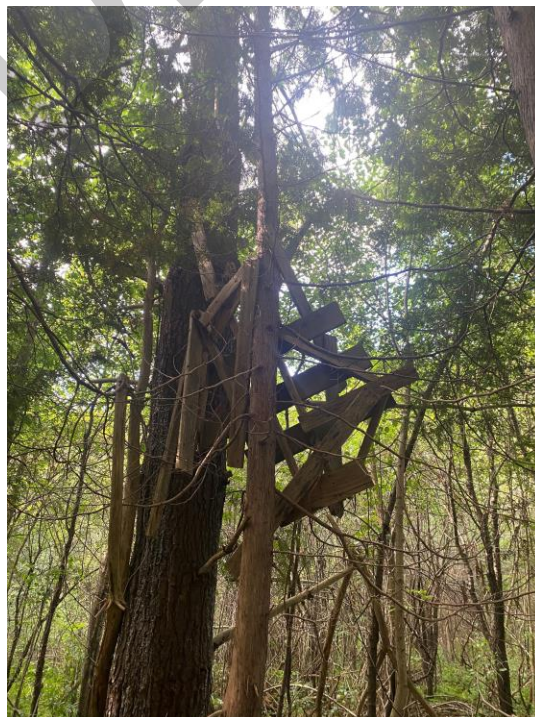
**Photo No:** 8**Date:** September 14,
2023**Viewing Direction:** North**Description:** Remains of
treehouse or deer blind
found on the south side of
the Site.

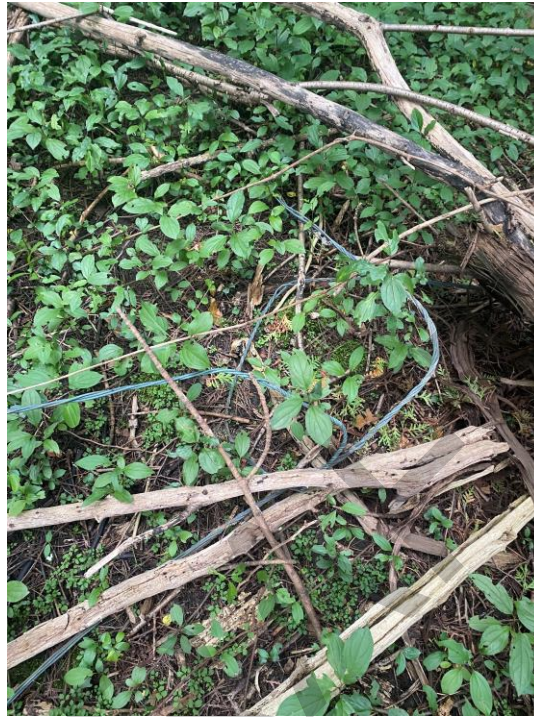
Client: ICON Homes**Site Location:**Part 2 and 3 of Plan 40R-25822,
Pickering, ON**Project No:** CT2694.05**Photo No:** 9**Date:** September 14,
2023**Viewing Direction:** NA**Description:** Cord-like
wire found on-Site.

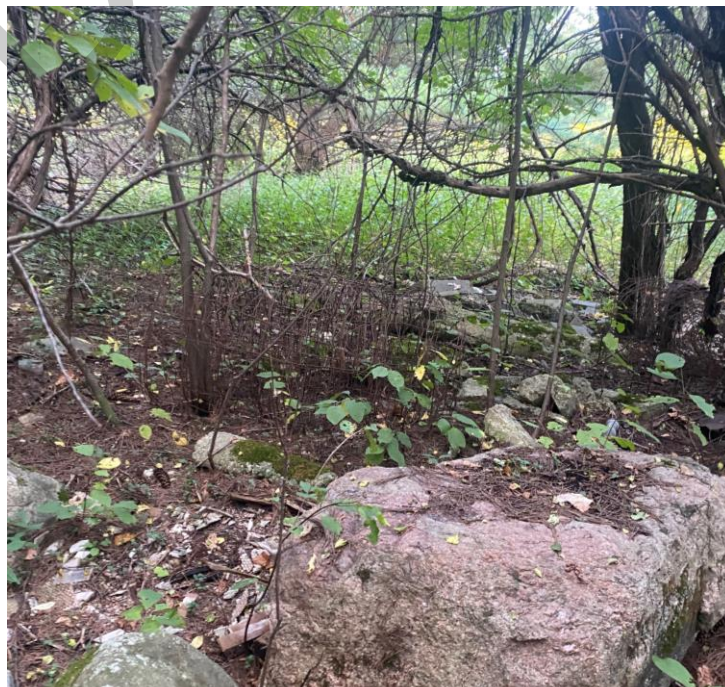
**Photo No:** 10**Date:** September 14,
2023**Viewing Direction:** East**Description:** Roll of wire
fencing found on east side
of site, next to post and
wire fence remnants.

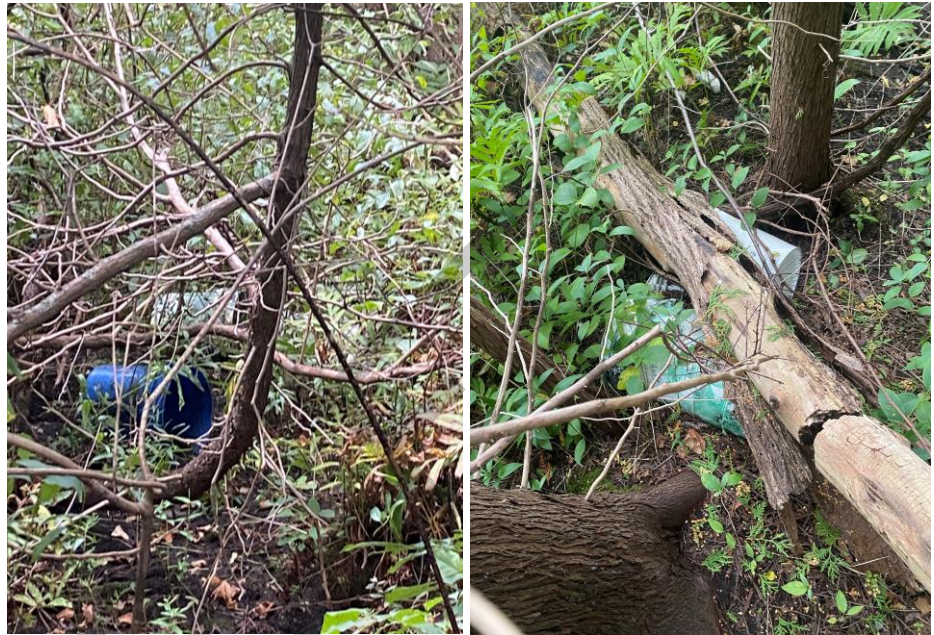
Description: Refuse and debris observed on the west-central area of the Site.

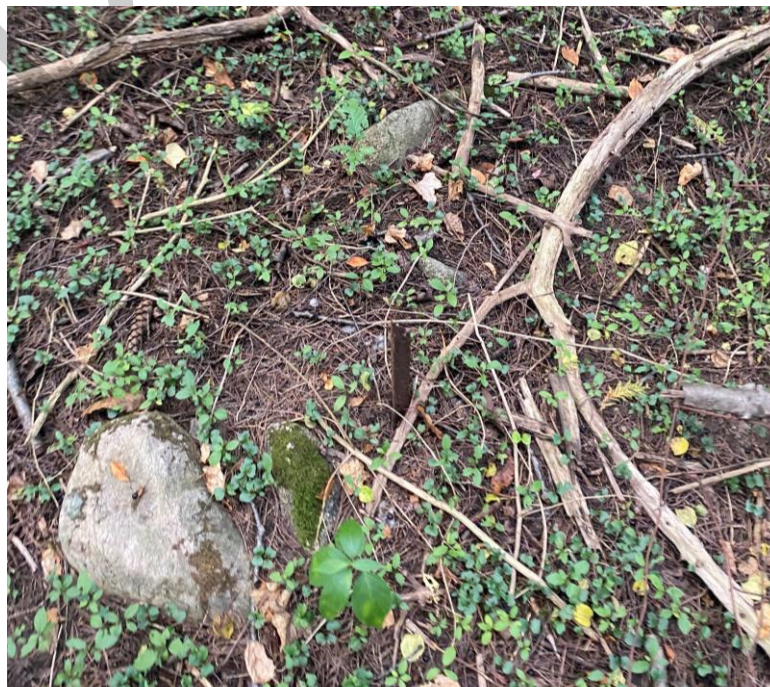
Photo No: 12

Description: Stake found near east side of property

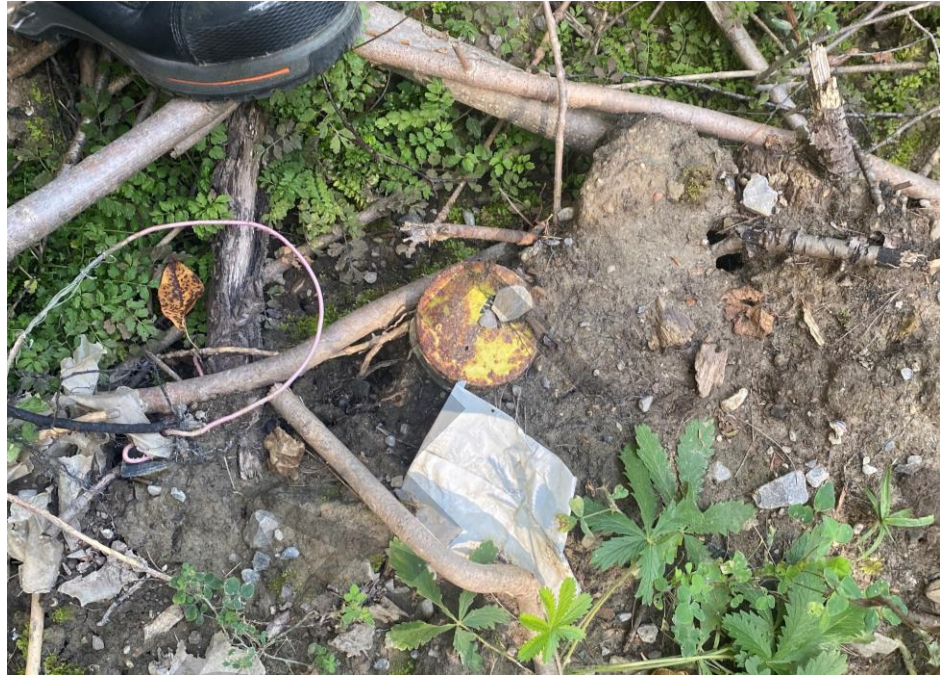
Client: ICON Homes**Site Location:**Part 2 and 3 of Plan 40R-25822,
Pickering, ON**Project No:** CT2694.05**Photo No:** 13**Date:** September 14,
2023**Viewing Direction:** NA**Description:** Unidentified
cap (possibly natural gas)
found on northeast portion
of the Site.

No utilities were observed to be present at the Site during the inspection. However, a pipe with yellow cap was observed in the northwest portion of the Site, which may be part of a pipeline distribution system.
