Supplementary Phase Two Environmental Site Assessment

Development Phase II: 1755 & 1805 Pickering Parkway
Pickering, Ontario

DS Project No: 22-110-100

Date: 2023-03-14

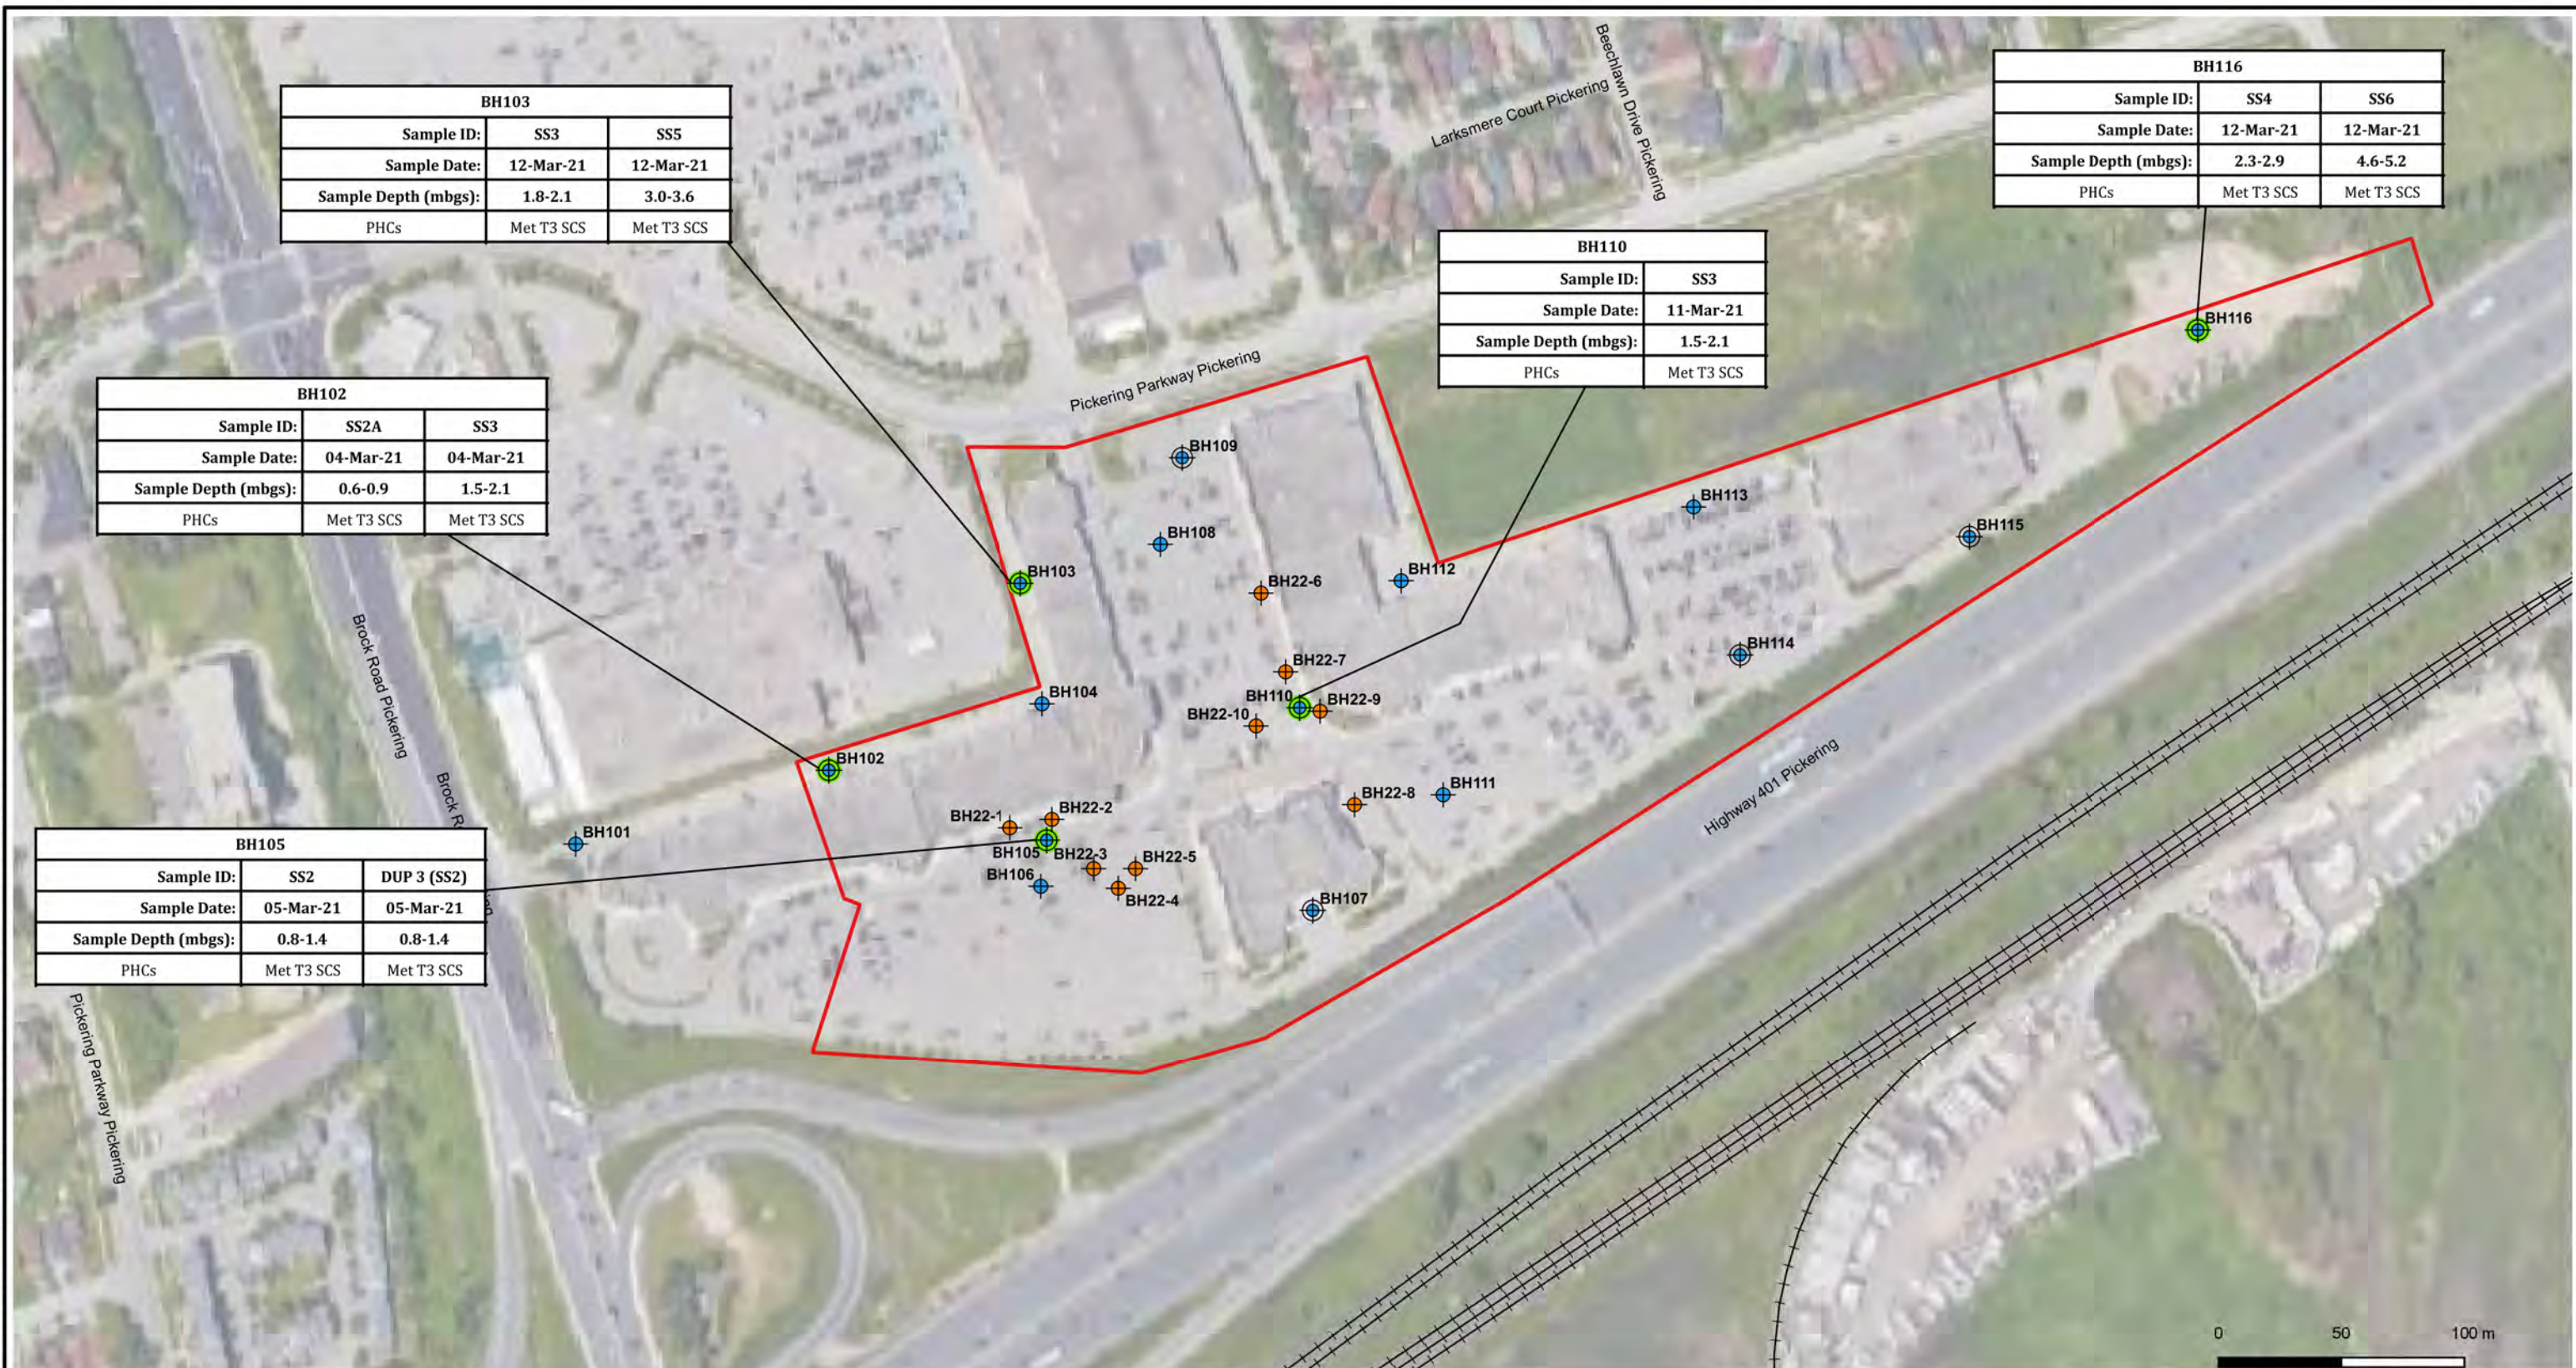
Size:	Approved By:	R.F.	Drawn By:	P.P	Date:	March 2023
11x17	Scale:	As Shown	Project No.:	22-110-100	Figure No.:	7B
Rev:	Image/Map Source: Google Satellite Image					
0

BH103		
Sample ID:	SS3	SS5
Sample Date:	12-Mar-21	12-Mar-21
Sample Depth (mbgs):	1.8-2.1	3.0-3.6
PHCs	Met T3 SCS	Met T3 SCS

BH116		
Sample ID:	SS4	SS6
Sample Date:	12-Mar-21	12-Mar-21
Sample Depth (mbgs):	2.3-2.9	4.6-5.2
PHCs	Met T3 SCS	Met T3 SCS

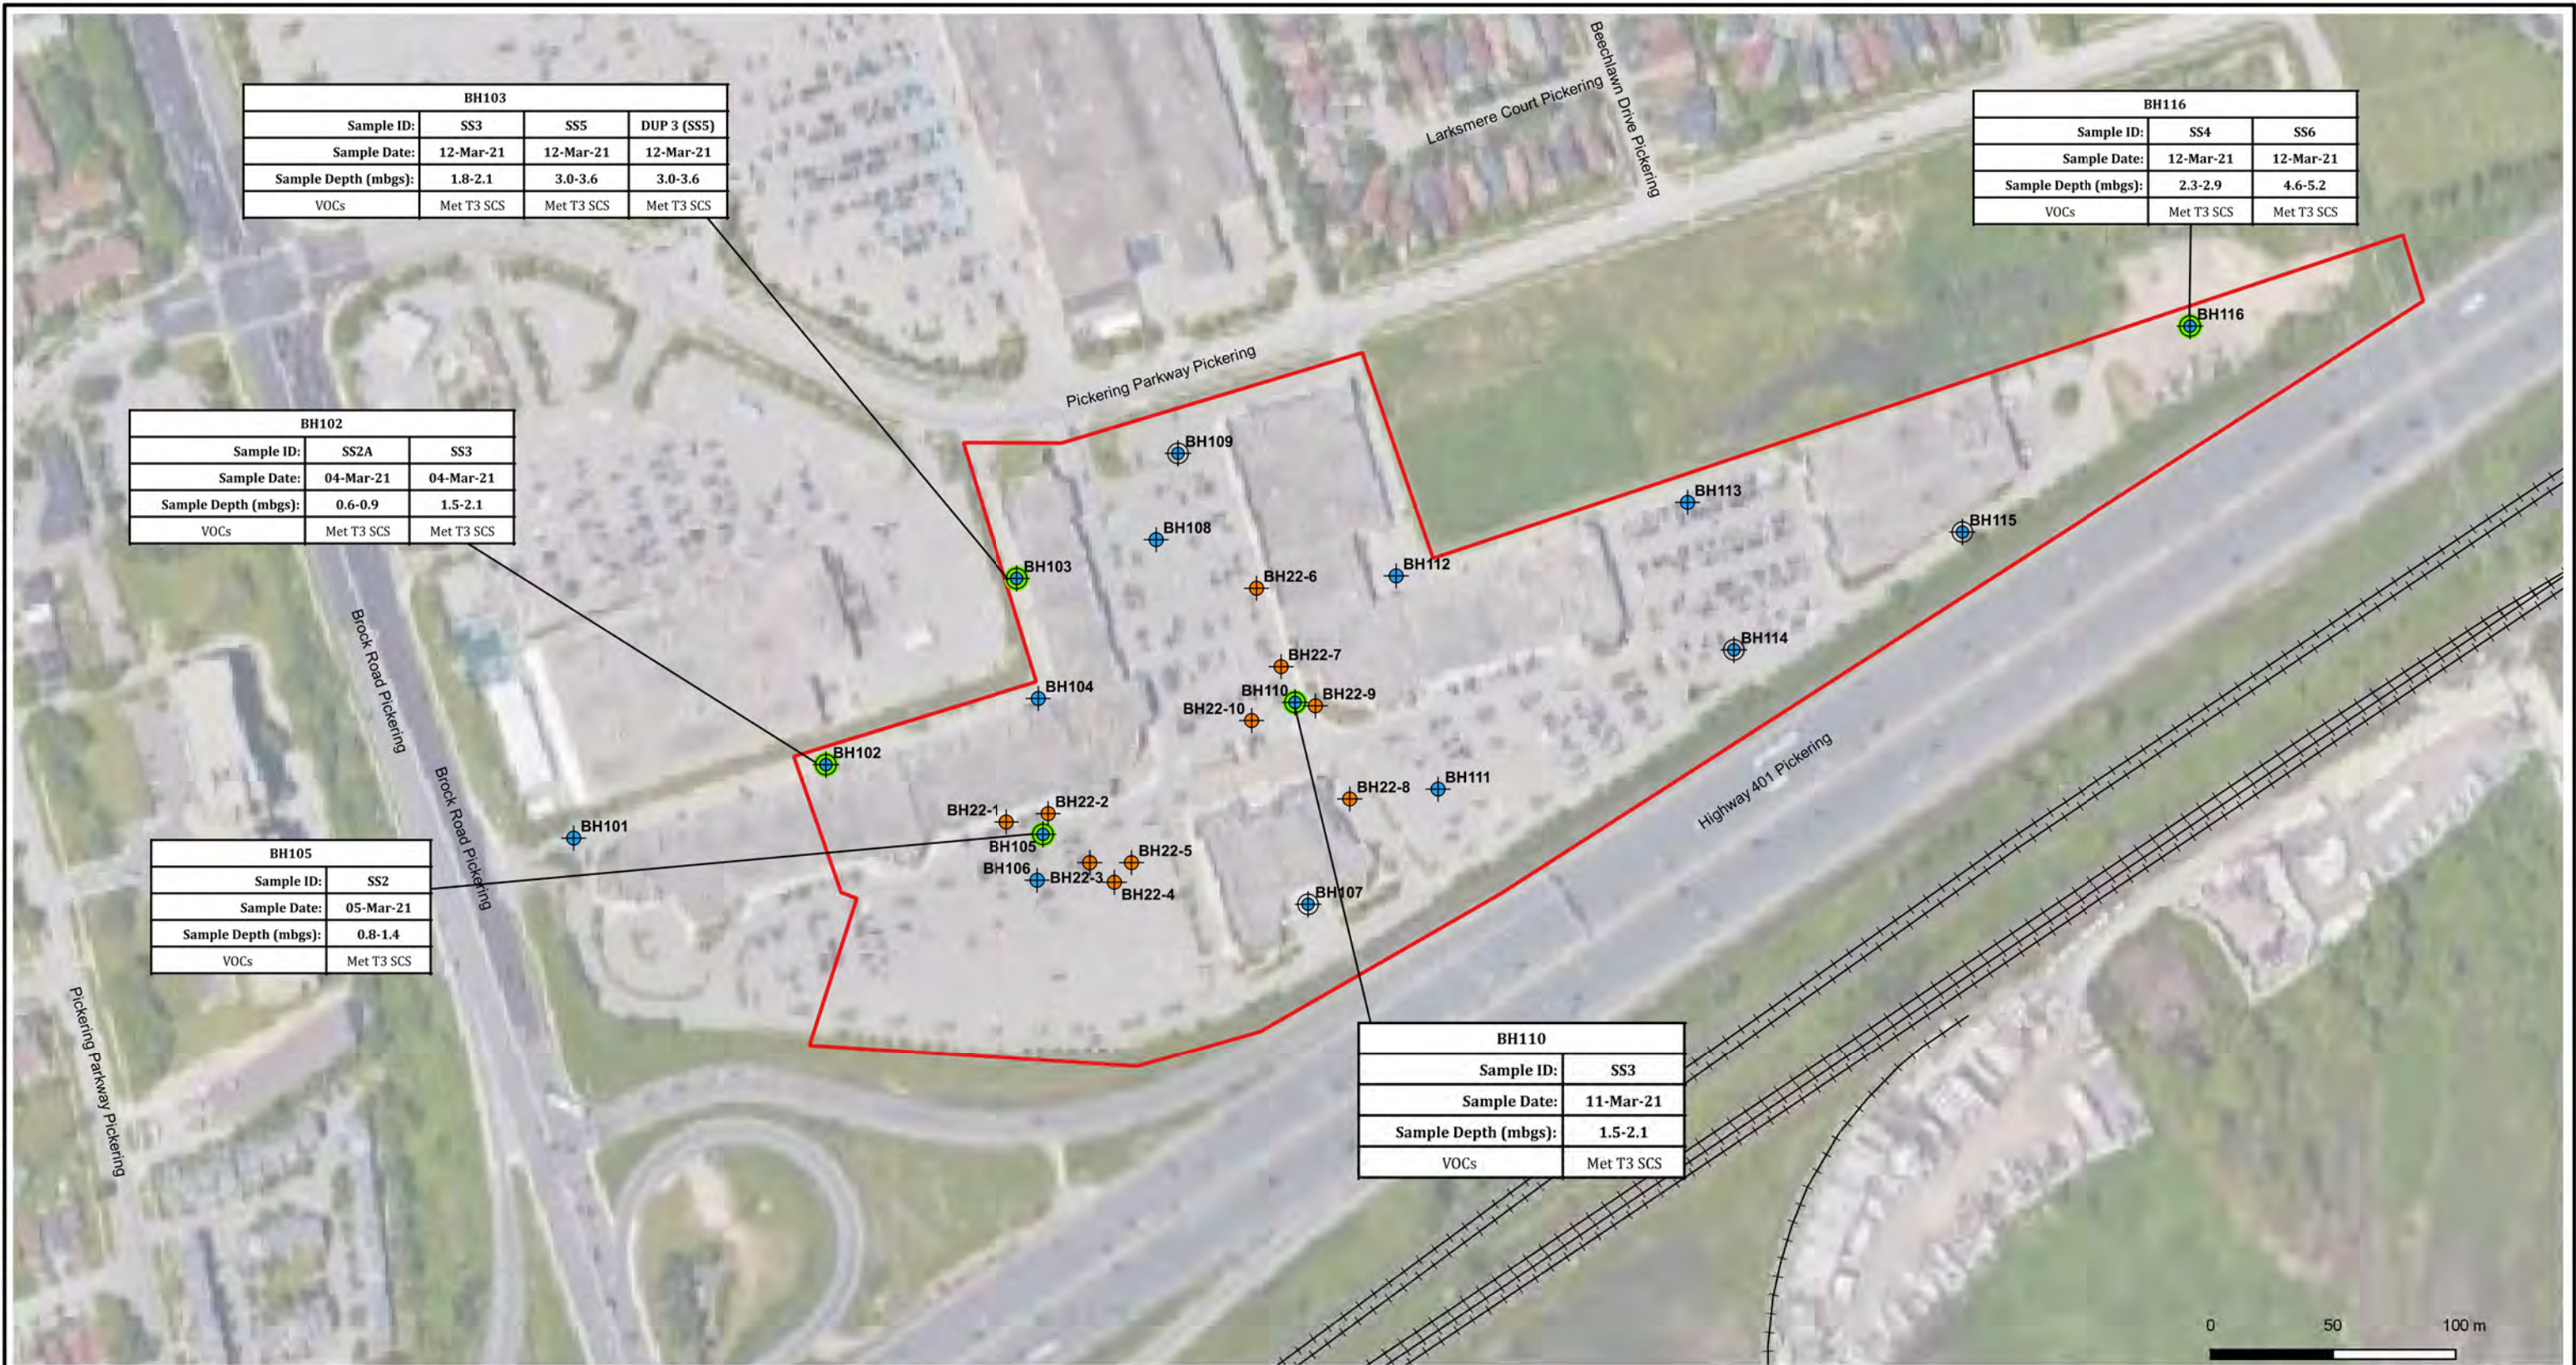
BH103			
Sample ID:	SS3	SS5	DUP 3 (SS5)
Sample Date:	12-Mar-21	12-Mar-21	12-Mar-21
Sample Depth (mbgs):	1.8-2.1	3.0-3.6	3.0-3.6
VOCs	Met T3 SCS	Met T3 SCS	Met T3 SCS

BH116		
Sample ID:	SS4	SS6
Sample Date:	12-Mar-21	12-Mar-21
Sample Depth (mbgs):	2.3-2.9	4.6-5.2
VOCs	Met T3 SCS	Met T3 SCS

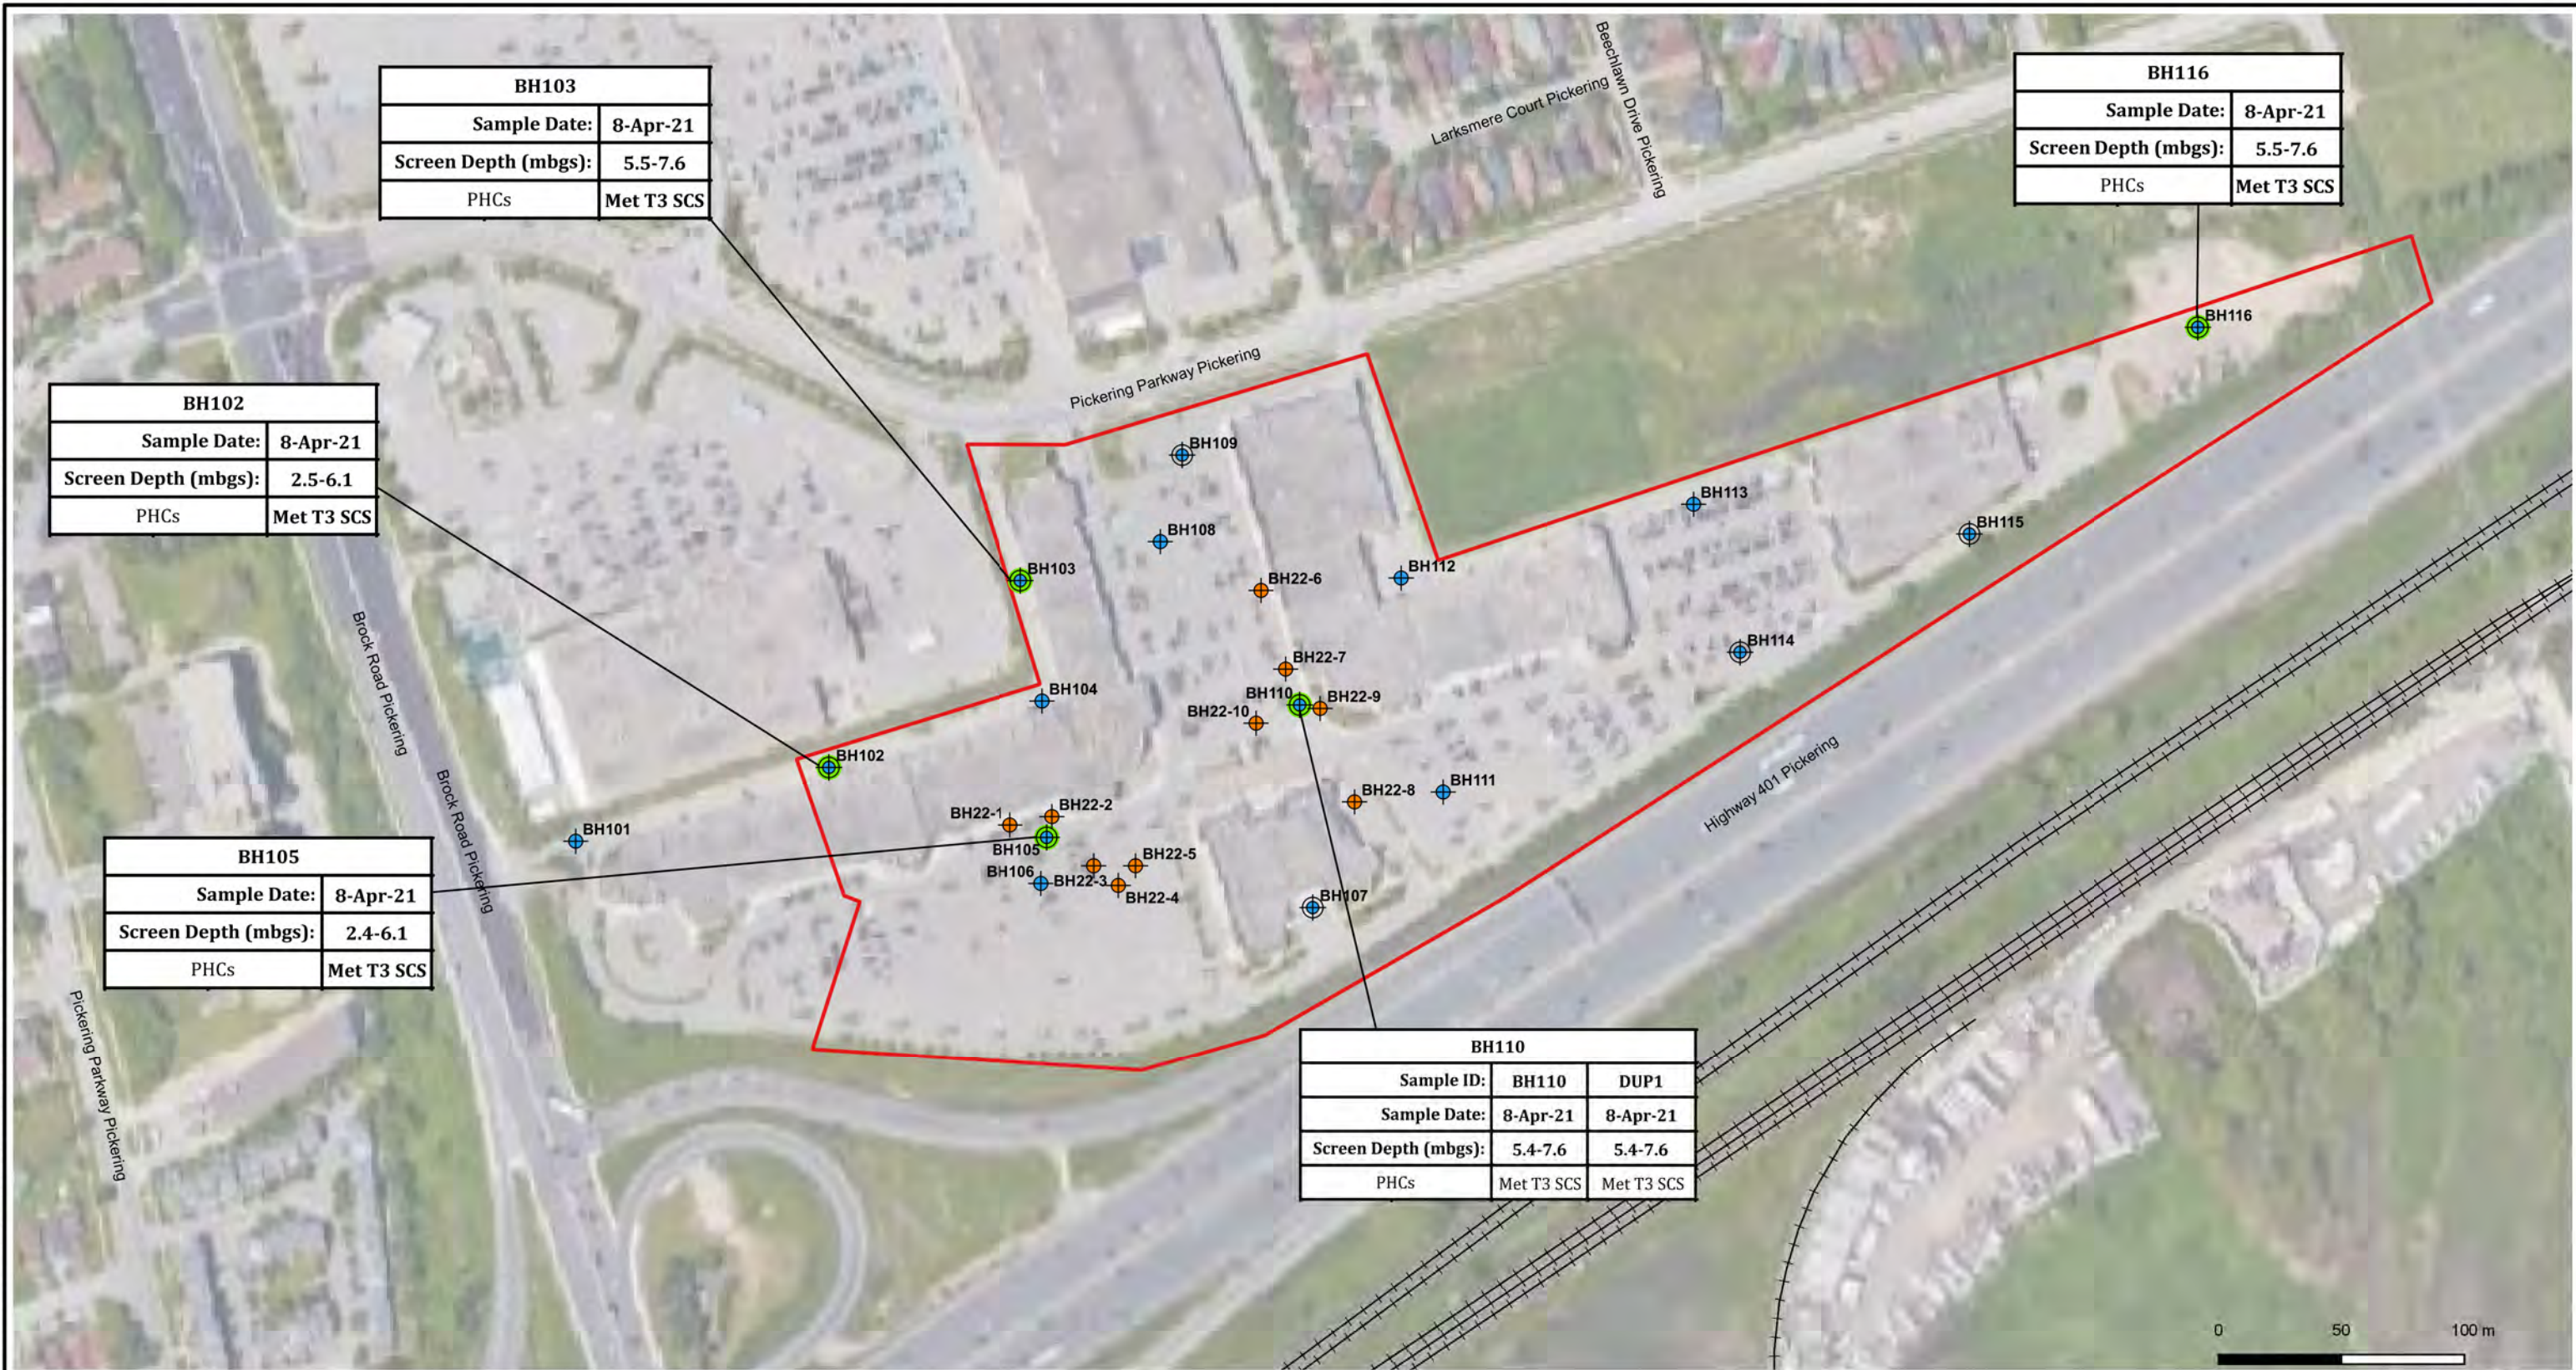
BH103	
Sample Date:	8-Apr-21
Screen Depth (mbgs):	5.5-7.6
PHCs	Met T3 SCS

BH116	
Sample Date:	8-Apr-21
Screen Depth (mbgs):	5.5-7.6
PHCs	Met T3 SCS

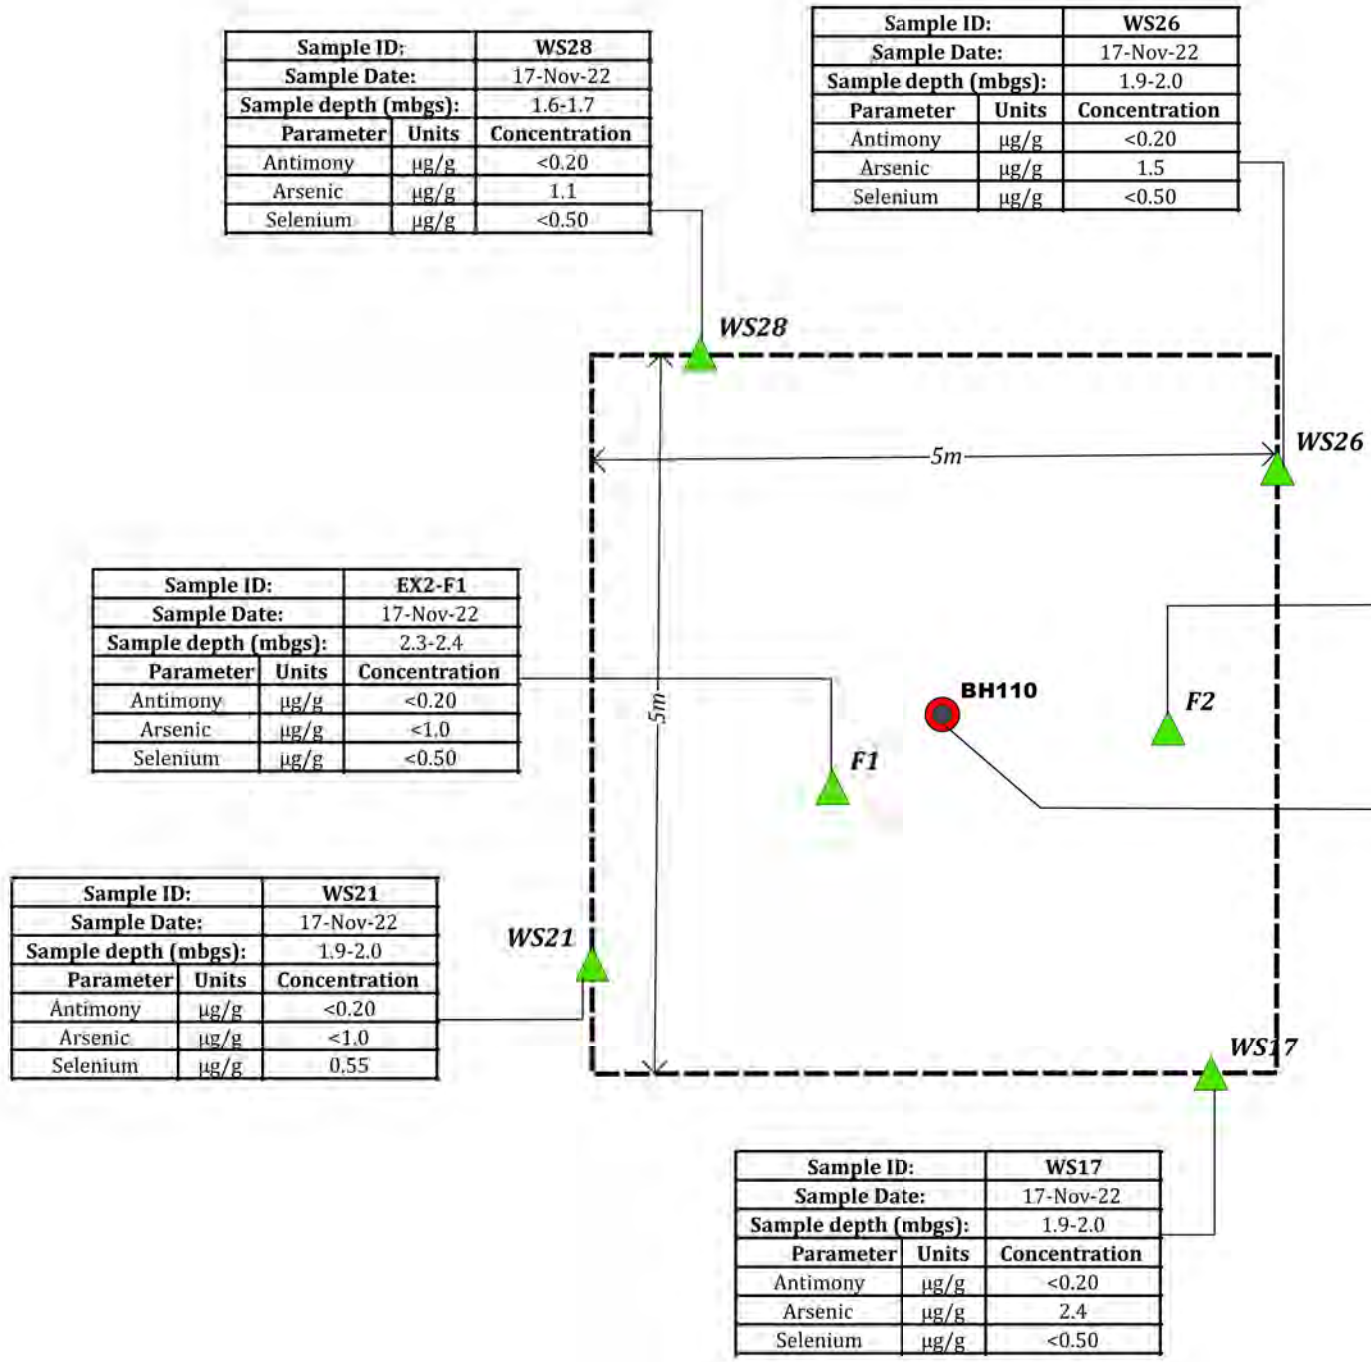
Sample ID:	WS28	
Sample Date:	17-Nov-22	
Sample depth (mbgs):	1.6-1.7	
Parameter	Units	Concentration
Antimony	µg/g	<0.20
Arsenic	µg/g	1.1
Selenium	µg/g	<0.50

Sample ID:	WS26	
Sample Date:	17-Nov-22	
Sample depth (mbgs):	1.9-2.0	
Parameter	Units	Concentration
Antimony	µg/g	<0.20
Arsenic	µg/g	1.5
Selenium	µg/g	<0.50

Sample ID:	WS17	
Sample Date:	17-Nov-22	
Sample depth (mbgs):	1.9-2.0	
Parameter	Units	Concentration
Antimony	µg/g	<0.20
Arsenic	µg/g	2.4
Selenium	µg/g	<0.50
