# **Hydrogeological Assessment – Durham Live! Tourist Destination Lands Re-Zoning Application**

**Pickering, ON**

1805601

Pickering Developments Inc.

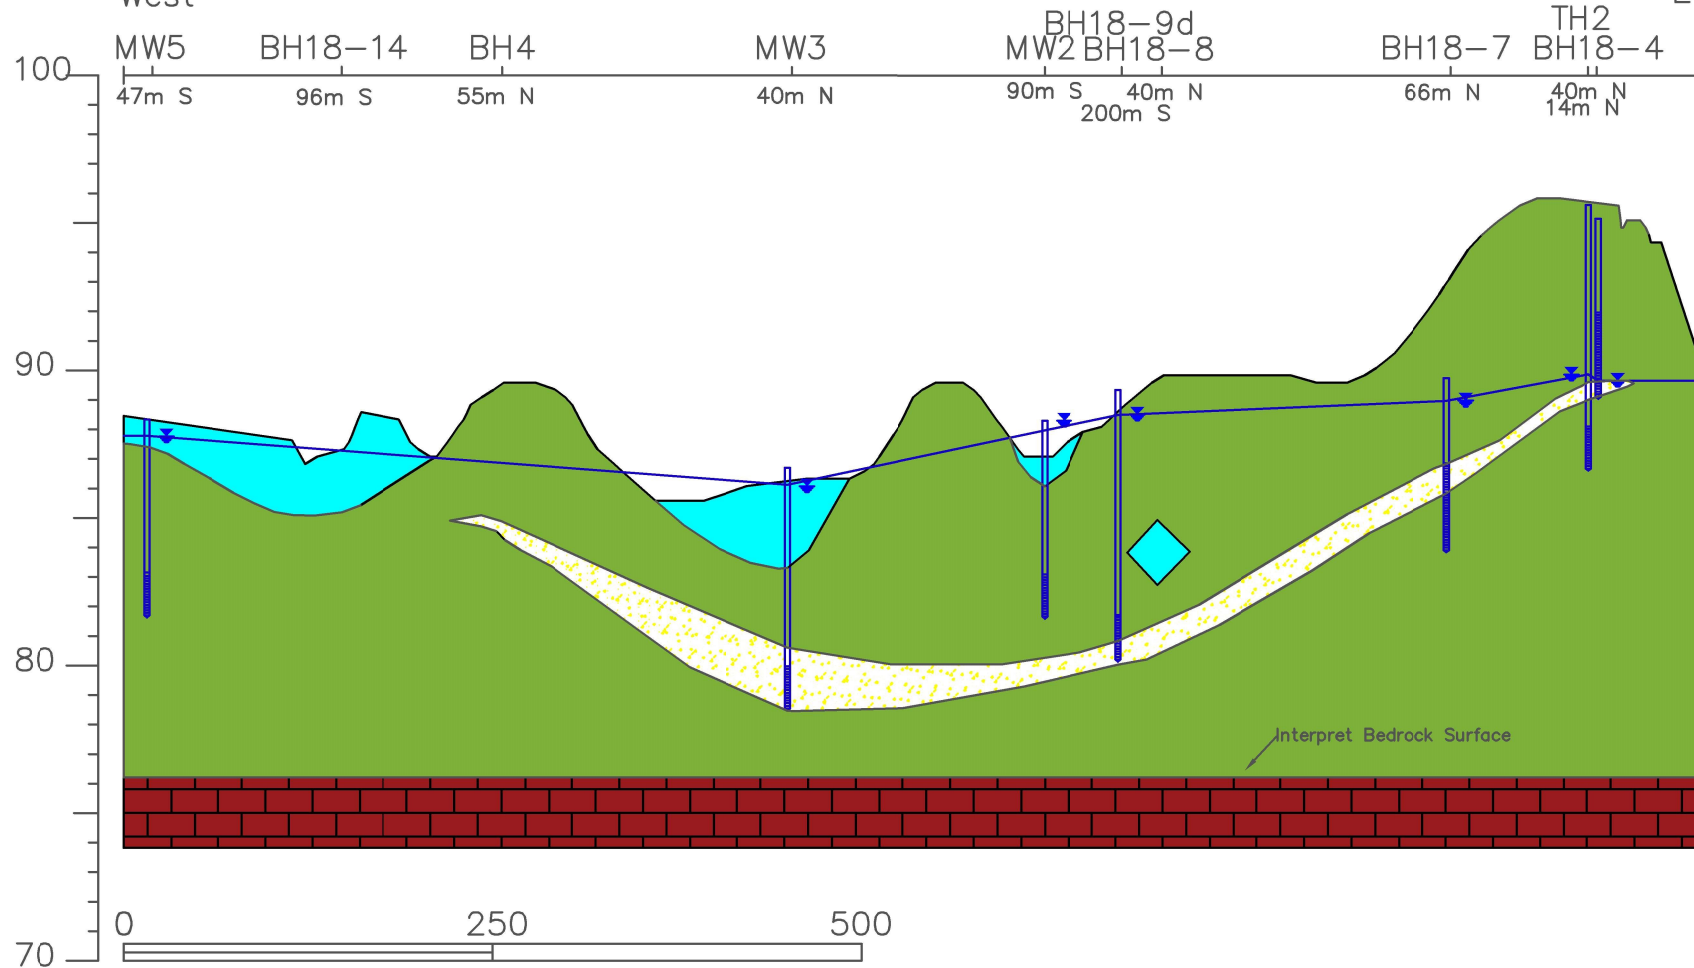
- Glaciolacustrine Sand, Silt, and Silty Clay
- Newmarket Till
- Sand
- Shale
- Piezometric Head
- Water Level

<b>CLIENT:</b> Pickering Developments Inc. 186 Bartley Drive North York, ON M4A 1E1			
<b>FIGURE:</b> Figure 7			
<b>TITLE:</b> B-B' East West Hydrostratigraphic Cross-Section			
<b>SCALE AT 11 X 8:</b> See inset	<b>DATE:</b> Dec 16, 2019	<b>DRAWN:</b> AL	<b>CHECKED:</b> JC
<b>PROJECT NO:</b> 180561	<b>SITE:</b> Pickering, ON		<b>REVISION:</b> A

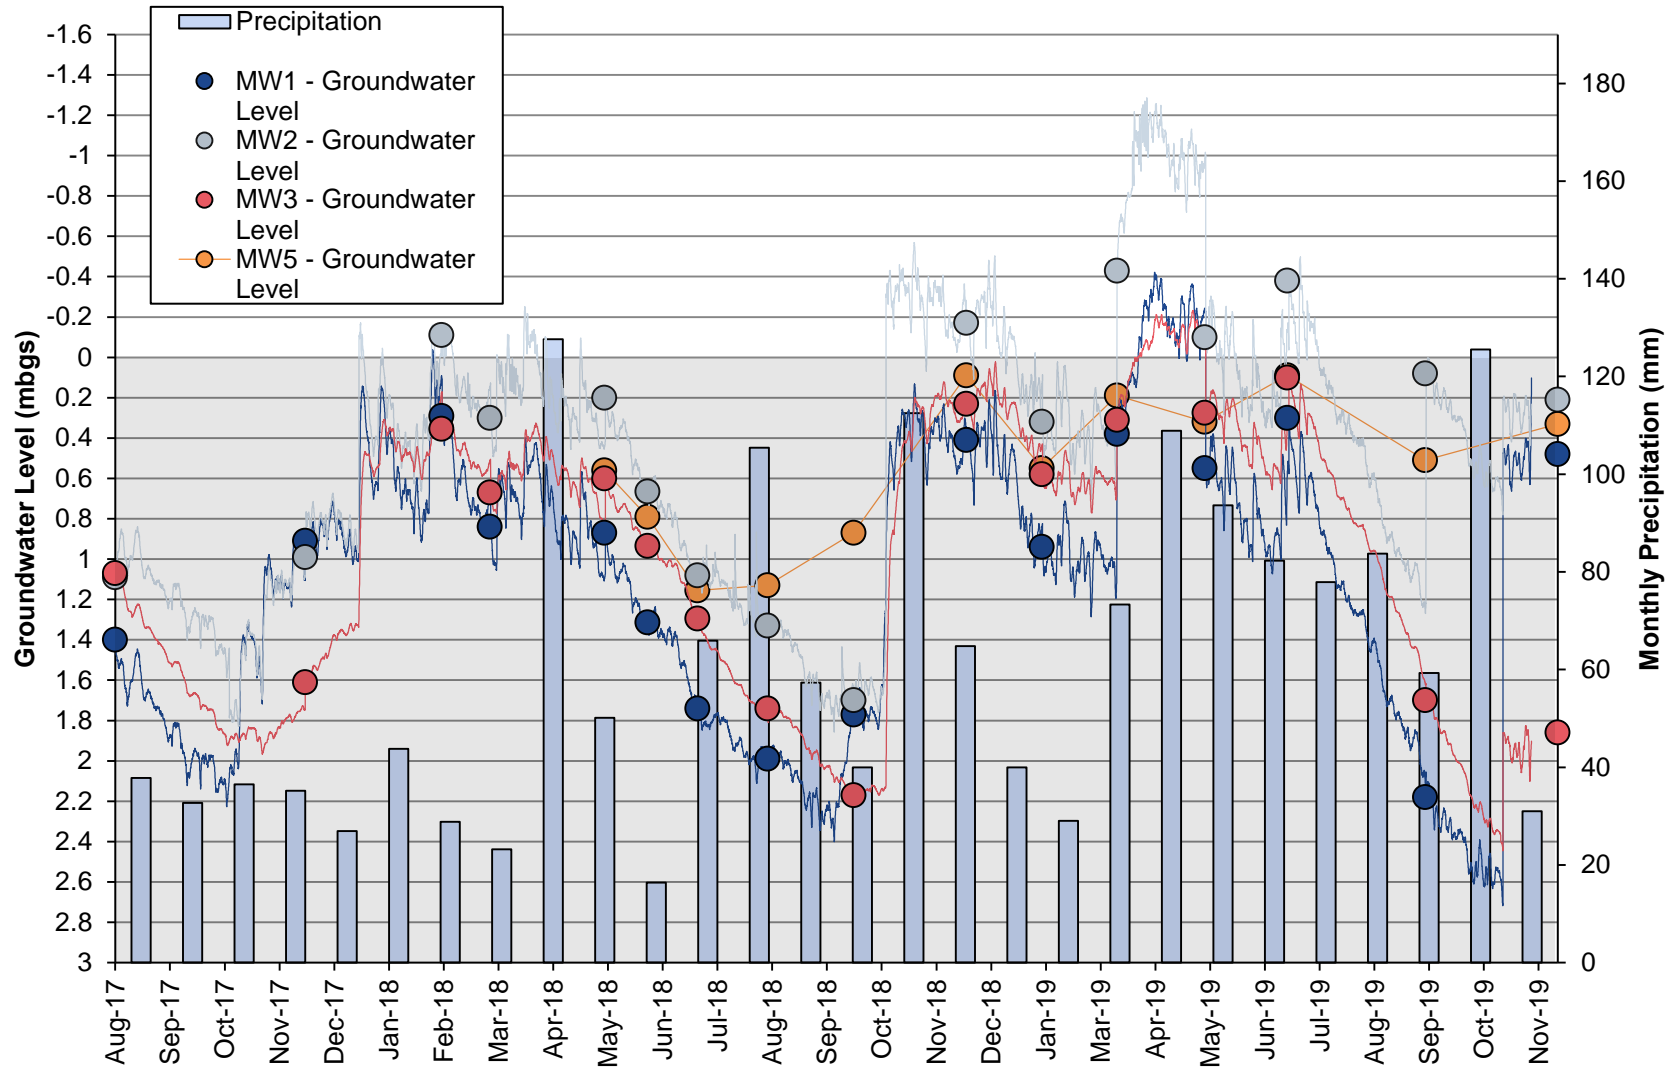
Figure 10. MW1, MW2, MW3, and MW5 Hydrograph (2017 – 2019)

Beginning in August 2017, MW1, MW2, and MW3 were instrumented with Solinst dataloggers to continuously measure groundwater levels, and a bi-monthly manual monitoring program for all wells in the study area was initiated. The continuous water level and manual data collected at all monitoring wells between August 2017 and November 2019 data are presented graphically in **Figure 10**. Manual data collected from the newly installed wells from 2018 are presented in **Figure 11**. Groundwater level monitoring results from all MWs at the site are found in **Table 2** and **Table 3**.

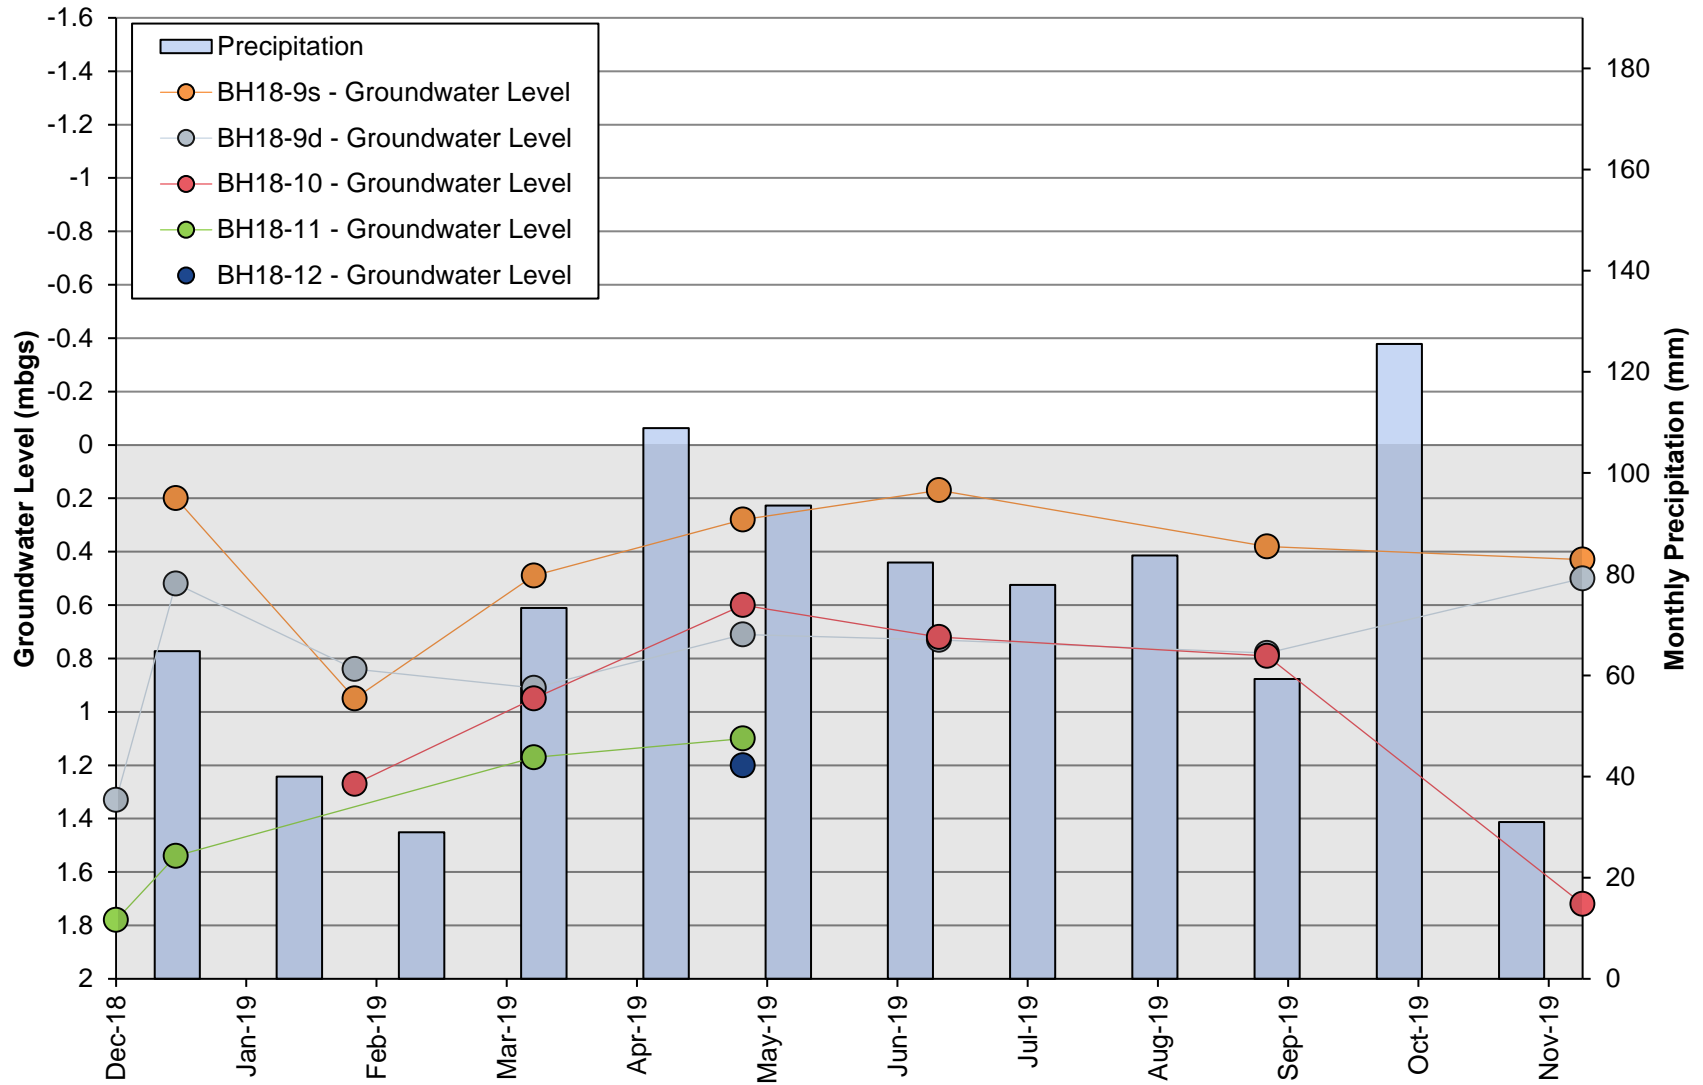
Figure 11. BH18-9s, BH18-9d, BH18-10, BH18-11, BH18-12 Manual Groundwater Levels (2018 – 2019)

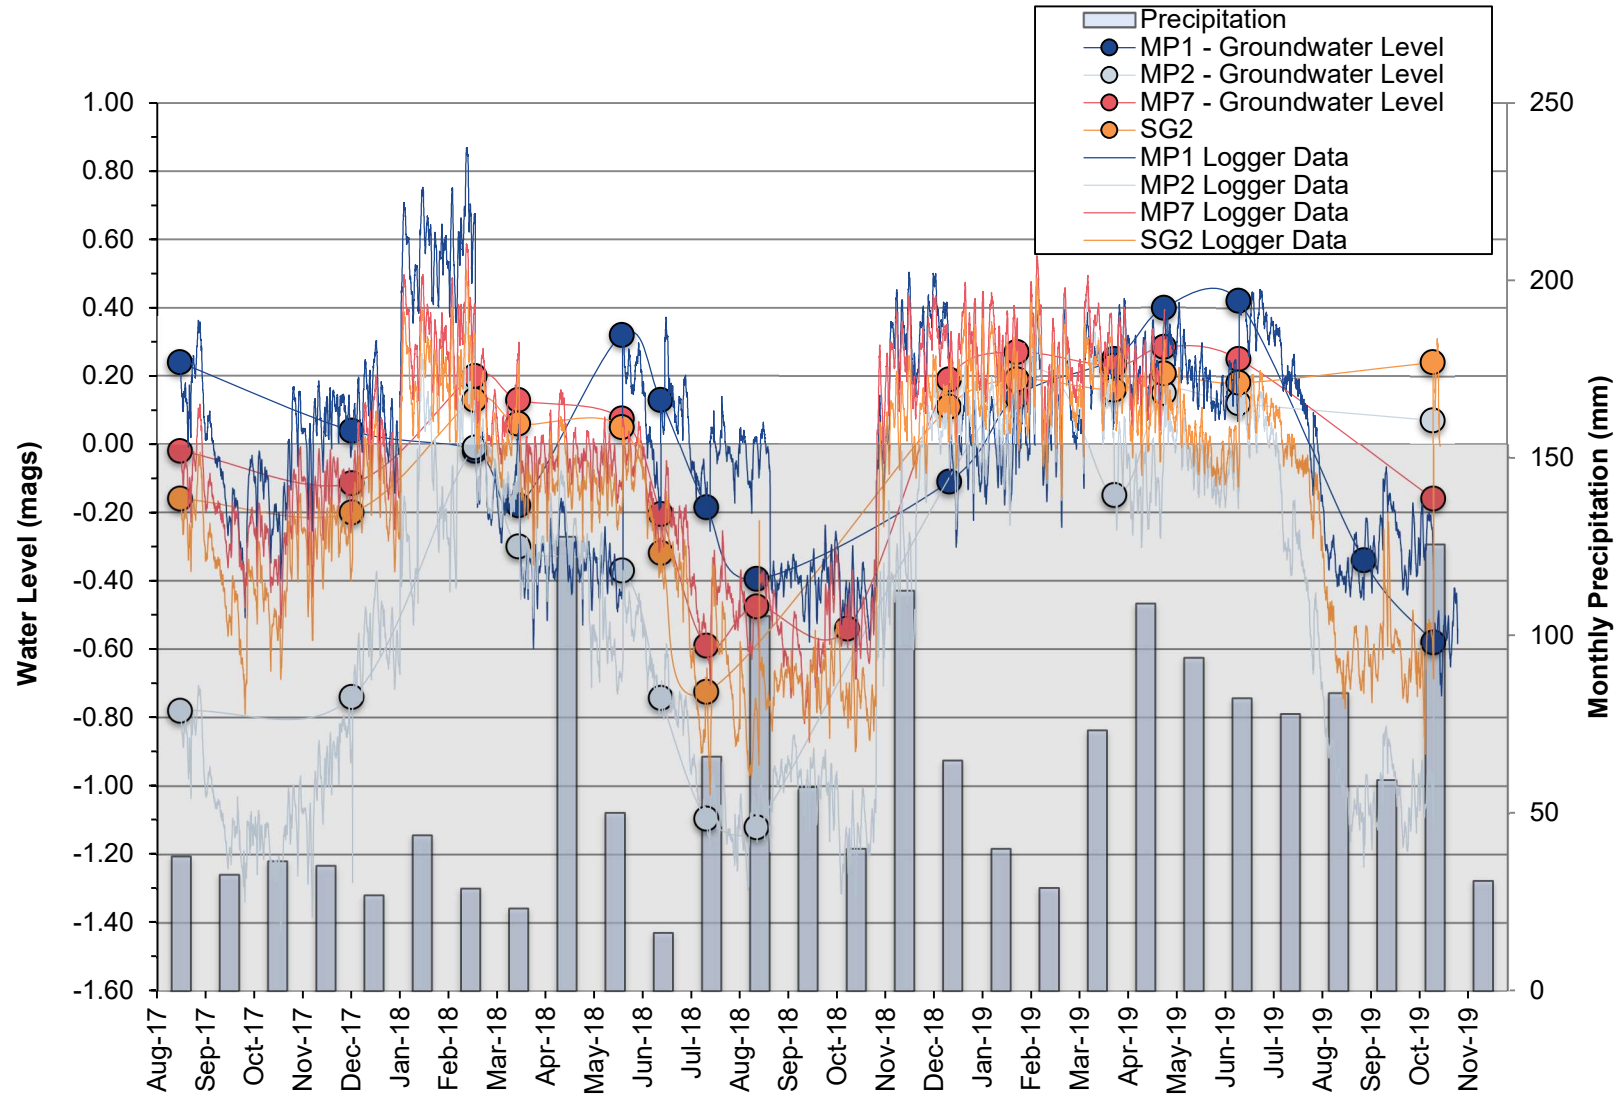
Figure 13. Wetland Hydrograph (MP1, MP2, MP7, and SG2) (2017 – 2019)

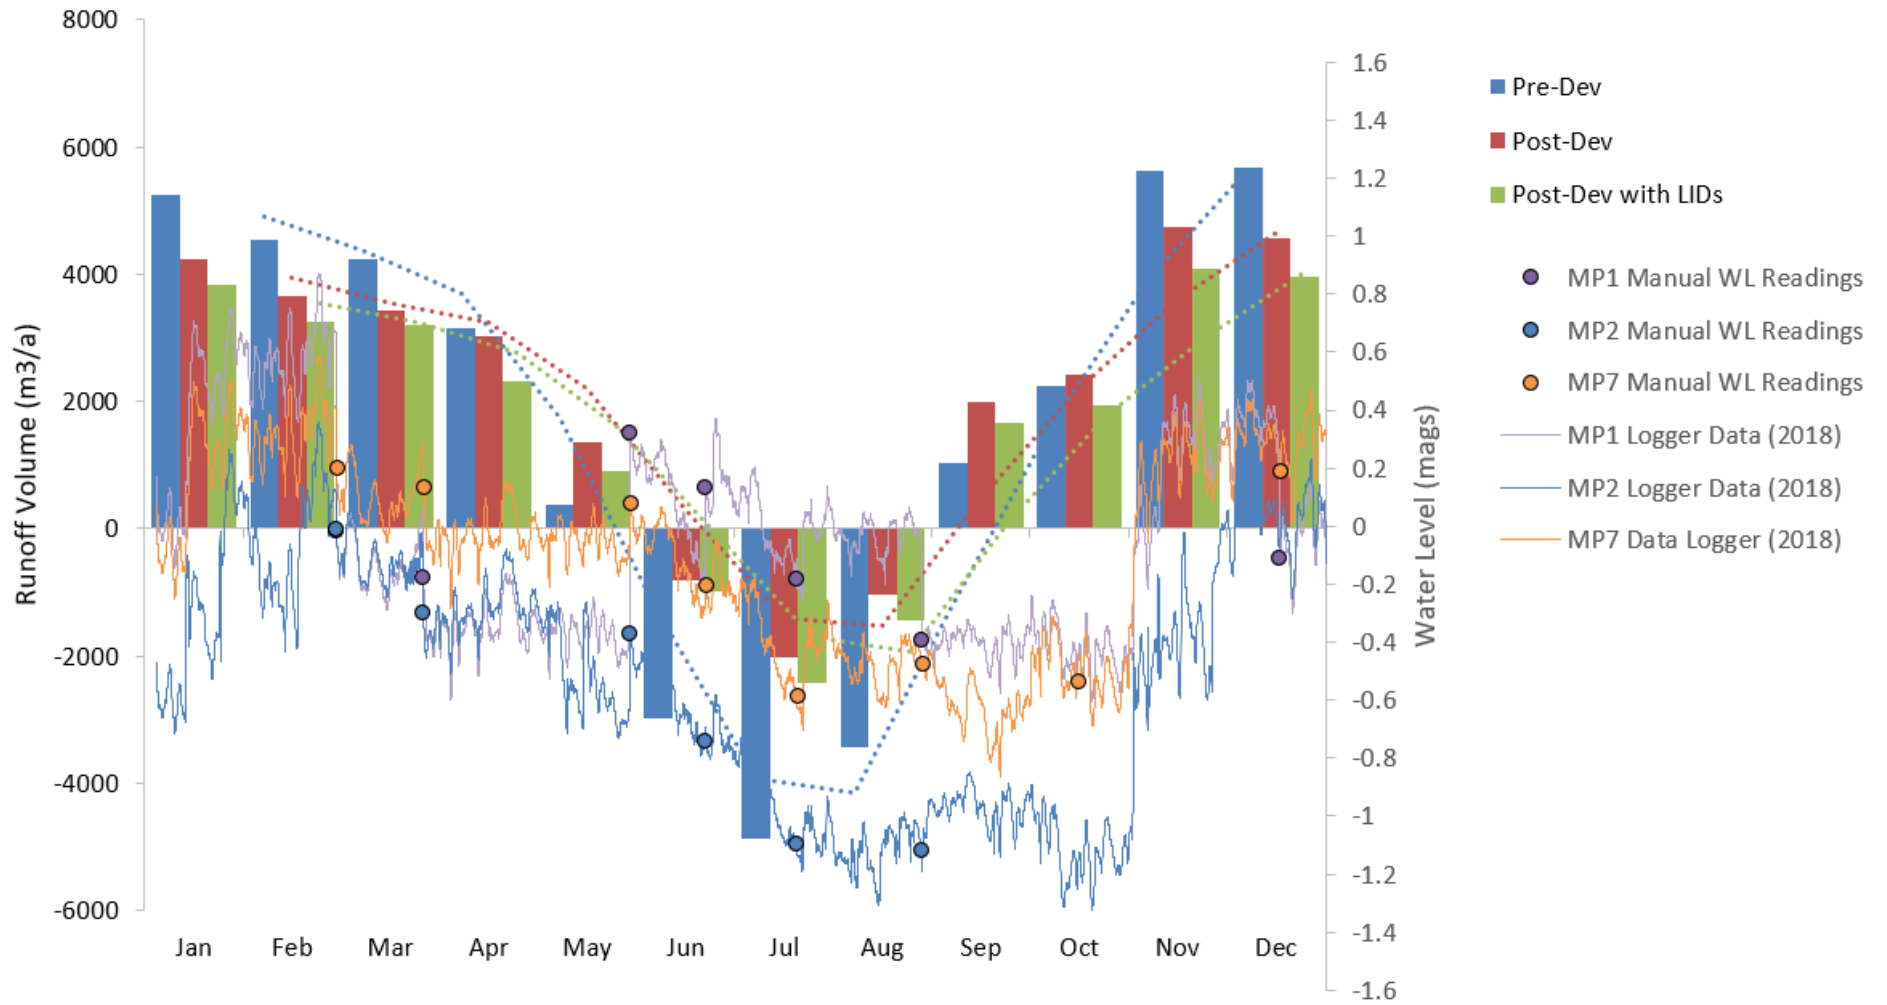
Figure 19. C2 Catchment – Eastern SWD3-2 Pre- and Post-Development Monthly Runoff Volume

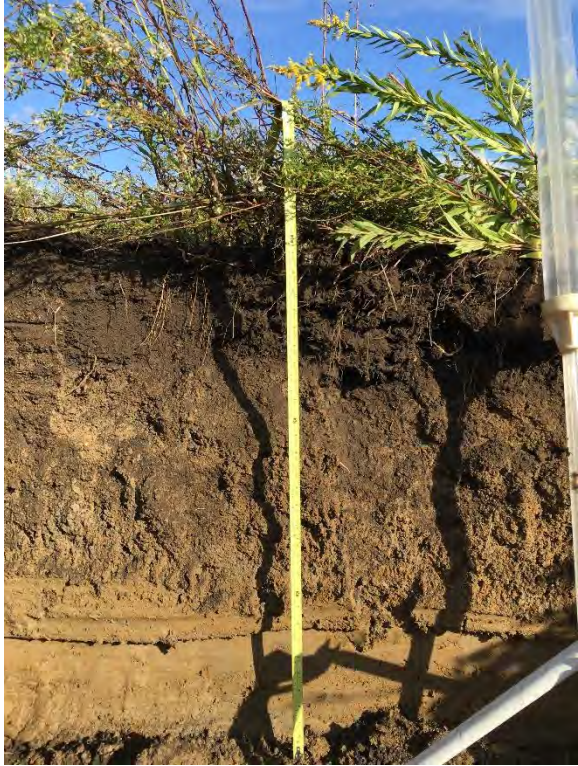
<i>Photo #:</i> <b>1</b>	<i>Date:</i> 9/24/2019

<i>Direction Photo Taken</i>		
<b>Description</b> TP 1 Shallow (PL1 Storm Tech System) Depth of Pit: 0.94 m
