City of Pickering

Schedule B Municipal Class Environmental Assessment – Project File Pine Creek Erosion Assessment

Aquafor Beech Ltd.

Published: May 10th, 2024

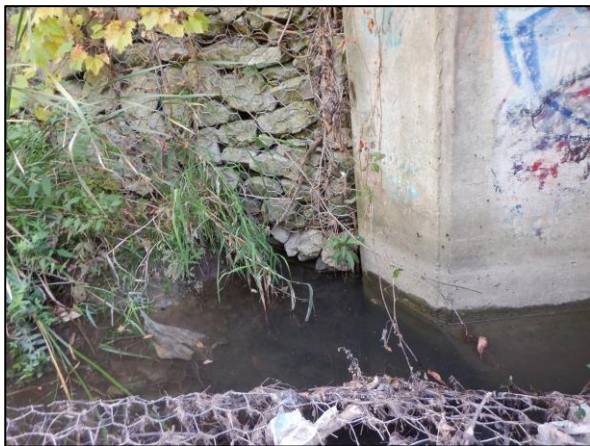
A number of erosion related risks to municipal and regional infrastructure are present including undermining of the gabion basket retaining wall that adjoins Kingston Road (Erosion Site #1 – **Figure 2-2**), outflanking of a 1,700 mm diameter storm sewer outfall headwall (Erosion Site #3 – **Figure 2-4**), and active bank erosion beneath a pedestrian bridge crossing leading to exposure of the bridge footings (Erosion Site #4 – **Figure 2-5**). Backwatering upstream of the beaver dam has also contributed to saturation and sloughing of the upstream channel banks creating an erosion risk to the private properties that border the channel corridor (Erosion Site #2 – **Figure 2-3**). It should be noted that proposed rehabilitation works to address the risks identified at Site #1 are included in the detailed design of the BRT project, which is currently being undertaken by the Region of Durham. These works will be coordinated between the City of Pickering and the Region to ensure that improvements effectively mitigate long-term erosion.

Figure 2-2: Erosion Site #1 – Undermined Gabion Baskets Upstream of Kingston Rd.

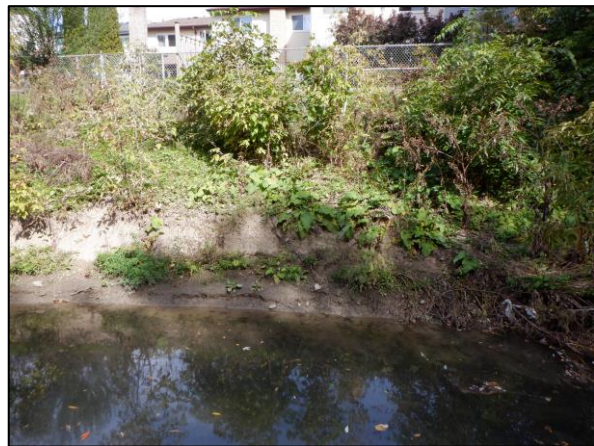
Figure 2-3: Erosion Site #2 – Bank Erosion Risk to Private Properties

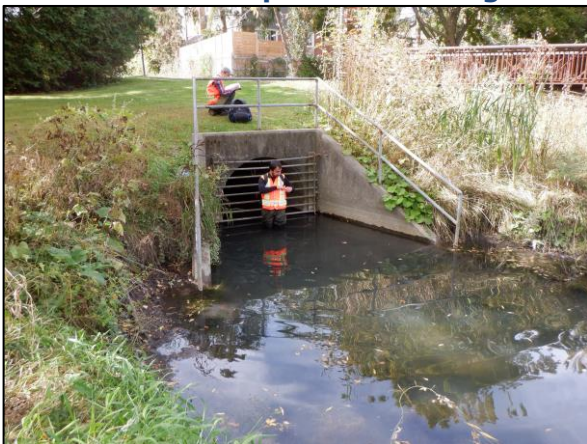
Figure 2-4: Erosion Site #3 – Outflanking of Concrete Wingwalls due to Erosion.

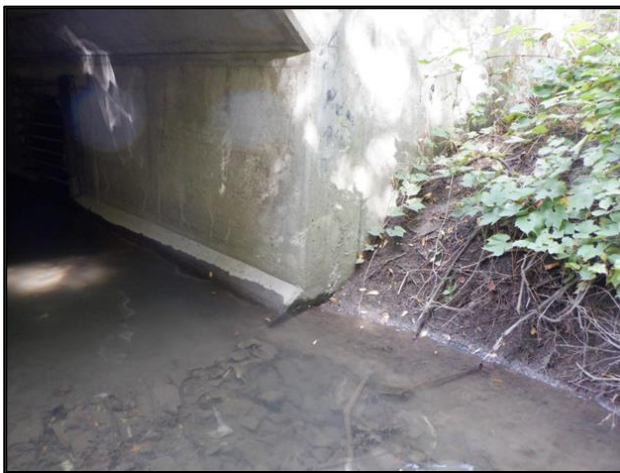
Figure 2-7: Erosion Site #5 – Minor Bank Erosion Downstream of the Glenanna Road Culvert Crossing.

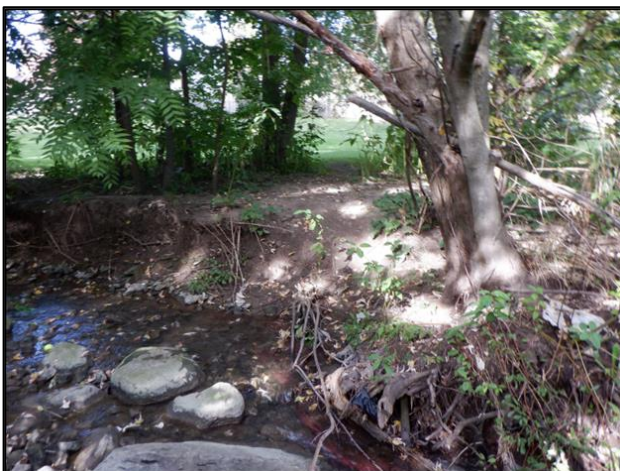
Figure 2-9: Erosion Site #7 – Over Encroachment into the Riparian Corridor Leading to Bank Erosion and a Risk to Parkland.

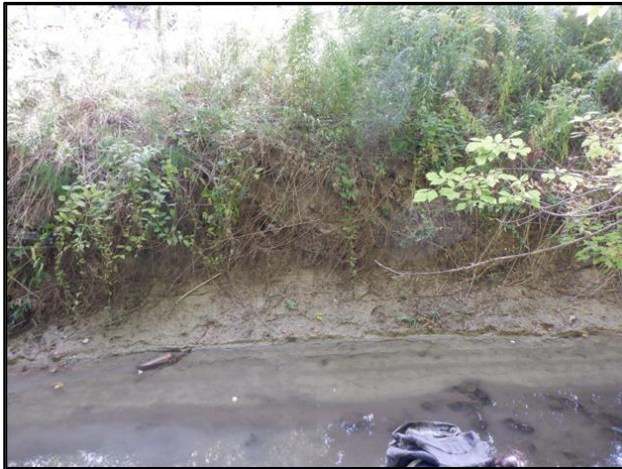
Figure 2-12: Erosion Site #9 – Active Bank Erosion Adjacent to a Multi-Use Trail System

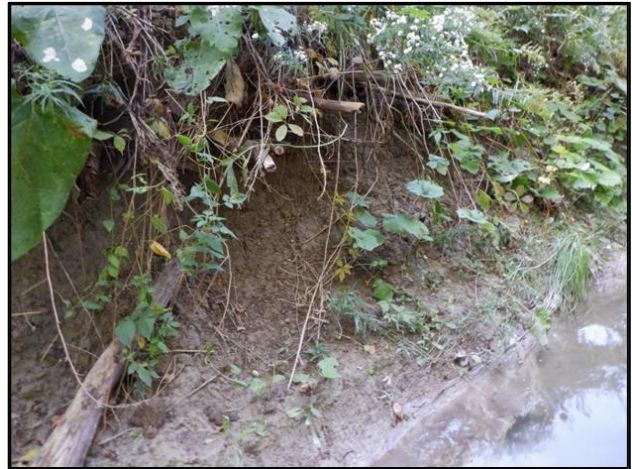
Figure 2-13: Erosion Site #10 – Major Erosion Scar Adjacent to a Multi-Use Trail System

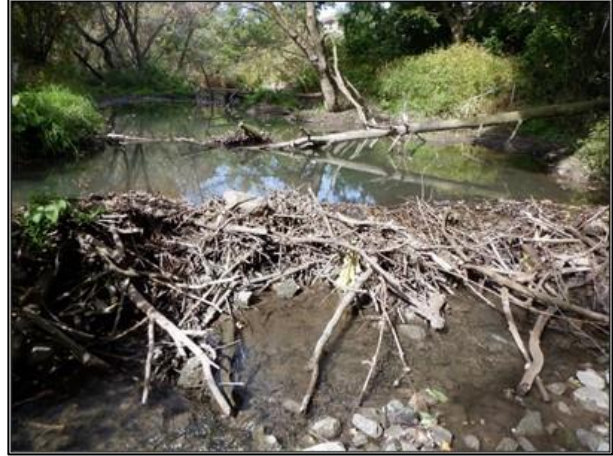
Figure 3-3: Beaver Dam Upstream of Kingston Road Culvert Causing Backwatering of the Reach Upstream.

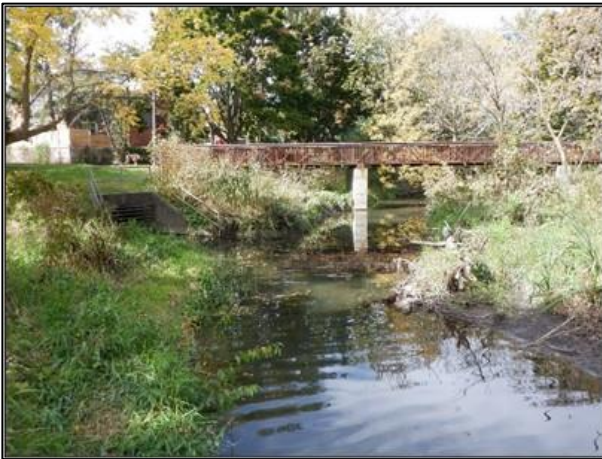
Figure 3-4: Backwater Effects from Beaver Dam Affecting Storm Outfall and Pedestrian Bridge Abutments Upstream.

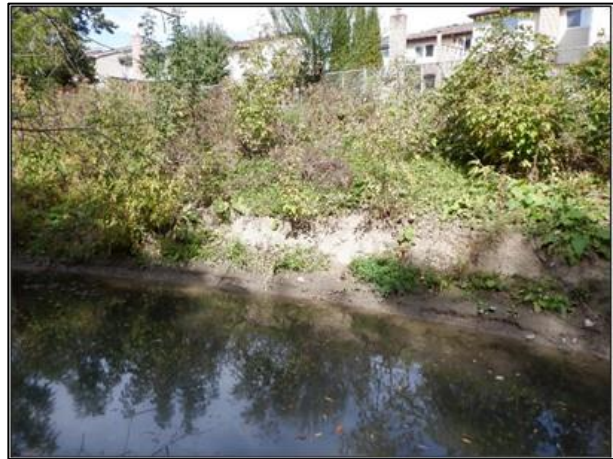
Figure 3-5: Unlined Channel with Sandy Banks Eroding at Meander less than 5m from Private Property.

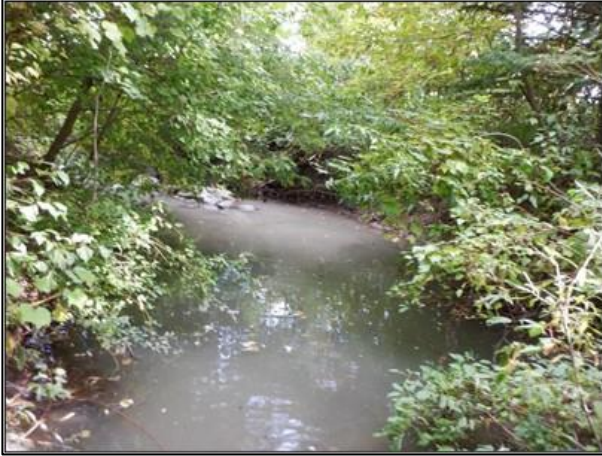
Figure 3-6: Looking Downstream at a Meander Bend with Dense Riparian Overbank Visible and Small to Medium Boulders Present within the Channel Bed.

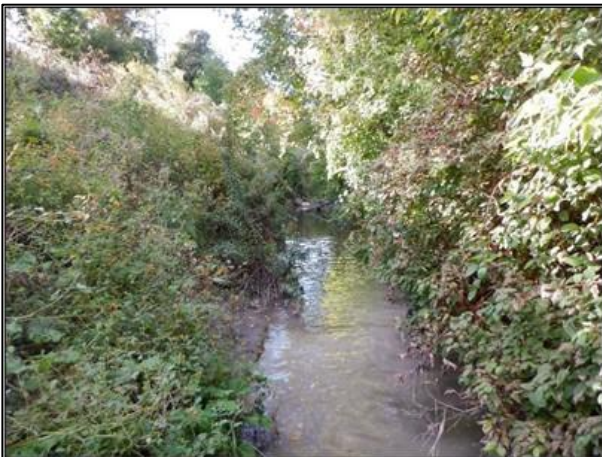
Figure 3-8: Looking Upstream at the Steep Slope Adjacent to City Owned Trail on the North Easterly Bank

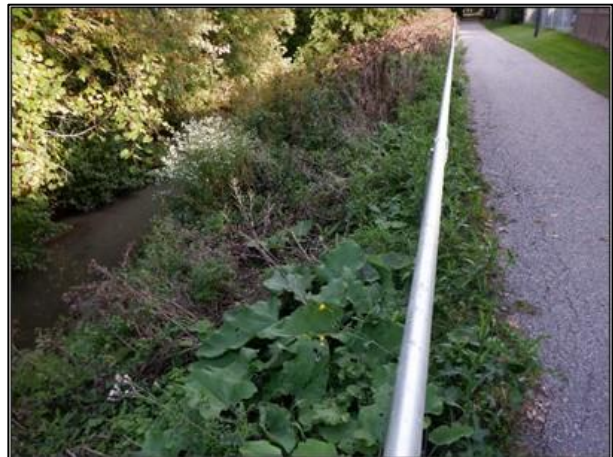
Figure 3-9: Looking Downstream from Trail Which is Within 2.0 m of Channel. Erosion Taking Place at the Toe of the Over Steepened Bank.

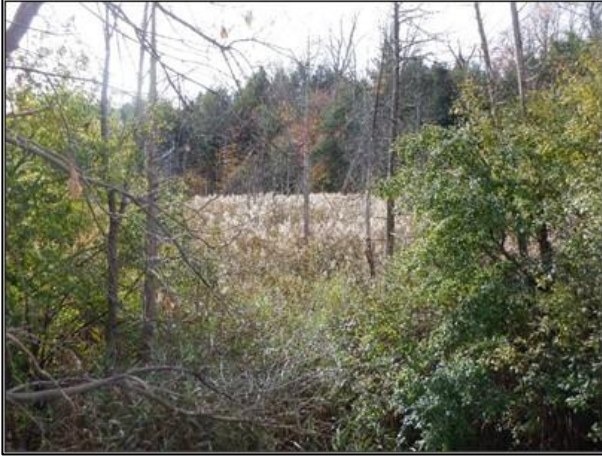
Figure 3-10: Looking Upstream at Wetland Through Which the Channel Passes.

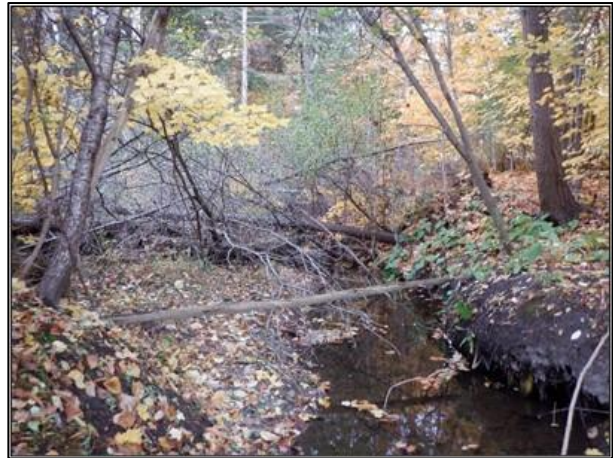
Figure 3-13: Looking Upstream at Natural Riparian Corridor Filled with Dense Trees and Shrubs. Bank Erosion Taking Place and Large Woody Debris Fallen into the Channel Obstructing Flow.

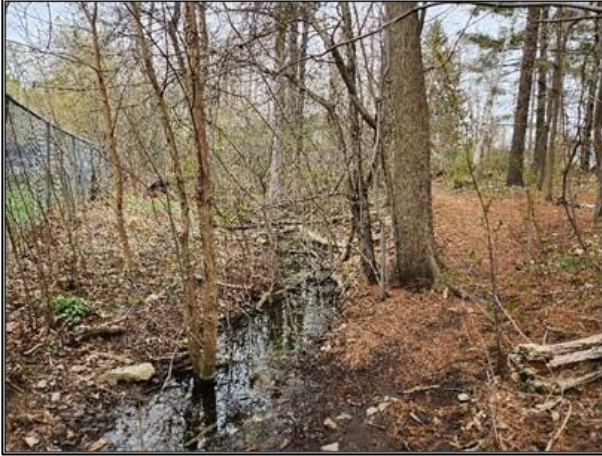
Figure 3-14: Looking Upstream Near the Midpoint of the Reach. Note bed materials consisting of fine to medium sand and sandy loam.

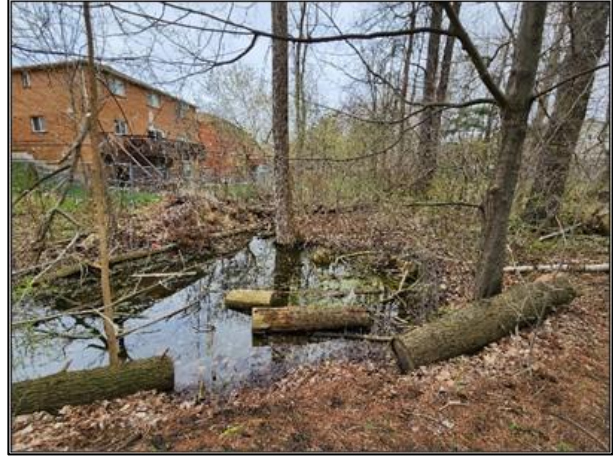
This reach lacks pool – riffle morphology and consists of low-lying areas where the watercourse transitions between channelized and un-channelized forms (**Figure 3-15**). Overall, the reach is characteristic of a poorly defined urban drainage ditch, with a heterogenous cross-sectional area along its length and intermittent access to the adjacent floodplain. There has been a significant accumulation of debris within the ravine corridor (**Figure 3-16**) as a result of local dumping and the failure of mature vegetation due to active erosion processes. The aforementioned debris jams are contributing to increased erosion and migration of the channel centerline, which has in turn caused encroachment towards private property (**Figure 3-17**) leading to a series of residential complaints related to erosion and flooding issues.

Figure 3-15: Looking Upstream at a Segment of the Kitley Ravine where the Channel Corridor is Poorly Defined.

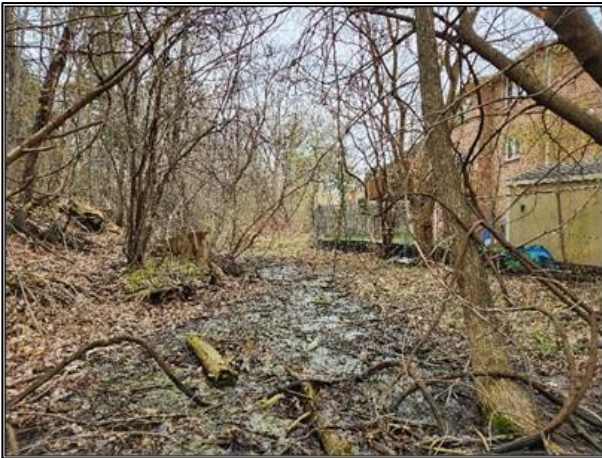
Figure 3-16: Looking Downstream Towards Accumulated Debris.

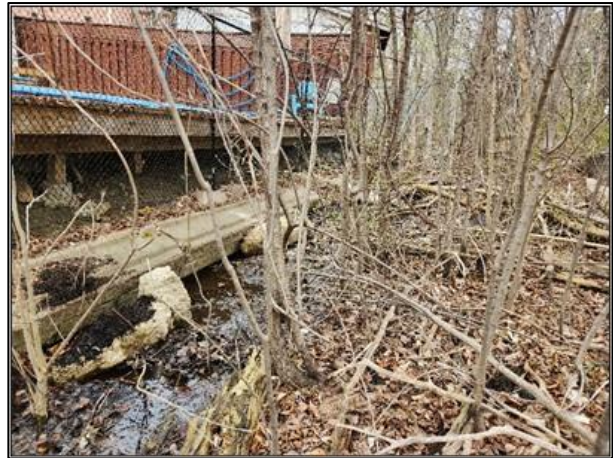
Figure 3-17: Looking Upstream near the Midpoint of the Reach. Note Encroachment of the Channel Towards Private Property.

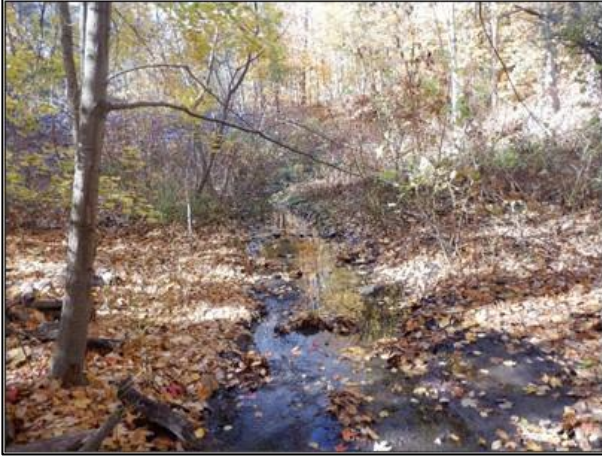
Figure 3-18: Looking Upstream at Channel with Shallow Banks Where Channel has Access to a Wide Floodplain

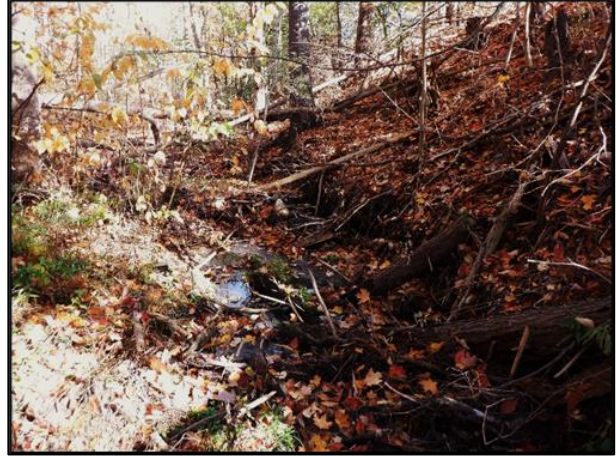
Along this reach, several cutbank erosion scars are notable, exposed tree roots are prevalent within the eroded banks, and large woody jams are observed as seen in **Figure 3-19**. This photo also shows that severe undermining of the toe of slope is present throughout the extent of the reach. Also present are areas of extensive bank slumping where channel planform migration and erosion has occurred (**Figure 3-20**). Island formation has taken place due to the large woody debris in the channel obstructing flow and causing sediment accumulation (**Figure 3-21**). The watercourse has full access to its floodplain through most of the reach, however; the channel is partially confined with steep valley walls through some areas. Geomorphic adjustment is taking place as a result of urban hydromodification which drives processes of channel widening, planform adjustment, and degradation in response to higher peak flows, greater runoff volumes, and more frequent flow events.

Figure 3-19: Looking Downstream at Steep Valley Slope where Cutbank Erosion Scars are Notable as well as Leaning and Fallen Trees within the Channel

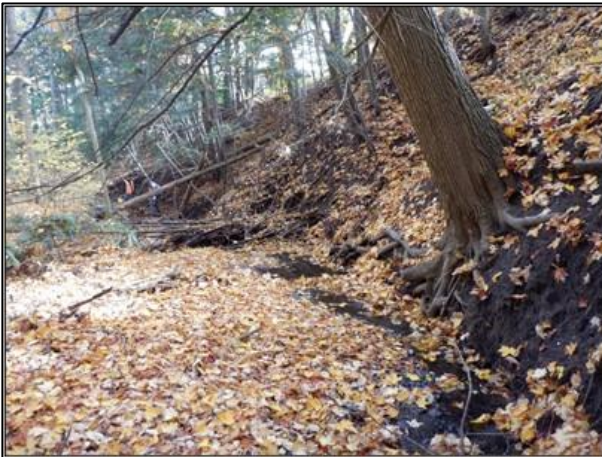
Figure 3-20: Looking Downstream at Channel Where Bank Erosion is Occurring on Meander Bends and Steep Valley Slopes

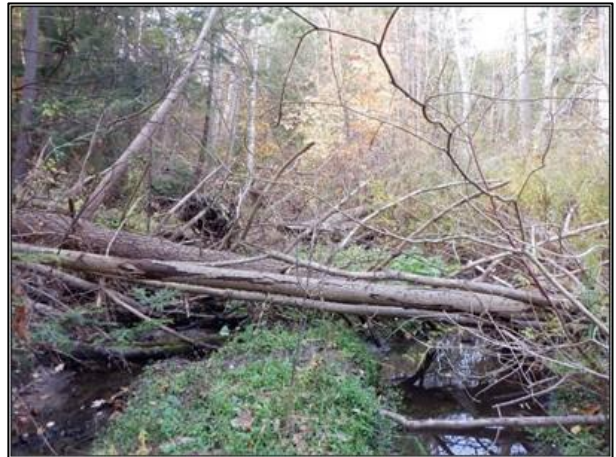
Figure 3-21: Looking Upstream at Large Woody Debris Obstructing Flow. Island Formation Taken Place Due to the Resulting Sediment Accumulation.

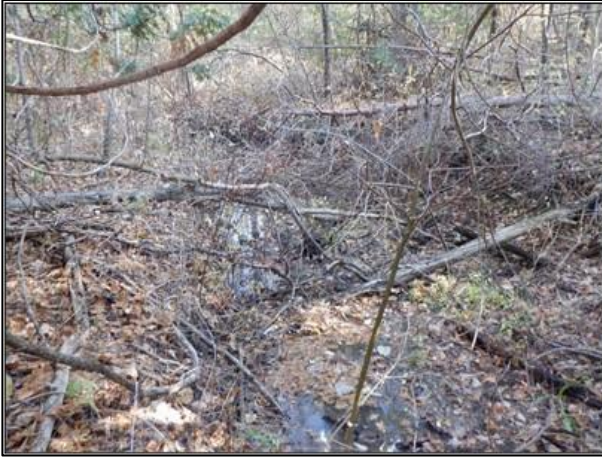
Reach PC4b extends from Lynn Heights Drive to the confluence downstream of Finch Avenue. The reach consists of a heavily vegetated channel where the riparian corridor is unmaintained, filled with dense trees and shrubs, and has multiple debris jams throughout the extent of the reach (**Figure 3-22**). The bed material ranges from of silt to fine sand and coarse gravel to small boulders. The bank material consists of silt to fine upper sand. The bankfull width ranges from 3 – 6 m and the bankfull depth ranges from 0.5 – 1.5 m. The reach has moderate to high sinuosity with a sinuosity index of 1.21.

Figure 3-22: Looking Downstream at Heavily Vegetated Channel. Multiple debris jams throughout the reach.

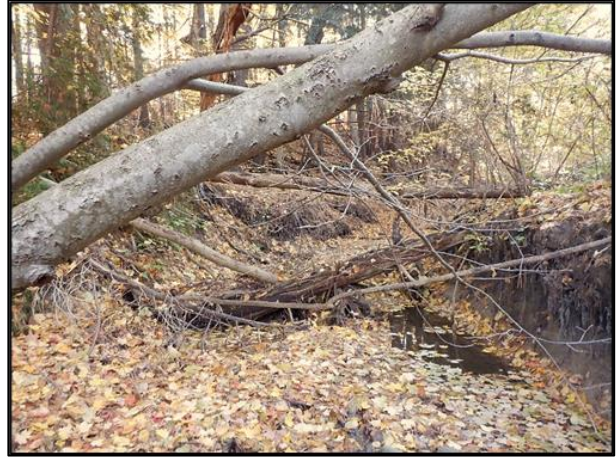
Along this reach, severe cutbank erosion scars are notable (**Figure 3-23**). There are several areas with extensive bank slumping occurring due to the steep slopes where channel planform migration and erosion is evident (**Figure 3-24**). Exposed tree roots are prevalent within the eroded banks and many fallen trees are present (**Figure 3-25**). Through this reach, the channel has varying access to the floodplain. Due to the densely vegetated banks towards the upstream extent of the reach, the channel has become intensely entrenched and does not have access to its floodplain. The watercourse towards the middle of the reach and sparsely throughout the downstream extent however, has access to a wide floodplain where the banks are shallow.

Figure 3-23: Looking Downstream at Channel where 1.2 m Deep Cutbank Erosion Scar can be Seen on the Right Bank and Another on the Left Bank in the Background.

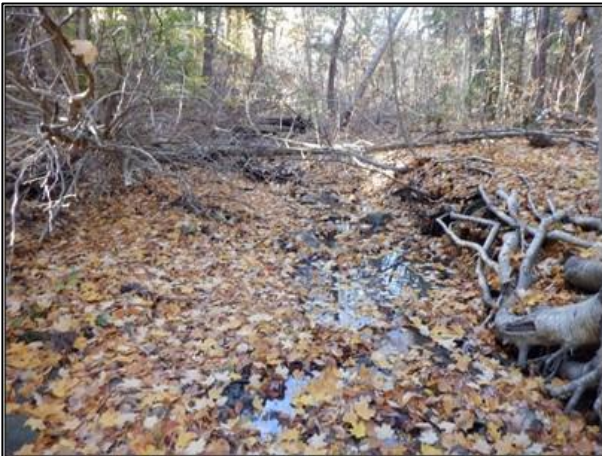
Figure 3-24: Looking Upstream of Channel Where Exposed Tree Roots Through the Banks are Visible.

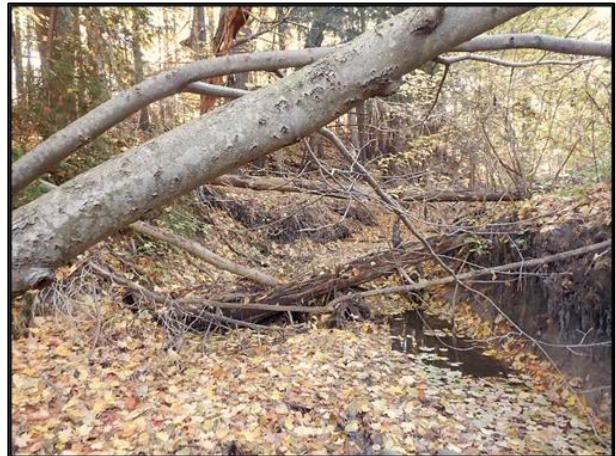
Geomorphic adjustment is occurring throughout the reach where channel widening and severe downcutting is evident. The watercourse is attempting to meander which is resulting in channel widening and severe bank erosion that is causing trees to fall in creating woody debris jams at many locations within the reach.

Figure 3-25: Erosion on the Outside of the Meander Bend Looking at the North Easterly Bank. Leaning Trees and Exposed Tree Roots Visible.
