INSPECTION CONDUCTED ON AUGUST 15, 2023 BY MIKE HUKUZALIE - ISA CERTIFIED ARBORIST No. ON-2408A
SURVEY INFORMATION PROVIDED BY JD BARNES AS OF SEPTEMBER 11, 2023

Project Name: 1101A, 1105, 1163 Kingston Road
Municipality: Town of Pickering

Sheet Title: Tree Inventory Plan

Job No: TRC148
Designed: ND / MH / MH
Drawn: ND / MH / MH
Date: October 19, 2023
Scale: 1:1000
Drawing No.: TP-1

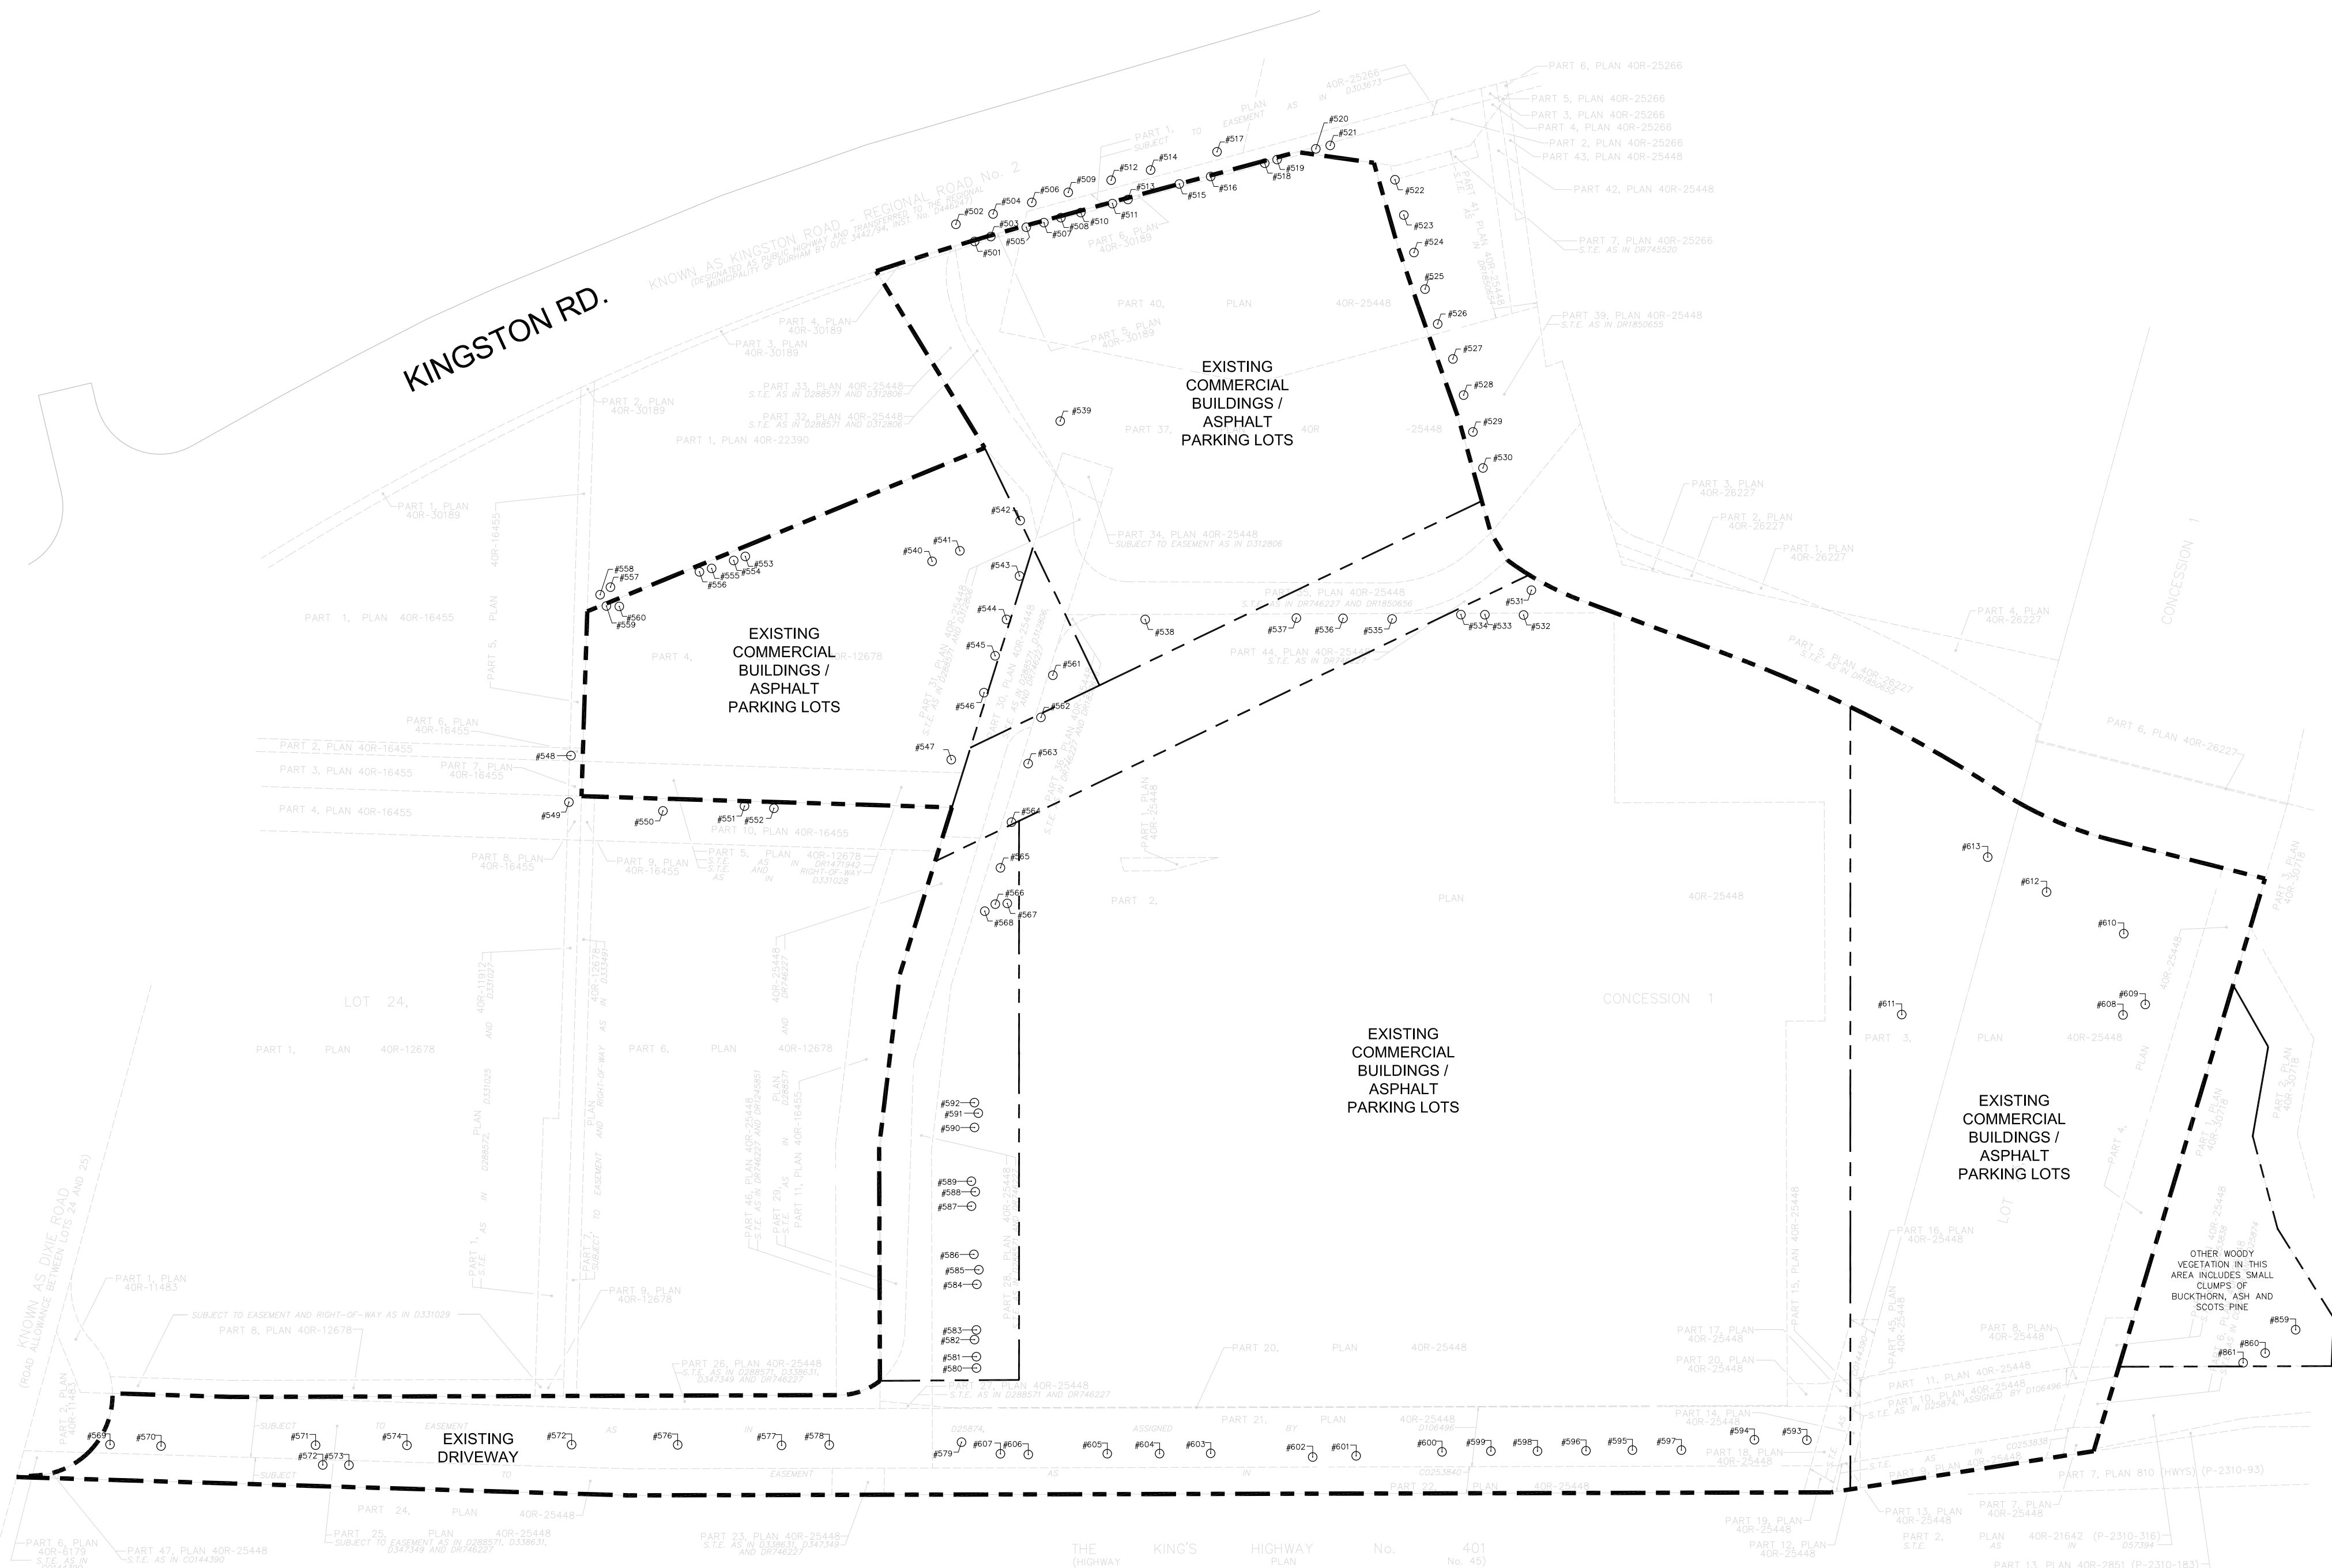
TAG #	BOTANICAL NAME	COMMON NAME	DBH (cm)	CNPY. SPR (m)	COND.	REMARKS	PRES. STATUS
501	<i>Amelanchier canadensis</i>	Serviceberry	11	3	Fair		TBD
502	<i>Acer rubrum</i>	Red Maple	8	2	Terminal Decline	75% dead	TBD
503	<i>Amelanchier canadensis</i>	Serviceberry	10	4	Good	Planted high	TBD
504	<i>Acer ginnala</i>	Amur Maple	12	3	Poor	Frost crack, many dead branches	TBD
505	<i>Amelanchier canadensis</i>	Serviceberry	8	3	Good		TBD
506	N/A	N/A	5	1	Dead		TBD
507	<i>Amelanchier canadensis</i>	Serviceberry	8	4	Good		TBD
508	<i>Amelanchier canadensis</i>	Serviceberry	8	3	Good		TBD
509	<i>Acer ginnala</i>	Amur Maple	18	6	Fair	Exposed roots, slight damage to trunk	TBD
510	<i>Amelanchier canadensis</i>	Serviceberry	5	2	Good		TBD
511	<i>Amelanchier canadensis</i>	Serviceberry	8	4	Good		TBD
512	N/A	N/A	7	3	Dead		TBD
513	<i>Amelanchier canadensis</i>	Serviceberry	8	3	Good		TBD
514	<i>Acer ginnala</i>	Amur Maple	14	5	Good		TBD

515	<i>Acer ginnala</i>	Amur Maple	13	3	Good		TBD
516	<i>Acer ginnala</i>	Amur Maple	12	3	Good		TBD
517	<i>Acer ginnala</i>	Amur Maple	23	5	Fair	Measured at 0.3m height, co-dominant at 0.3m height	TBD
518	<i>Amelanchier canadensis</i>	Serviceberry	6	2	Poor	Few dead branches	TBD
519	<i>Amelanchier canadensis</i>	Serviceberry	3	1	Good		TBD
520	<i>Amelanchier canadensis</i>	Serviceberry	7	2	Poor	Poor vigor	TBD
521	<i>Amelanchier canadensis</i>	Serviceberry	7	2	Poor	Lean	TBD
522	<i>Gleditsia triacanthos</i>	Honeylocust	7	4	Good		TBD
523	<i>Gleditsia triacanthos</i>	Honeylocust	6	4	Good		TBD
524	<i>Gleditsia triacanthos</i>	Honeylocust	6	5	Good		TBD
525	<i>Gleditsia triacanthos</i>	Honeylocust	6	3	Good		TBD
526	<i>Gleditsia triacanthos</i>	Honeylocust	5	4	Good		TBD
527	<i>Gleditsia triacanthos</i>	Honeylocust	7	4	Good		TBD
528	<i>Gleditsia triacanthos</i>	Honeylocust	7	3	Good		TBD
529	<i>Gleditsia triacanthos</i>	Honeylocust	6	3	Good		TBD

530	<i>Gleditsia triacanthos</i>	Honeylocust	6	4	Fair	Damage at base	TBD
531	<i>Gleditsia triacanthos</i>	Honeylocust	13	6	Good		TBD
532	<i>Amelanchier canadensis</i>	Serviceberry	5	2	Fair	Insect damage in bark	TBD
533	<i>Amelanchier canadensis</i>	Serviceberry	6	2	Good		TBD
534	<i>Amelanchier canadensis</i>	Serviceberry	6	2	Good		TBD
535	<i>Pyrus sp.</i>	Pear	8	2	Fair		TBD
536	<i>Pyrus sp.</i>	Pear	10	2	Poor	Leader dead	TBD
537	<i>Pyrus sp.</i>	Pear	10	2	Fair	Slight dieback	TBD
538	<i>Pyrus sp.</i>	Pear	13	3	Fair		TBD
539	<i>Celtis occidentalis</i>	Hackberry	23	7	Good		TBD
540	<i>Acer saccharum</i>	Sugar Maple	6	3	Terminal Decline	80% dead	TBD
541	<i>Acer saccharum</i>	Sugar Maple	7	4	Fair		TBD
542	<i>Pyrus sp.</i>	Pear	13	4	Terminal Decline	90% dead, measured from 0.9m height	TBD
543	<i>Pyrus sp.</i>	Pear	12	3	Fair		TBD
544	<i>Pyrus sp.</i>	Pear	14	3	Fair		TBD
545	<i>Pyrus sp.</i>	Pear	12	3	Fair		TBD
546	<i>Pyrus sp.</i>	Pear	14	3	Fair		TBD

547	<i>Pyrus sp.</i>	Pear	15	3	Fair		TBD
548	<i>Gleditsia triacanthos</i>	Honeylocust	32	8	Good		TBD
549	<i>Gleditsia triacanthos</i>	Honeylocust	30	8	Good		TBD
550	<i>Acer saccharinum</i>	Silver Maple	7	3	Poor	Slight damage to leader / trunk	TBD
551	<i>Ginkgo biloba</i>	Ginkgo	6	2	Good		TBD
552	<i>Ginkgo biloba</i>	Ginkgo	6	2	Good		TBD
553	<i>Picea pungens</i>	Colorado Spruce	16	3	Fair		TBD
554	<i>Picea pungens</i>	Colorado Spruce	15	3	Fair	Twist in stem	TBD
555	<i>Picea pungens</i>	Colorado Spruce	15	4	Dead		TBD
556	<i>Picea pungens</i>	Colorado Spruce	8	2	Good		TBD
557	<i>Picea pungens</i>	Colorado Spruce	15	3	Poor	Dieback	TBD
558	<i>Picea pungens</i>	Colorado Spruce	15	3	Fair		TBD
559	<i>Picea pungens</i>	Colorado Spruce	12	3	Fair		TBD
560	<i>Picea pungens</i>	Colorado Spruce	13	3	Poor	Dieback	TBD
561	<i>Gleditsia triacanthos</i>	Honeylocust	15	5	Fair	Few dead branches	TBD
562	<i>Gleditsia triacanthos</i>	Honeylocust	15	5	Good		TBD

563	<i>Gleditsia triacanthos</i>	Honeylocust	13	4	Good		TBD
564	<i>Gleditsia triacanthos</i>	Honeylocust	19	6	Good		TBD
565	<i>Gleditsia triacanthos</i>	Honeylocust	23	10	Good		TBD
566	<i>Picea pungens</i>	Colorado Spruce	15	3	Fair		TBD
567	<i>Picea pungens</i>	Colorado Spruce	18	3	Fair		TBD
568	<i>Picea pungens</i>	Colorado Spruce	16	3	Fair		TBD
569	<i>Quercus alba</i>	White Oak	27	6	Good		TBD
570	<i>Celtis occidentalis</i>	Hackberry	12	5	Good		TBD
571	<i>Celtis occidentalis</i>	Hackberry	13	3	Good		TBD
572	<i>Pinus strobus</i>	White Pine	12	4	Good		TBD
573	<i>Pinus strobus</i>	White Pine	12	3	Good		TBD
574	<i>Celtis occidentalis</i>	Hackberry	10	3	Good		TBD
575	<i>Celtis occidentalis</i>	Hackberry	8	2	Good		TBD
576	<i>Celtis occidentalis</i>	Hackberry	10	3	Good		TBD
577	<i>Celtis occidentalis</i>	Hackberry	14	3	Good		TBD
578	<i>Quercus alba</i>	White Oak	28	3	Good		TBD
579	<i>Quercus alba</i>	White Oak	28	8	Good		TBD

580	<i>Picea pungens</i>	Colorado Spruce	17	3	Good		TBD
581	<i>Picea pungens</i>	Colorado Spruce	16	3	Good		TBD
582	<i>Picea pungens</i>	Colorado Spruce	17	3	Good		TBD
583	<i>Picea pungens</i>	Colorado Spruce	15	3	Good		TBD
584	<i>Picea pungens</i>	Colorado Spruce	20	3	Good		TBD
585	<i>Picea pungens</i>	Colorado Spruce	15	3	Good		TBD
586	<i>Picea pungens</i>	Colorado Spruce	14	3	Good		TBD
587	<i>Picea pungens</i>	Colorado Spruce	18	3	Good		TBD
588	<i>Picea pungens</i>	Colorado Spruce	15	3	Good		TBD
589	<i>Picea pungens</i>	Colorado Spruce	13	2	Good		TBD
590	<i>Picea pungens</i>	Colorado Spruce	16	3	Good		TBD
591	<i>Picea pungens</i>	Colorado Spruce	13	6	Good		TBD
592	<i>Picea pungens</i>	Colorado Spruce	14	6	Good		TBD
593	<i>Celtis occidentalis</i>	Hackberry	18	6	Good		TBD
594	<i>Celtis occidentalis</i>	Hackberry	16	6	Good		TBD
595	<i>Quercus alba</i>	White Oak	4.4	2	Poor	Main stem cut, two suckers now co-dominant stems at base	TBD

596	<i>Quercus alba</i>	White Oak	13	6	Good		TBD
597	<i>Celtis occidentalis</i>	Hackberry	18	5	Fair		TBD
598	<i>Celtis occidentalis</i>	Hackberry	16	5	Good		TBD
599	<i>Celtis occidentalis</i>	Hackberry	18	6	Good		TBD
600	<i>Celtis occidentalis</i>	Hackberry	15	5	Good		TBD
601	<i>Quercus alba</i>	White Oak	26	6	Good		TBD
602	<i>Quercus macrocarpa</i>	Bur Oak	19	6	Good		TBD
603	<i>Celtis occidentalis</i>	Hackberry	18	6	Good		TBD
604	<i>Celtis occidentalis</i>	Hackberry	22	6	Good		TBD
605	<i>Celtis occidentalis</i>	Hackberry	21	6	Good		TBD
606	<i>Quercus alba</i>	White Oak	25	8	Good		TBD
607	<i>Quercus alba</i>	White Oak	27	8	Good		TBD
608	<i>Gleditsia triacanthos</i>	Honeylocust	12	3	Good		TBD
609	<i>Gleditsia triacanthos</i>	Honeylocust	8	3	Good		TBD
610	<i>Celtis occidentalis</i>	Hackberry	6	2	Poor	Leader dead, slight dieback	TBD
611	<i>Gleditsia triacanthos</i>	Honeylocust	8	4	Good		TBD
612	<i>Acer rubrum</i>	Red Maple	10	4	Fair	wires	TBD

613	<i>Celtis occidentalis</i>	Hackberry	6	2	Fair	Few dead branches	TBD
859	<i>Ulmus pumila</i>	Siberian Elm	80	14	Fair	Codominant stems at 2m, within naturalized area	TBD
860	<i>Celtis occidentalis</i>	Siberian Elm	13	3	Fair	Within naturalized area	TBD
861	<i>Celtis occidentalis</i>	Siberian Elm	15	3	Fair	Within naturalized area	TBD
