City of Pickering

Schedule B Municipal Class Environmental Assessment – Project File Pine Creek Erosion Assessment

Aquafor Beech Ltd.

Published: May 10th, 2024

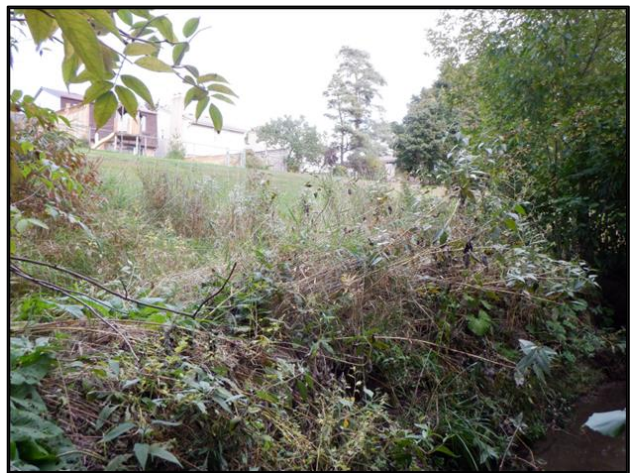
Figure 2-8: Erosion Site #6 – Minor Bank Erosion Creating Risk to Parkland.

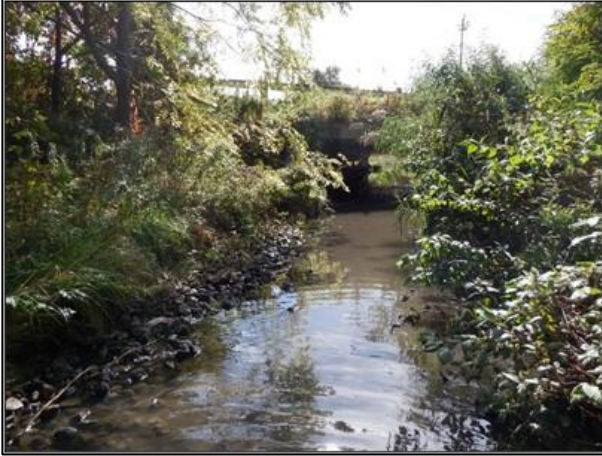
Figure 3-2: Riprap Lined Channel with Dense Riparian Overbank near Kingston Road Culvert.

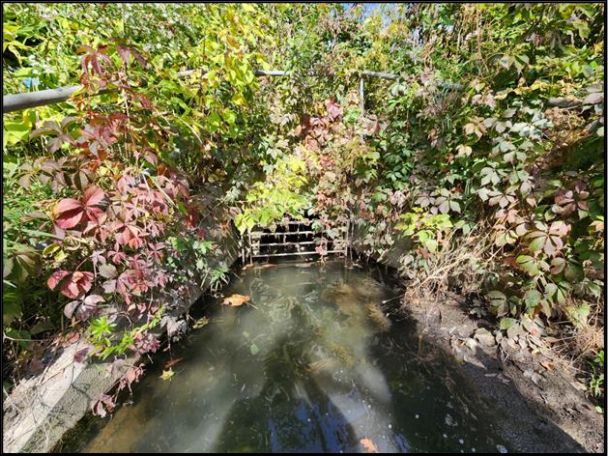
Outfall #	Reach	Asset ID	Diameter (mm)	Material	Construction Year	Condition	Headwall	Erosion Protection Works	Comments	Photo
4	PC3-a	SIO-53-0003	900	Concrete	1976	Fair	Concrete Headwall with Flared Wingwalls and Steel Railing	None	Significant Sedimentation observed within the Outfall Channel ~350 mm backwatering at low flow due to the downstream beaver dam Steel grate in good condition.

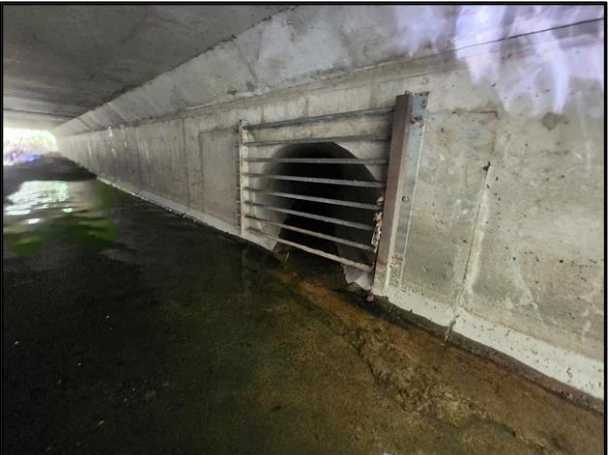
5	PC3-a / PC3-b	SIO-63-0003	1,200	Concrete	1976	Good	None - Outlets inside the Glenanna Road Culvert	None	~100 mm backwatering at low flow Steel grate in good condition

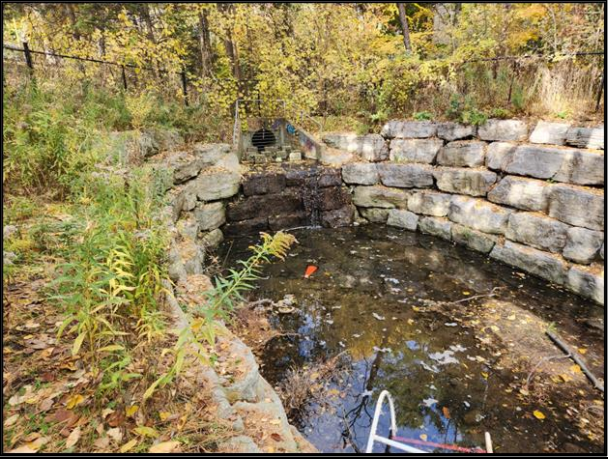
Outfall #	Reach	Asset ID	Diameter (mm)	Material	Construction Year	Condition	Headwall	Erosion Protection Works	Comments	Photo
10	Mountcastle Tributary	SIO-71-0001	1,050	Concrete	1987	Good	Concrete Headwall with Flared Wingwalls and Steel Railing	Energy Dissipation Blocks Downstream of Outfall Engineered Armourstone Plunge Pool	Outfall protected through previous channel restoration works identified as part of the Frenchman's Bay Stormwater Management Master Plan

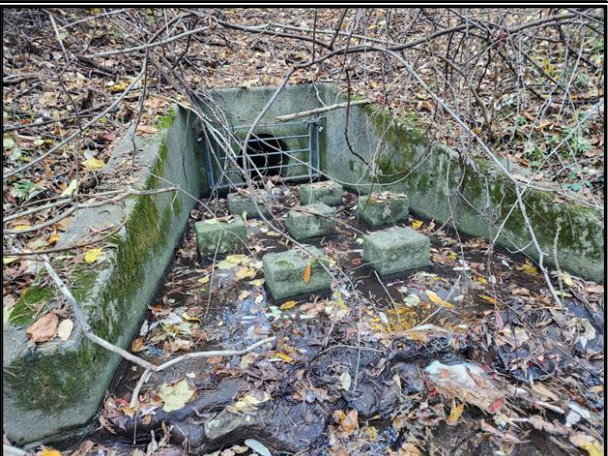
15	PC4-b	Unknown	500	Concrete	Unknown	Good	Concrete Headwall with Flared Wingwalls	Engineered Energy Dissipation Blocks	<p>This outfall is located in Lynn Heights Park, immediately Southeast of 923 Alanbury Crescent</p> <p>Steel Grate in Good Condition</p> <p>Outfall is setback from the Main Channel</p> <p>Minor Erosion Observed Around the Concrete Wingwalls</p>
